RENESAS TECHNICAL UPDATE

Product Category	MPU & MCU		Document No.	TN-16C-A224A/E	Rev.	1.00
Title	Errata to R32C/117 Group User's Manual: Hardware		Information Category	Technical Notification		
Applicable Product	R32C/117 Group	Lot No.	Reference Document	R32C/117 Group User's Manual: Hardware Rev. 1.10 (REJ09B0533-0110)

This document describes corrections to the R32C/117 Group User's Manual: Hardware, Rev. 1.10. The corrections are indicated in red in the list below.

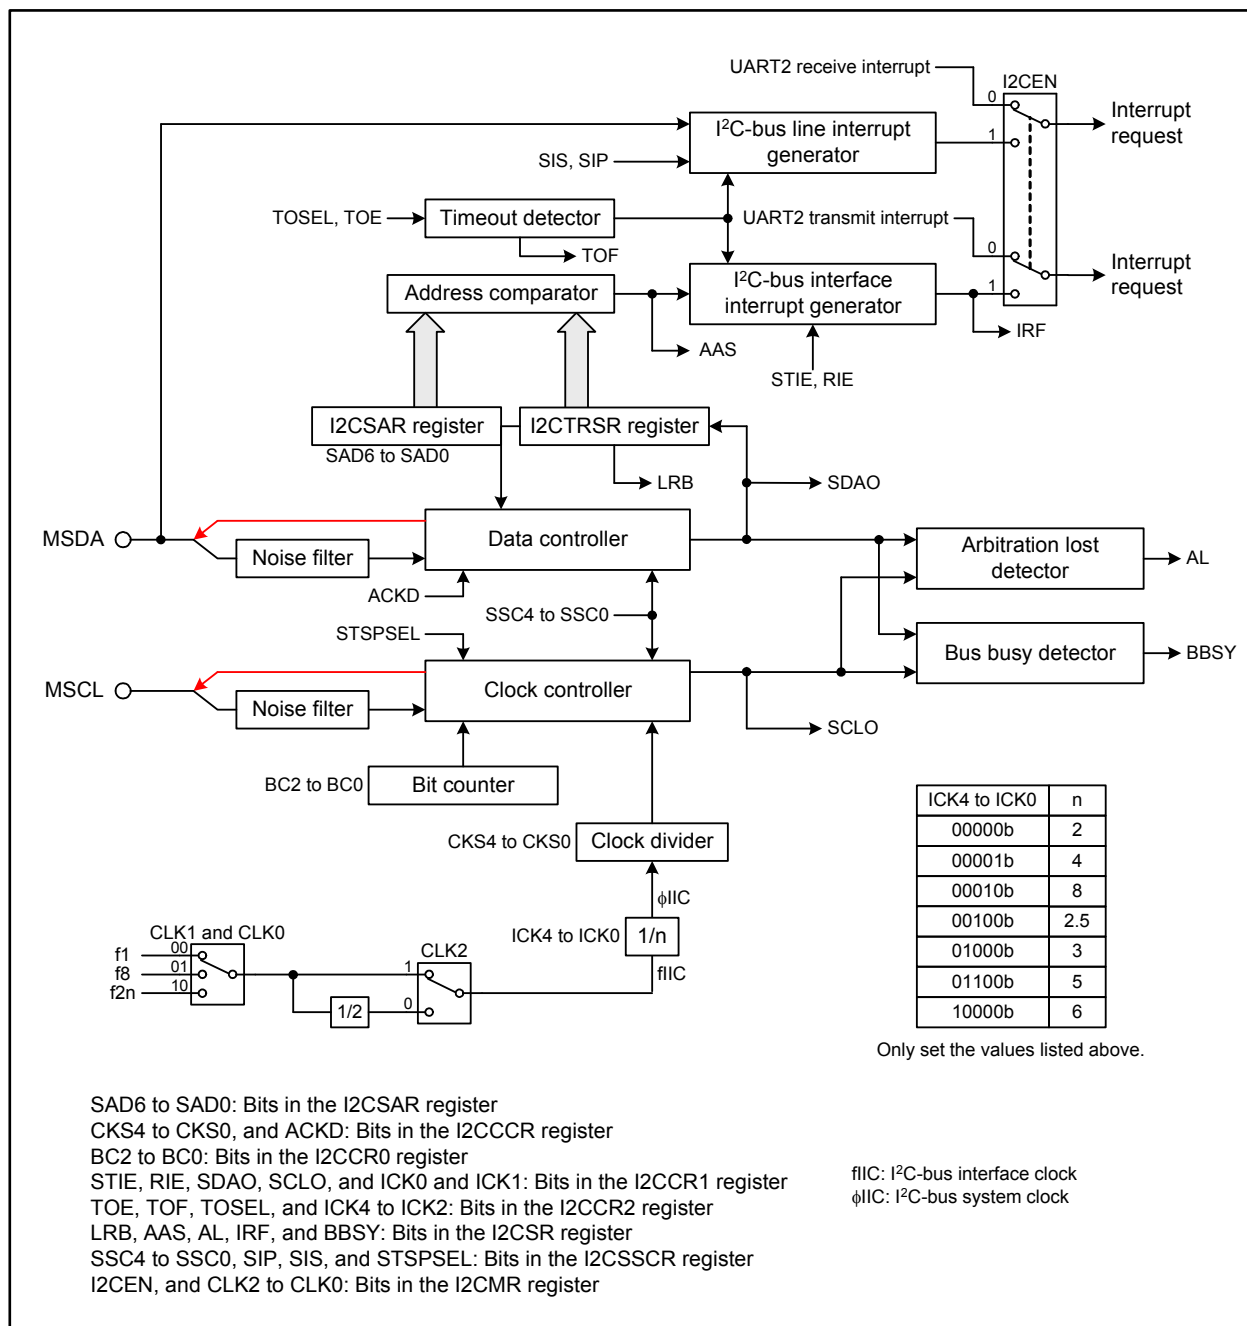
Figure 24.1 Multi-master I²C-bus Interface Block Diagram

•Page 377 of 604, Figure 24.1 is corrected as follows:

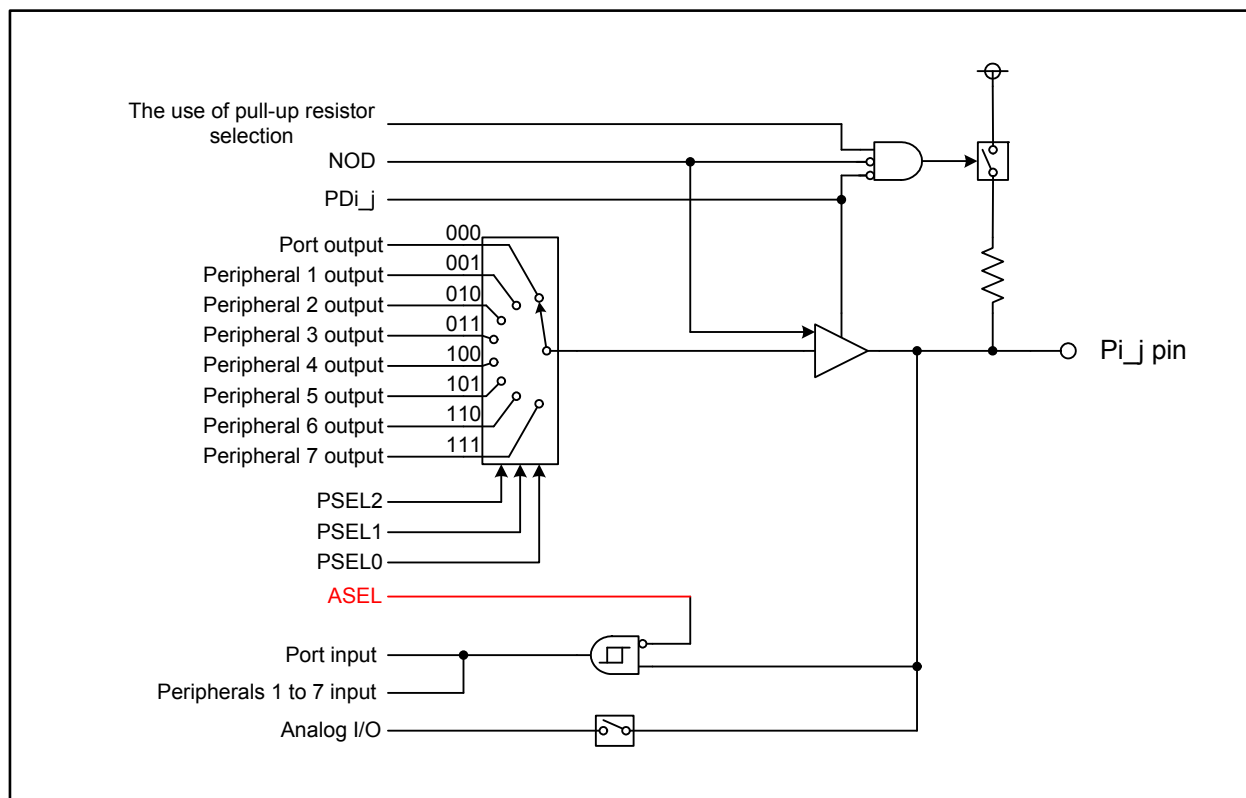
Figure 26.1 Typical I/O Pin Block Diagram (i = 0 to 15; j = 0 to 7)

- Page 476 of 604, Figure 26.1 is corrected as follows (refer to TN-16C-A200A/E):
