# RENESAS TECHNICAL UPDATE

Product Category	MPU & MCU	Document No.	TN-16C-A206A/E	Rev.	1.00
Title	Errata to R32C/120 Group Hardware Manual		Information Category	Technical Notification	
Applicable Product	R32C/120 Group	Lot No.	Reference Document	R32C/120 Group Hardware Manual Rev. 1.10 (REJ09B0476-0110)

This document describes corrections to the R32C/120 Group Hardware Manual, Rev. 1.10.  
The corrections are indicated in red in the list below.

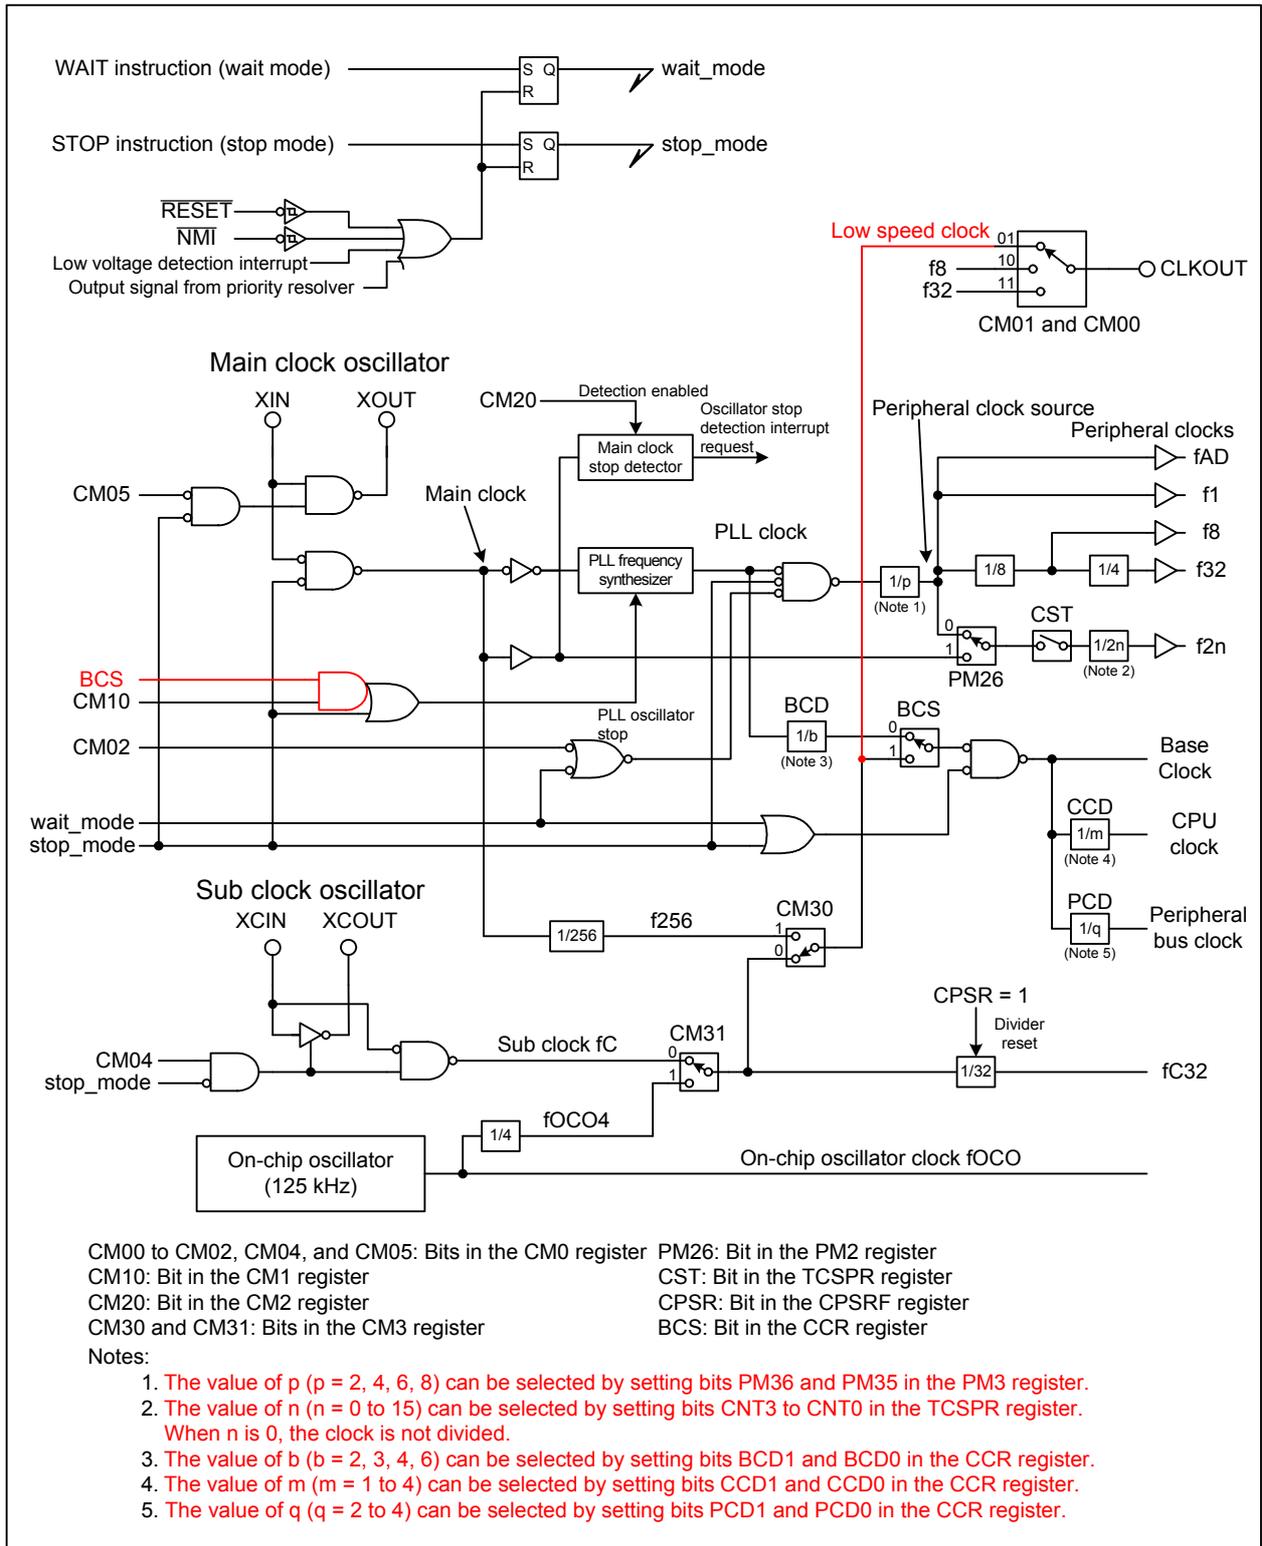
Figure 7.1 Clock Generation Circuitry

•Page 72 of 588, Figure 7.1 is corrected as follows:

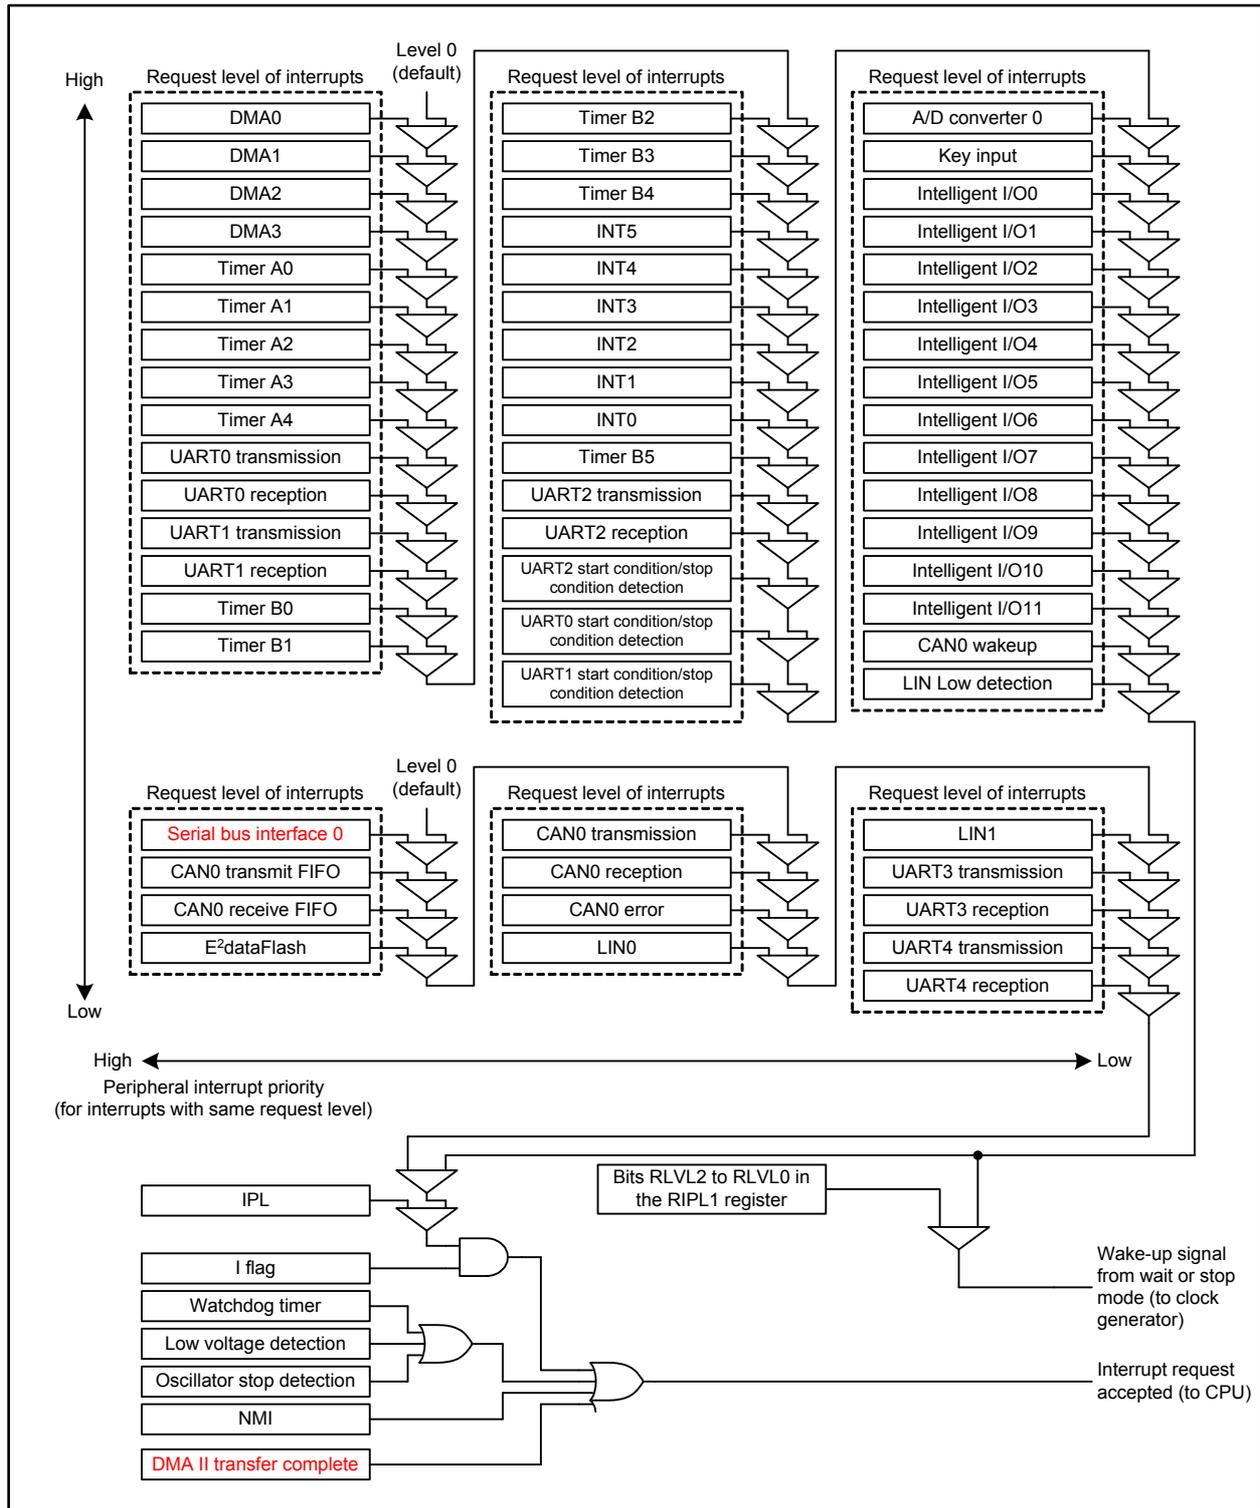
**Figure 10.8 Priority Resolver**

•Page 124 of 588, Figure 10.8 is corrected as follows:

(Description “Bits RLV2 to RLV0 in the RIPL2 register” and associated signal lines are deleted from Figure 10.8)

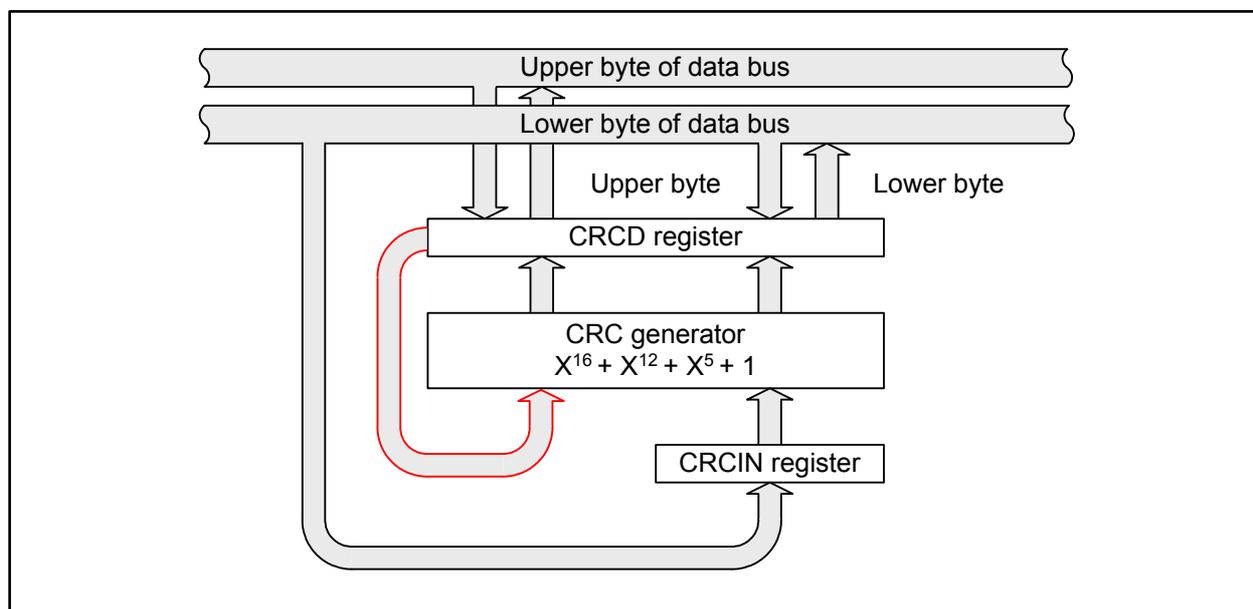
Figure 20.1 CRC Calculator Block Diagram

- Page 289 of 588, Figure 20.1 is corrected as follows:

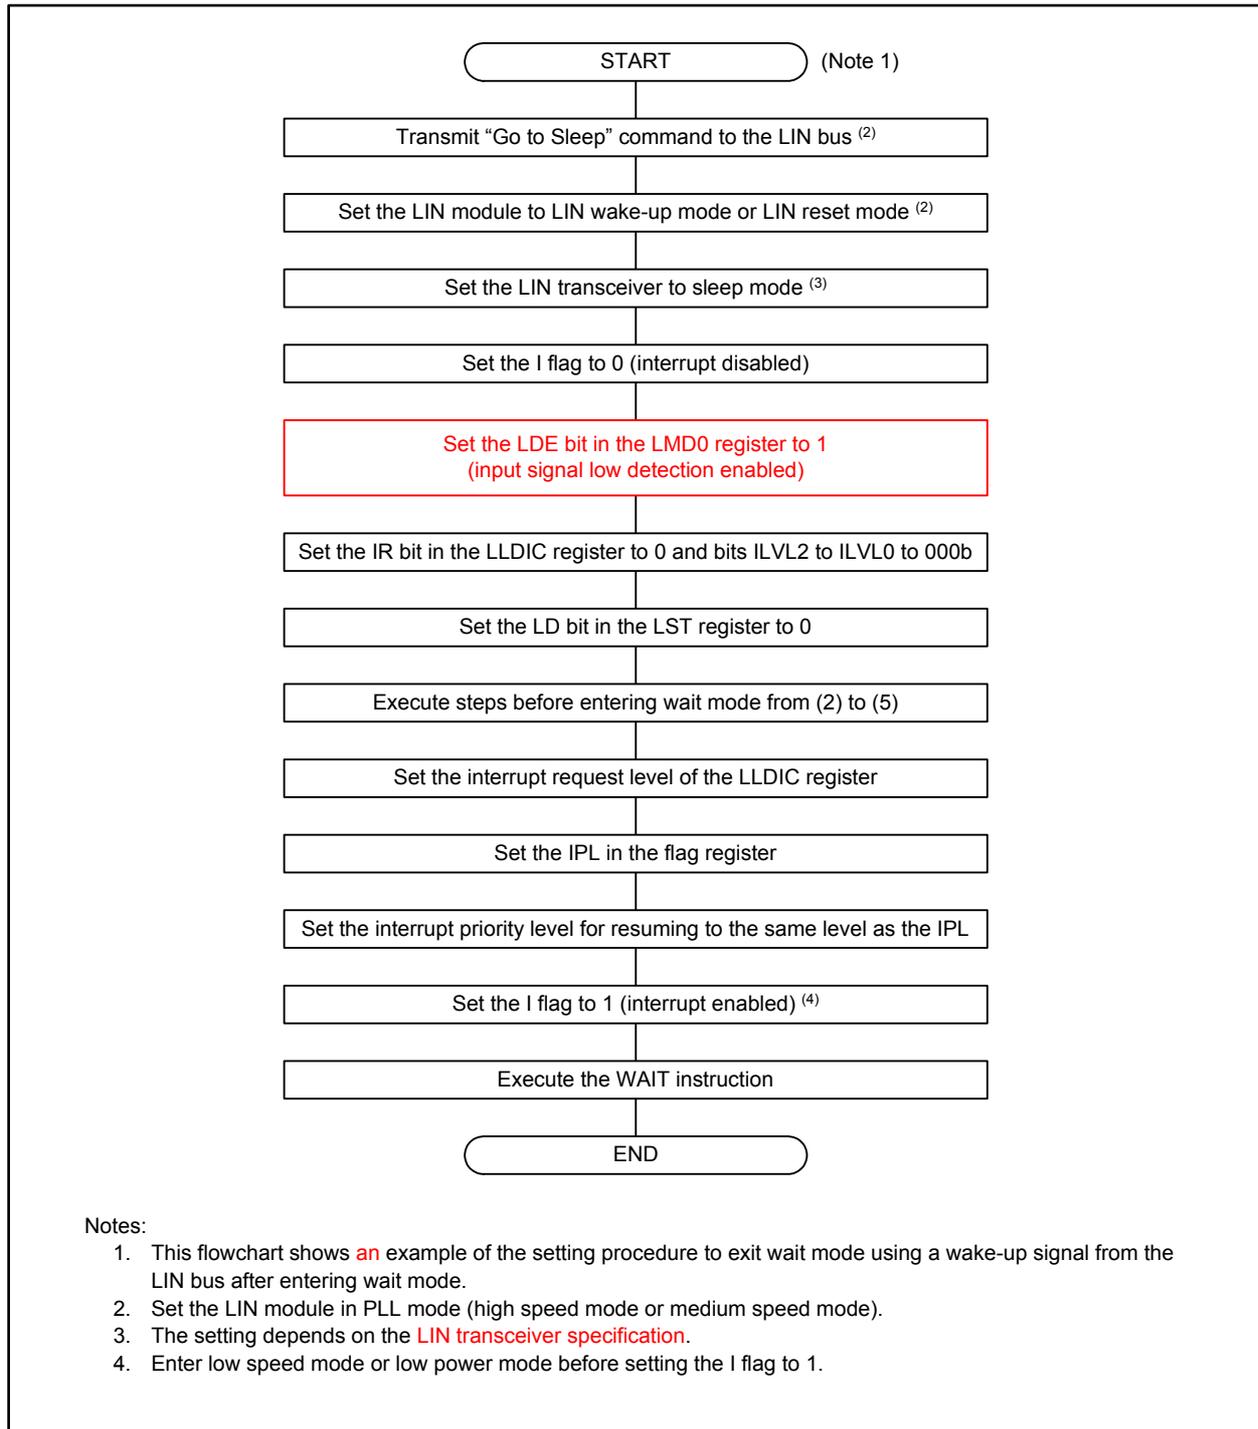
**Figure 24.30 Example of Setting Before Transition to Wait Mode**

•Page 394 of 588, Figure 24.30 is corrected as follows:

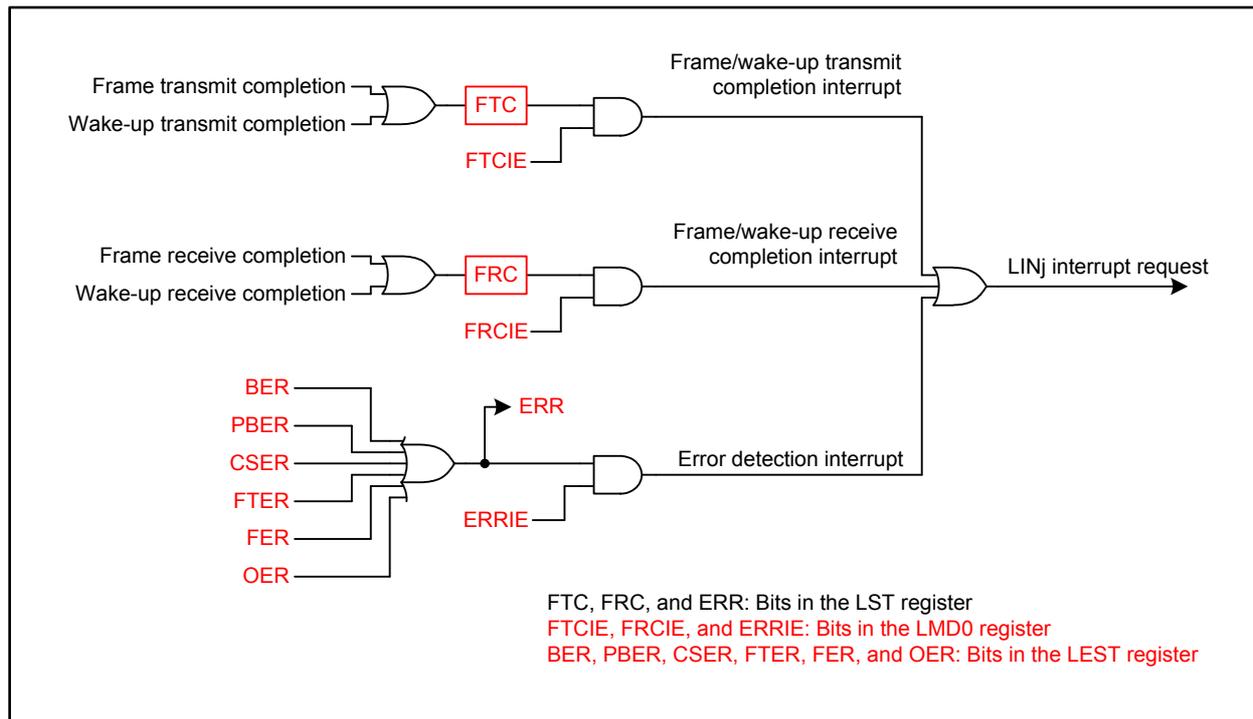
Figure 24.32 LINj Interrupt Block Diagram (j = 0, 1)

•Page 398 of 588, Figure 24.32 is corrected as follows:

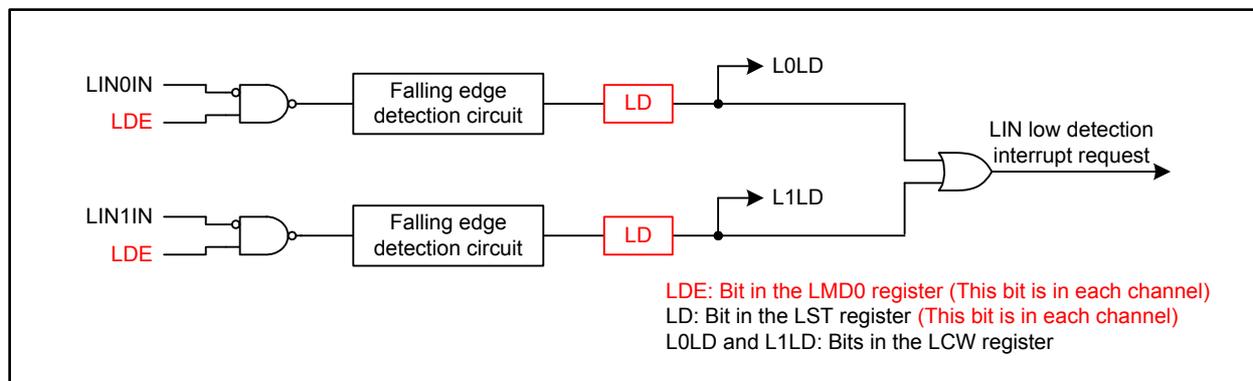
Figure 24.33 LIN Low Detection Interrupt Block Diagram

•Page 398 of 588, Figure 24.33 is corrected as follows:

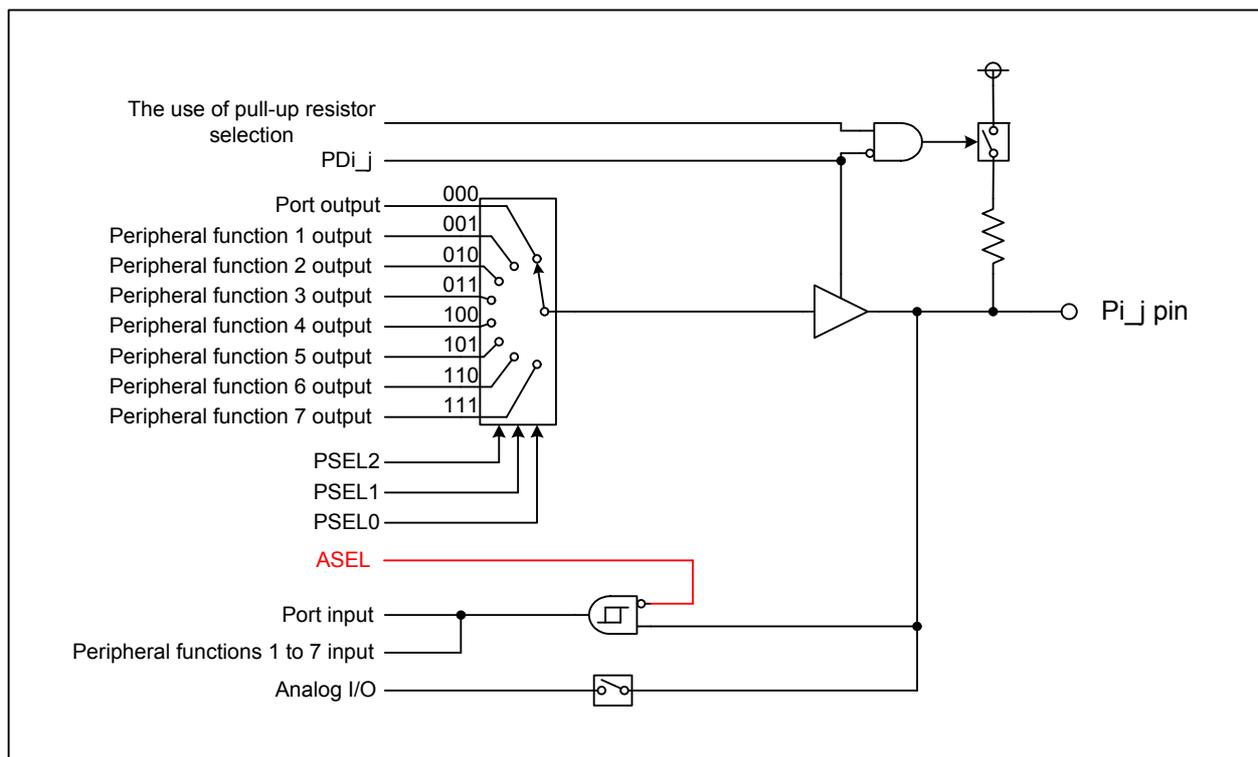
**Figure 26.1 Typical I/O Pin Block Diagram (i = 0 to 10; j = 0 to 7)**

- Page 468 of 588, Figure 26.1 is corrected as follows (refer to TN\_16C\_A198A/E):

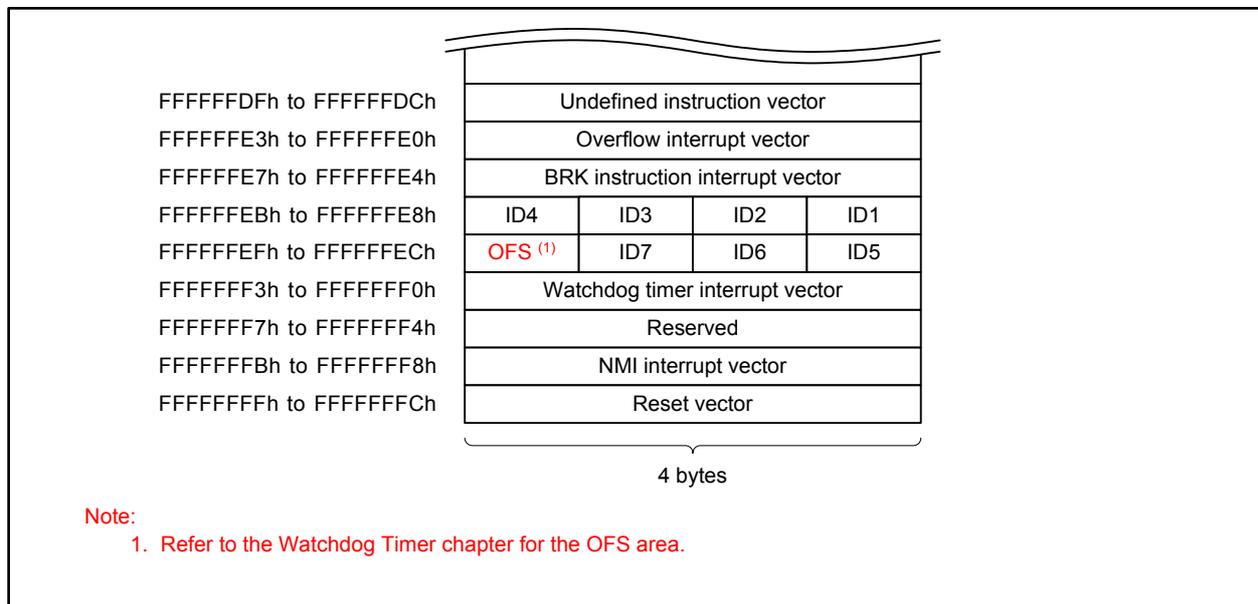
Figure 27.2 Addresses for ID Code Stored

- Page 493 of 588, description “use the serial programmer to” is deleted from line 3 of 27.2.2.
- Page 494 of 588, Figure 27.2 is corrected as follows:

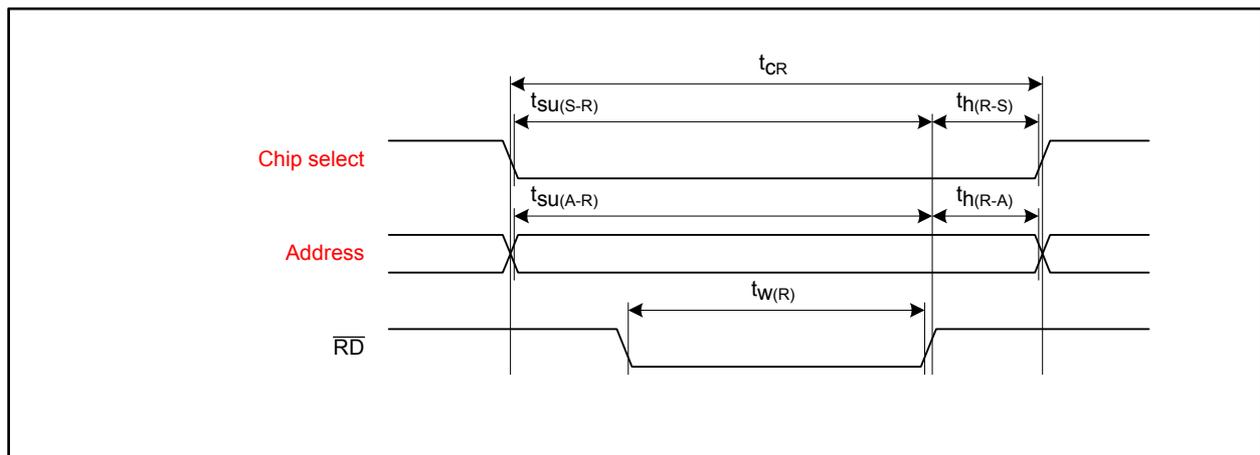
Figure 27.12 Read Timing

•Pages 502 and 504 of 588, descriptions in Figures 27.12 and 27.13 are corrected as follows:

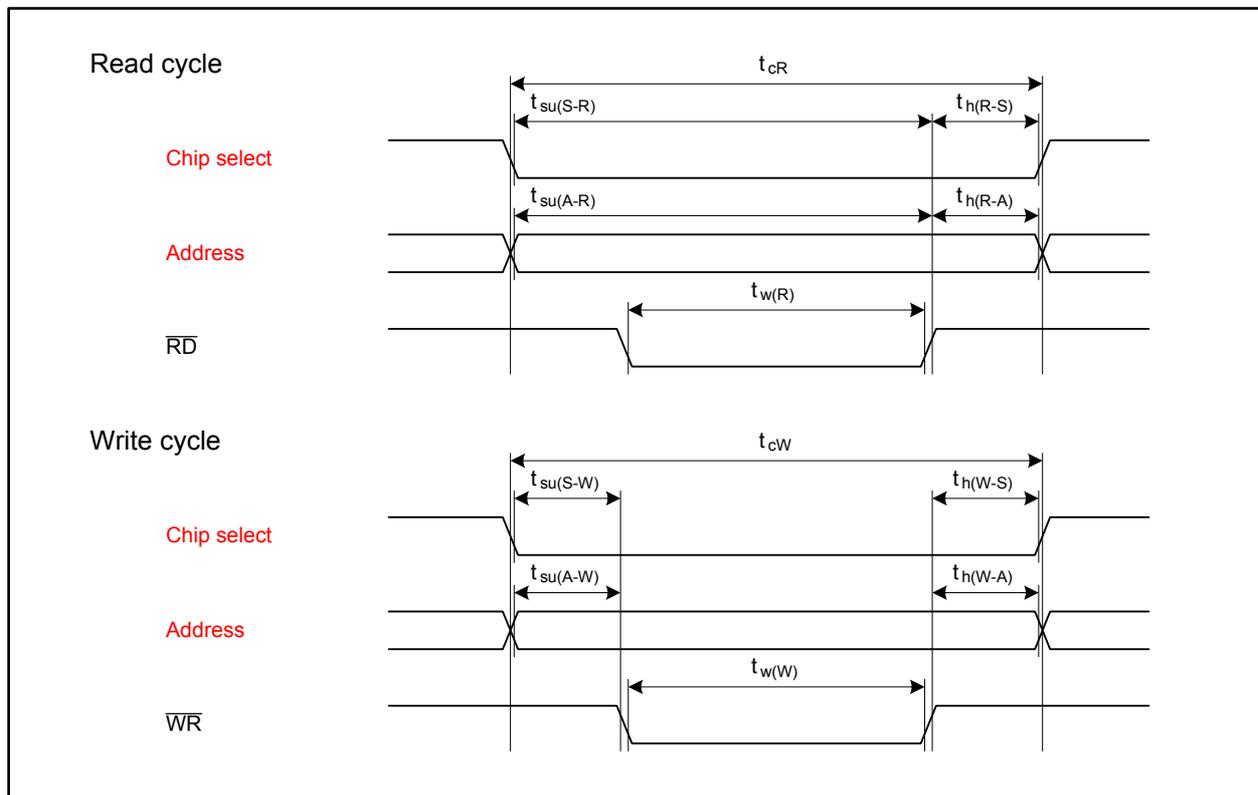
Figure 29.5 Flash Memory CPU Rewrite Mode Timing

- Page 522 of 588, the following description is added to Note 3 of Figure 28.2:  
 “However, the registers are not initialized.”
- Page 522 of 588, description “This mode setting prevents data from being overwritten if a program goes out of control.” is deleted from Note 5 in Figure 28.2.
- Page 528 of 588, description “EERR bit in the E2FS0 register is 1?” in Figure 28.12 is corrected as follows:  
 “EERR bit in the E2FS0 register is 0?”
- Pages 537 and 538 of 588, description “Programming and erasure endurance of flash memory” in Tables 29.8 and 29.9 is changed as follows:  
 “Program and erase cycles”
- Pages 537 and 538 of 588, unit “times” for “Programming and erasure endurance of flash memory” in Tables 29.8 and 29.9 and Note 1 is corrected as follows:  
 “Cycles”
- Page 541 of 588, descriptions in Figure 29.5 are corrected as follows:
