RENESAS TECHNICAL UPDATE

Product Category	MPU & MCU	Document No.	TN-16C-A193A/E	Rev.	1.00
Title	Errata to R32C/151 Group Hardware Manual	Information Category	Technical Notification		
Applicable Product	R32C/151 Group	Lot No.	Reference Document	R32C/151 Group Hardware Manual Rev. 1.03 (REJ09B0503-0103)

This document describes corrections to the R32C/151 Group Hardware Manual, Rev. 1.03.
The corrections are indicated in red in the list below.

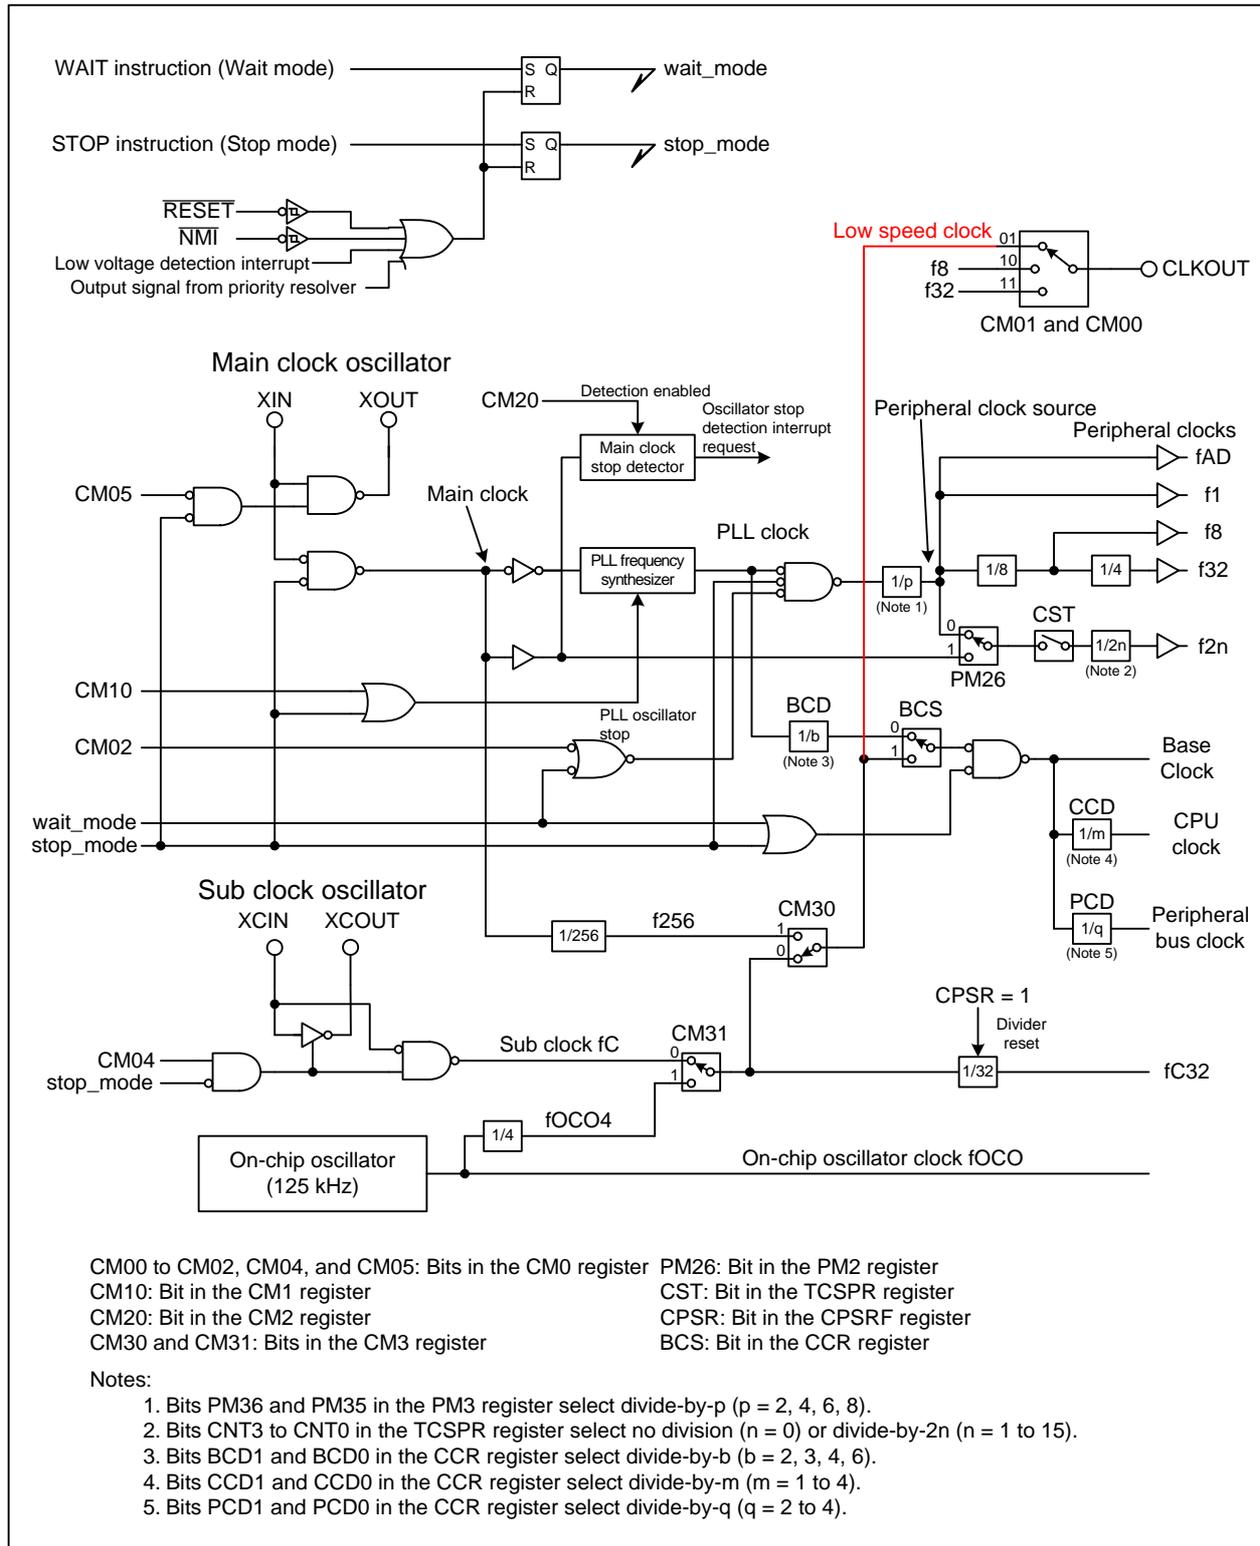
Figure 7.1 Clock Generation Circuitry

•Page 91 of 624, Figure 7.1 is corrected as follows:

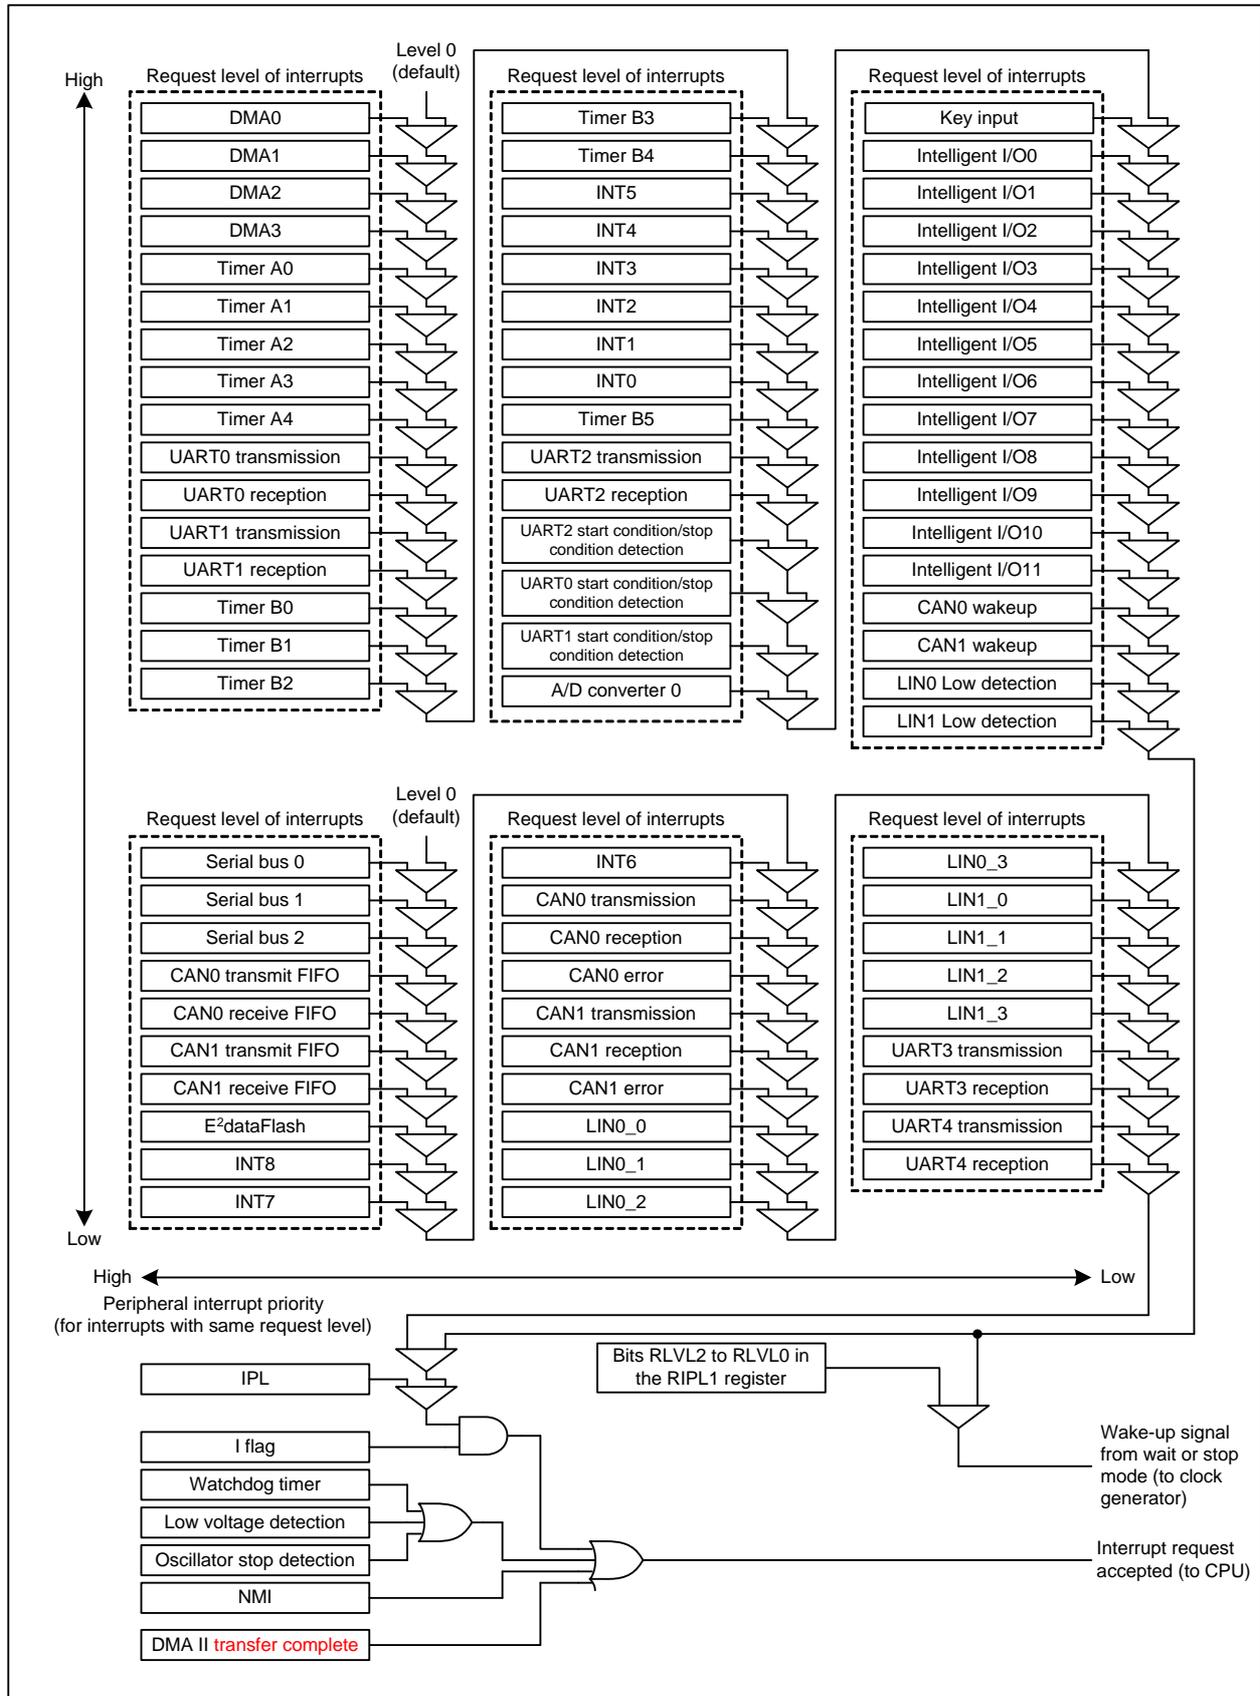
Figure 10.8 Priority Resolver

•Page 143 of 624, Figure 10.8 is corrected as follows:

(Description “Bits RLV2 to RLV0 in the RIPL2 register” and associated signal lines are deleted from Figure 10.8)

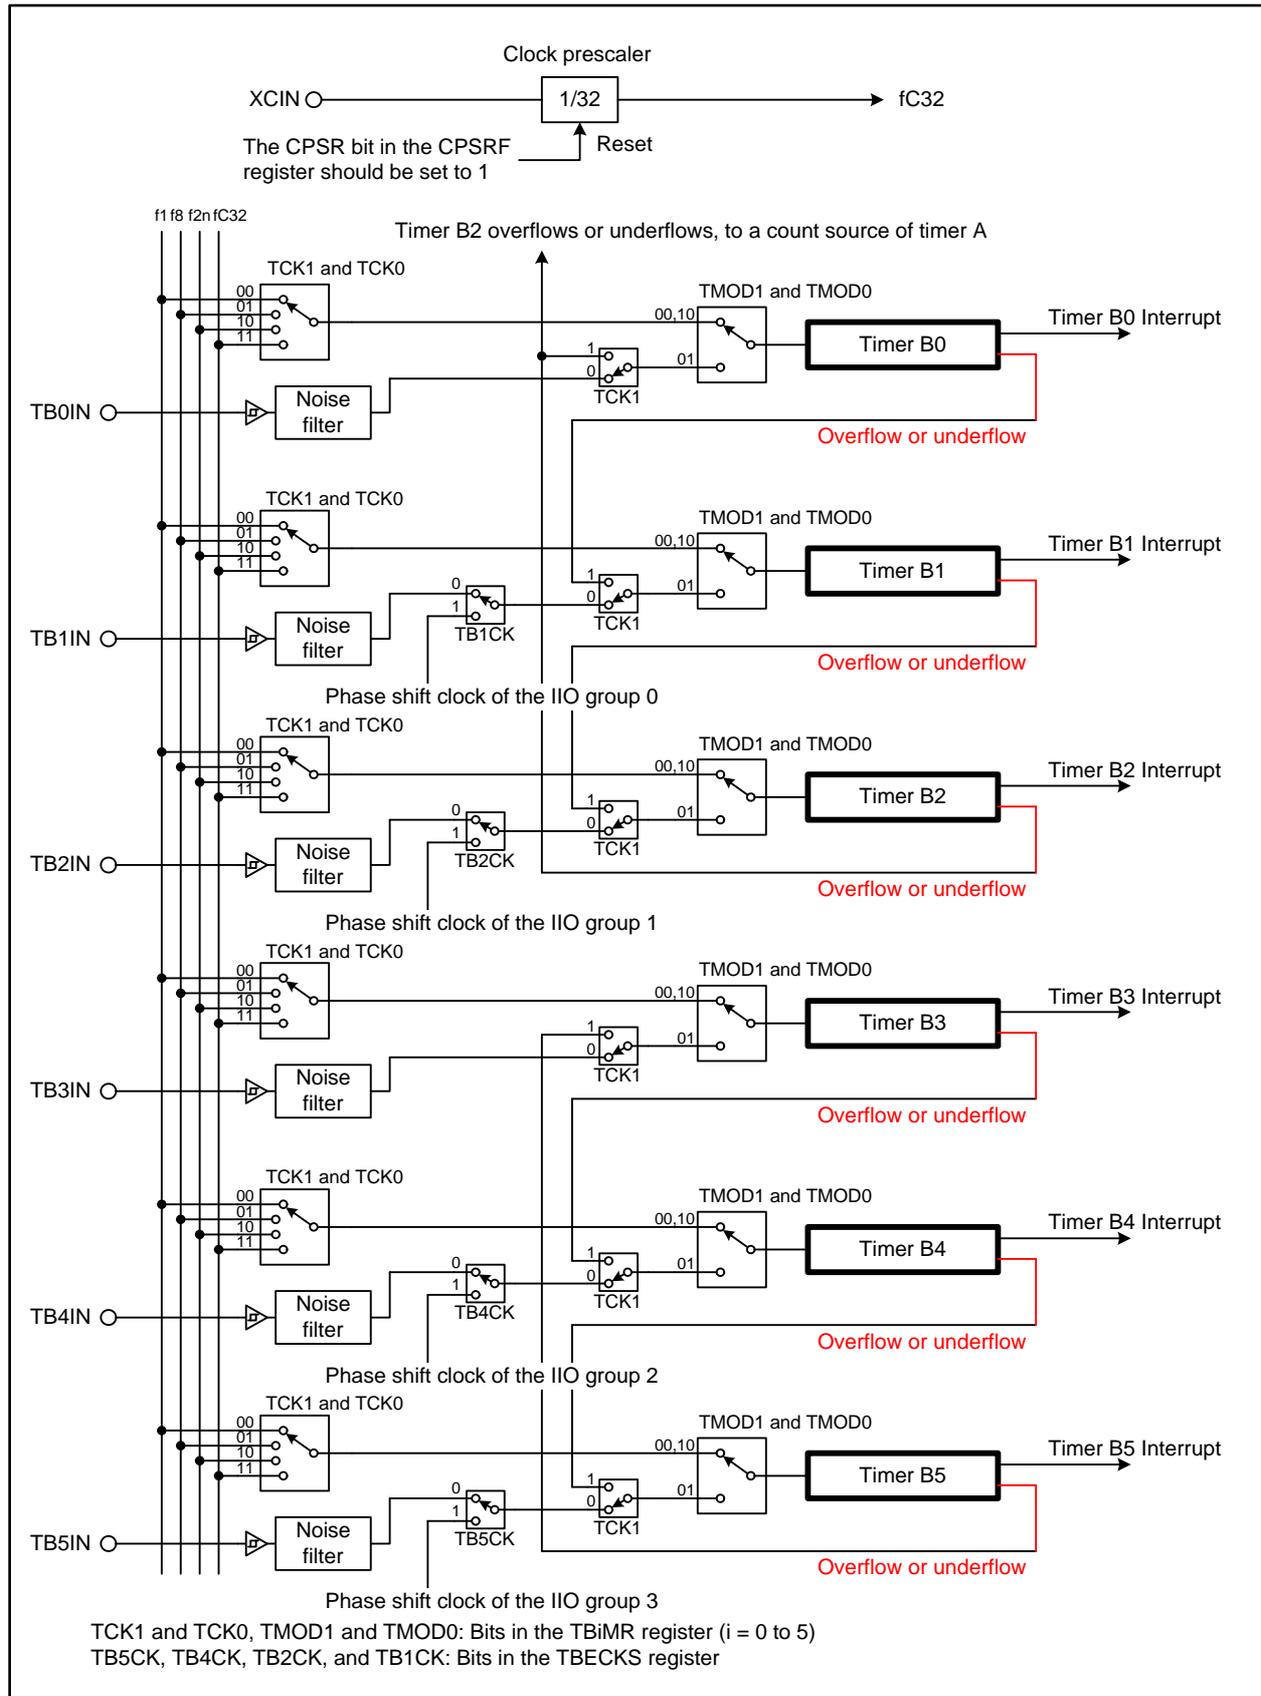
Figure 15.2 Timer B Configuration

•Page 185 of 624, Figure 15.2 is corrected as follows:

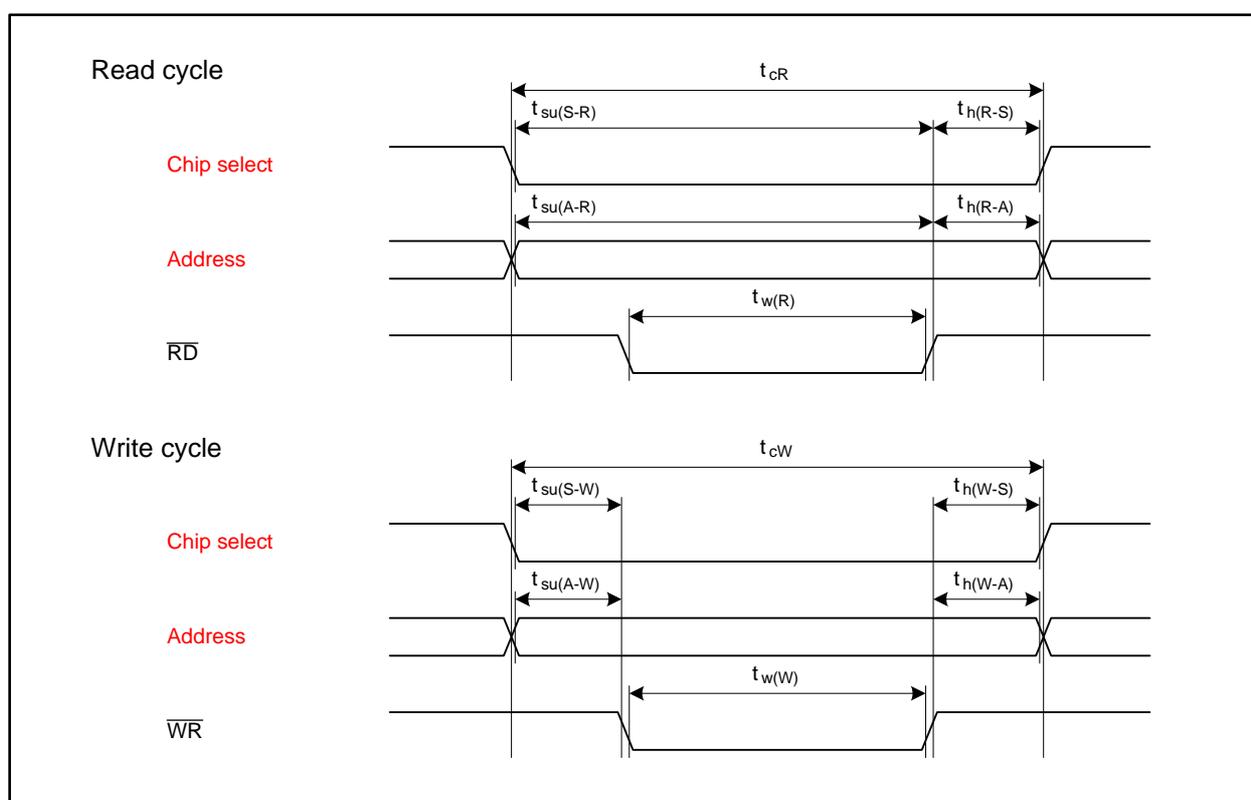
Figure 29.5 Flash Memory CPU Rewrite Mode Timing

•Page 577 of 624, descriptions in Figure 29.5 are corrected as follows:
