RENESAS TECHNICAL UPDATE

Product Category	MPU & MCU	Document No.	TN-RX*-A052A/E	Rev.	1.00
Title	Notes on Sub-clock Initialization in the RX630 Group, RX63N Group, and RX631 Group		Information Category	Technical Notification	
Applicable Product	RX630 Group RX63N Group, RX631 Group	Lot No.	Reference Document	RX630 Group User's Manual: Hardware Rev.1.50 (R01UH0040EJ0150)	
		All		RX63N Group, RX631 Group User's Manual: Hardware Rev.1.60 (R01UH0041EJ0160)

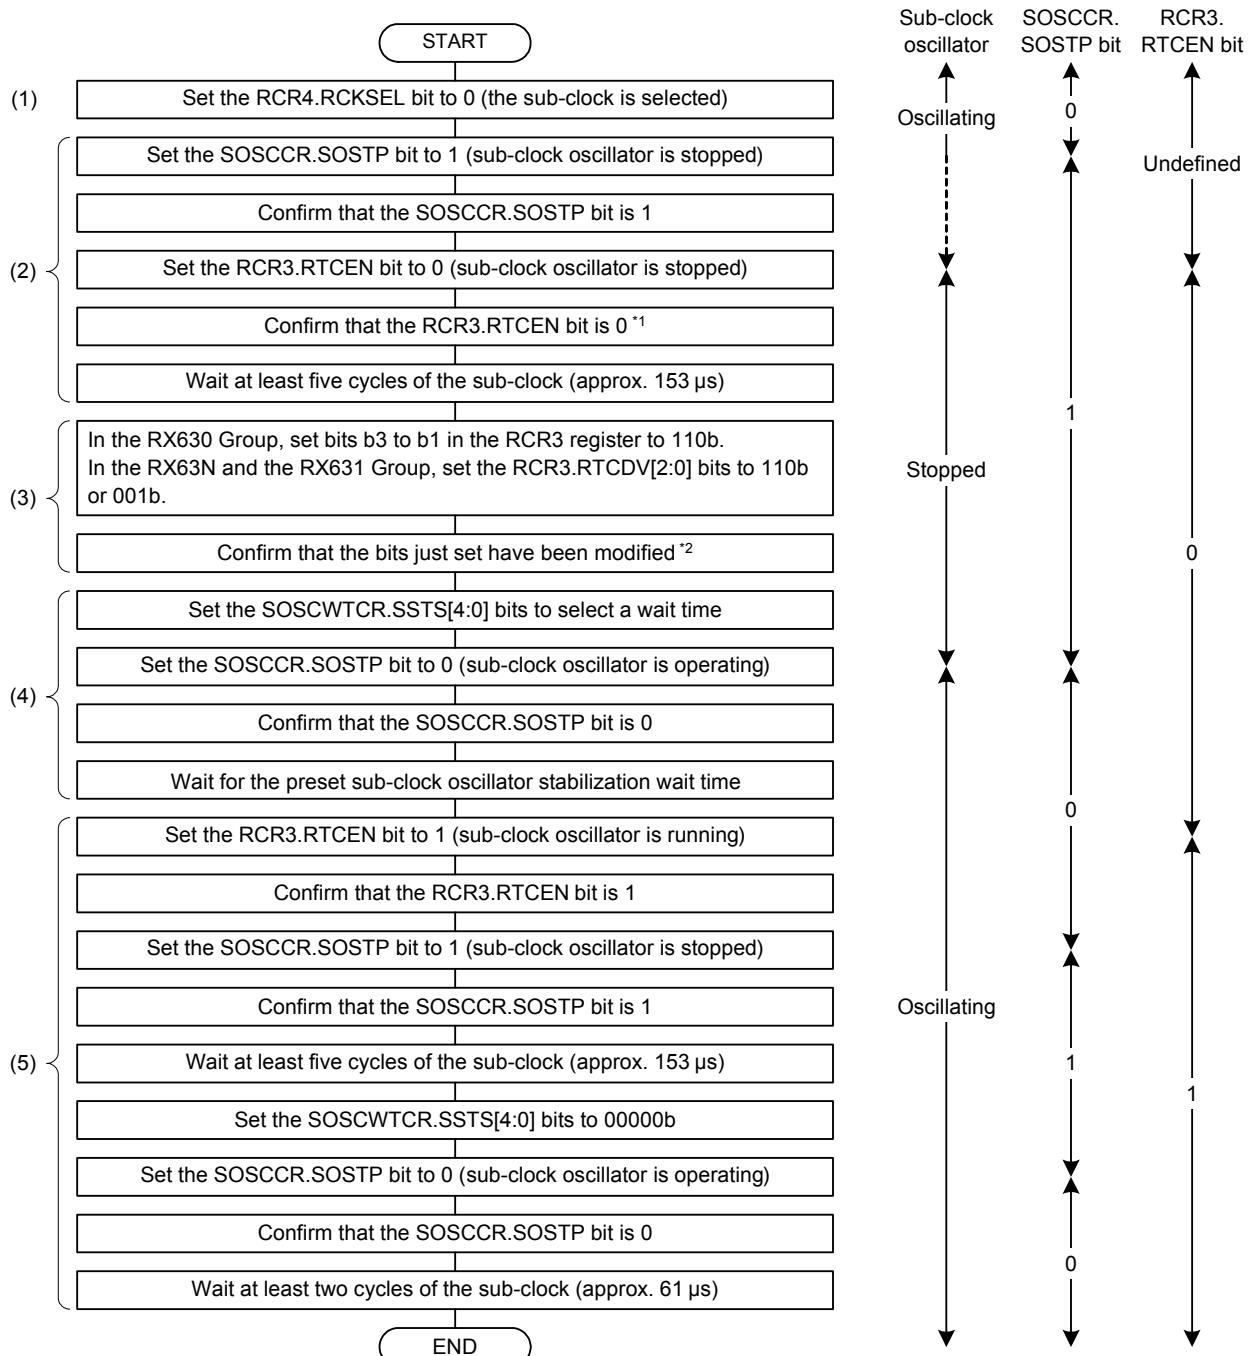
Figure 2.1 Initialization Flowchart When Using the Sub-clock as an RTC Count Source

Since the sub-clock is enabled by setting the RCR3.RTCEN bit to 1 (sub-clock oscillator is running), the sub-clock does not stop even in software standby mode. However, when the SOSCCR.SOSTP bit is 0, since the MCU waits for the number of cycles preset in the SOSCWTCSR.SSTS[4:0] bits when exiting software standby mode, it takes time. Therefore, make sure to set the SOSCWTCSR.SSTS[4:0] bits again so that the sub-clock oscillator stabilization wait time is minimized.

(1) Select the RTC count source

The RCR4.RCKSEL bit is undefined at power-on; therefore, select the sub-clock as the RTC count source. Since the sub-clock frequency is lower than LOCO clock frequency, the system clock does not need to be changed.

(2) Stop the sub-clock

Stop the sub-clock temporarily to modify bits b3 to b1 in the RCR3 register for the RX630 Group (the RCR3.RTCDV[2:0] bits in the RX63N and RX631 Groups).

(3) Set bits in the RCR3 register

In the RX630 Group, set bits b3 to b1 to 110b. In the RX63N Group and the RX631 Group, set the RTCDV[2:0] bits to 110b or 001b according to the crystal being used.

(4) Oscillate the sub-clock

Set wait time of the sub-clock oscillator and then set the SOSCCR.SOSTP bit to 0 (sub-clock oscillator is operating).

(5) Minimize the sub-clock oscillator stabilization wait time

Set the SOSCWTCSR.SSTS[4:0] bits to 00000b in order to minimize the time required for exiting software standby mode. To modify the SOSCWTCSR register, temporarily set the SOSCCR.SOSTP bit to 1 after setting the RCR3.RTCEN bit to 1 so the sub-clock does not stop oscillating.

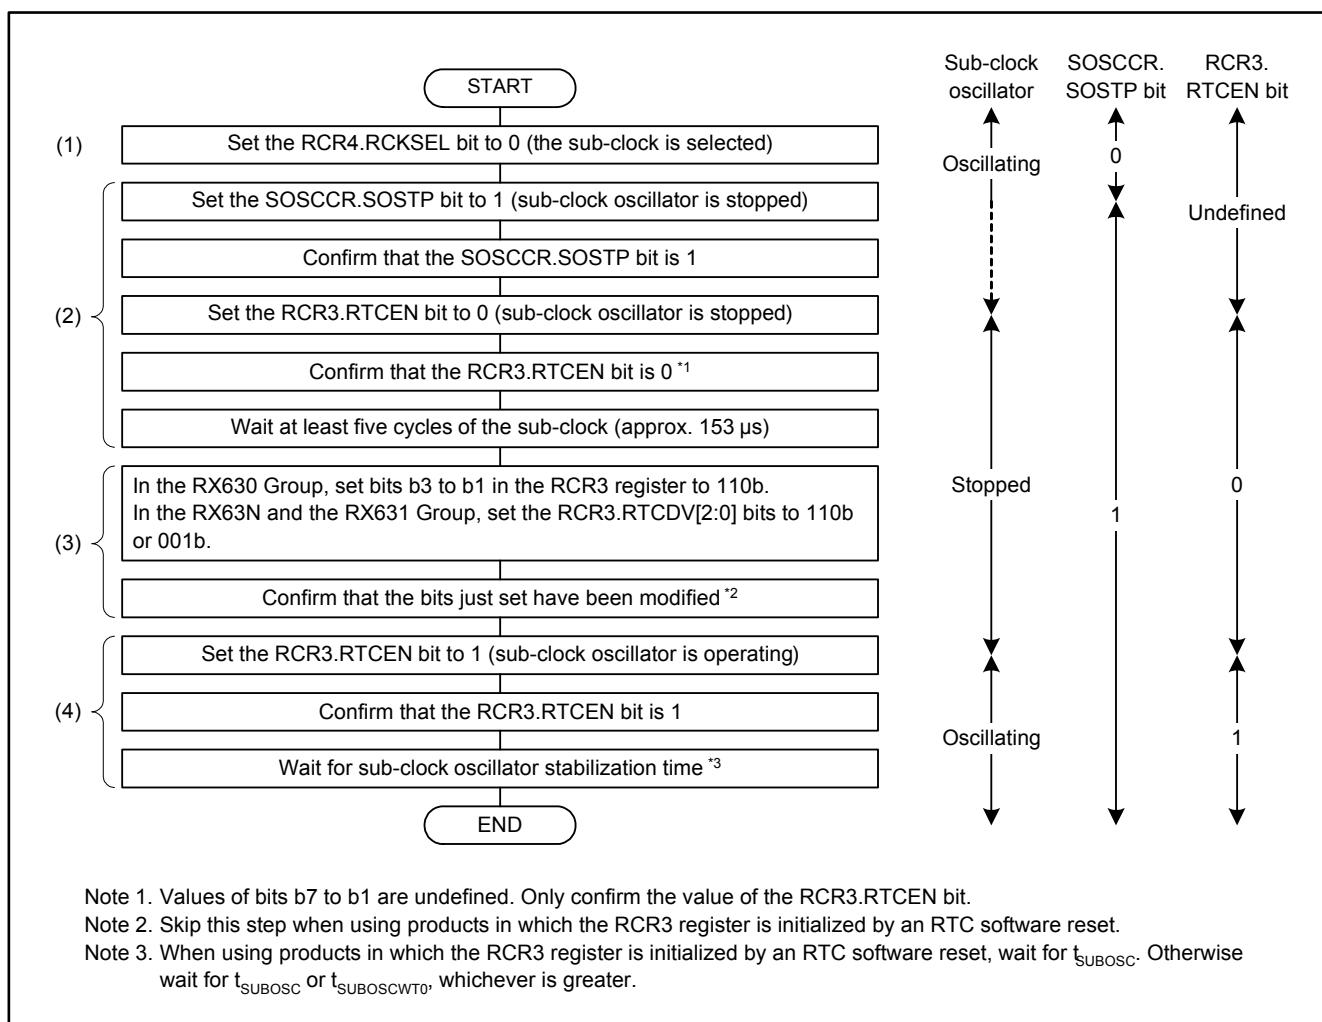
Figure 2.2 Initialization Flowchart When Using the Sub-clock Only as an RTC Count Source

Unlike the procedure described in the user's manuals, the following is an example of how to oscillate the sub-clock while the SOSCCR.SOSTP bit is 1 (sub-clock oscillator is stopped). Oscillation of the sub-clock is controlled with the RCR3.RTCEN bit. In this case, oscillation of the sub-clock is not influenced by software standby mode.

(1) Select the RTC count source

The RCR4.RCKSEL bit is undefined at power-on; therefore, select the sub-clock as the RTC count source. Since the sub-clock frequency is lower than the LOCO clock frequency, the system clock does not need to be changed.

(2) Stop the sub-clock

Stop the sub-clock temporarily to modify bits b3 to b1 in the RCR3 register for the RX630 Group (the RCR3.RTCDV[2:0] bits in the RX63N and RX631 Groups).

(3) Set bits in the RCR3 register

In the RX630 Group, set bits b3 to b1 to 110b. In the RX63N Group and the RX631 Group, set the RTCDV[2:0] bits to 110b or 001b according to the crystal being used.

(4) Oscillate the sub-clock

Set the RCR3.RTCEN bit to 1 to oscillate the sub-clock.

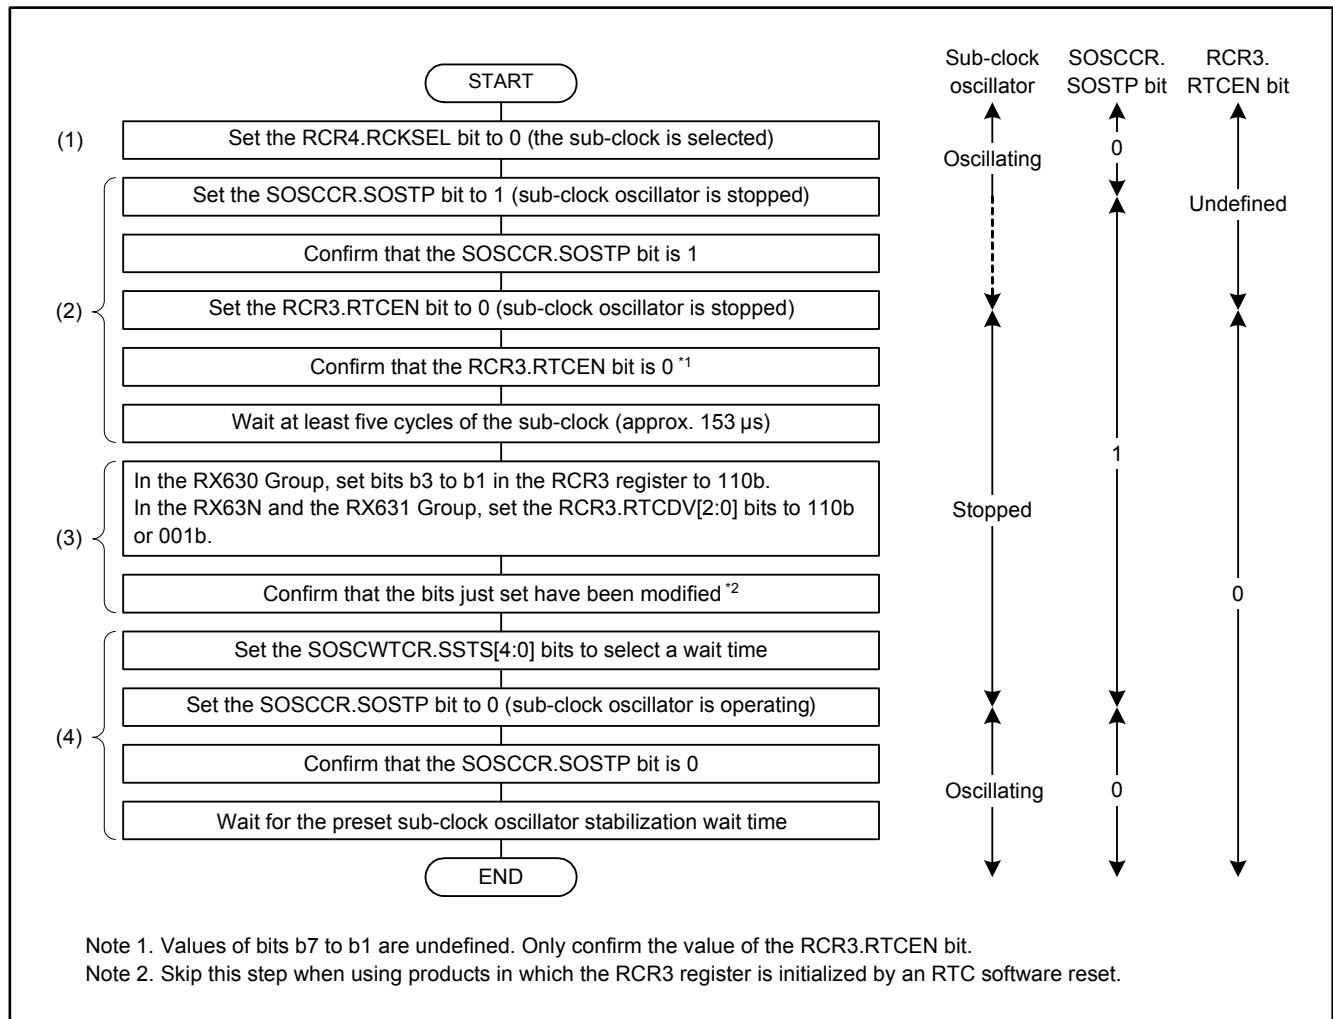
Figure 2.3 Initialization Flowchart When Using the Sub-clock Only as a System Clock

Since the RCR3.RTCEN bit is set to 0 (sub-clock oscillator is stopped), the sub-clock stops in software standby mode.

The sub-clock initialization procedure assuming this condition is identical to steps (1) to (4) described in A. "When using the sub-clock as a count source of the RTC".

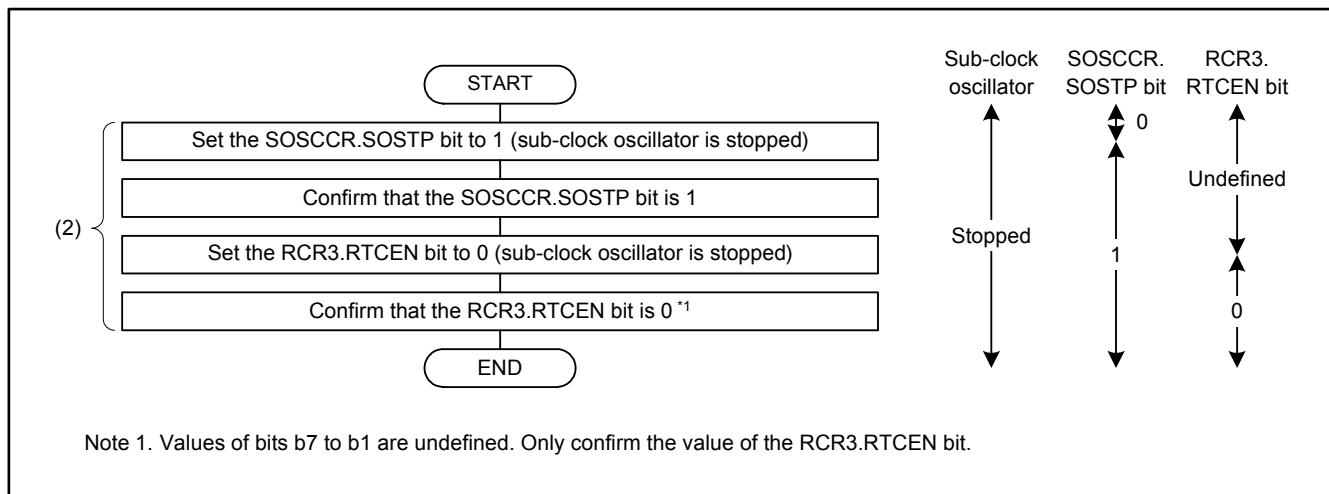
Figure 2.4 Initialization Flowchart When Not Using the Sub-clock

When a crystal for the sub-clock is not connected, if the SOSCCR.SOSTP bit is 0, the MCU cannot exit software standby mode. Make sure to set both bits SOSCCR.SOSTP and RCR3.RTCEN so as to stop oscillation of the sub-clock.
