Abstract

The design of a daisy chain battery system, while fairly straightforward, has a number of design elements that can become obstacles to implementation. This case study provides a glimpse into the questions and responses in the development of one daisy chain system.

Introduction

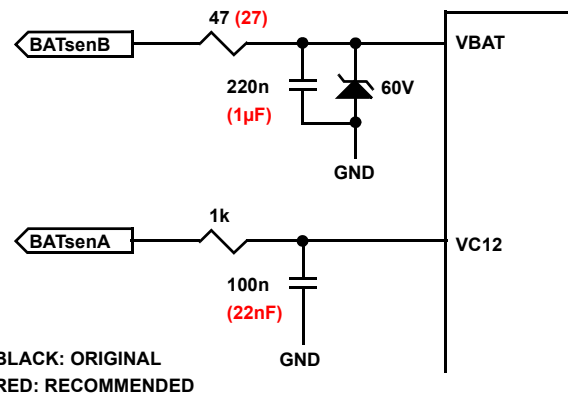
FIGURE 1. INITIAL VBAT CONNECTION

The VBAT input resistor was not damaged. Attached is a schematic of the VBAT connection.

Normally, we recommend a 27Ω resistor. While a 47Ω resistor may be OK, what happens is that the voltage at the VBAT pin drops when there is higher current, like during SPI or daisy chain communications. If the voltage drops too much, then there is not enough headroom on the front end analog circuits and there can be measurement errors. So, if the input resistor is not damaged then try a 27Ω resistor to see if this makes a difference.

If a smaller resistor value does not make a difference, then check that there is no large voltage differential across the VBAT series resistor. There should be a small drop in voltage (up to

about 80mV), however, if there is more than this, check the diode. If the diode is OK and there is still a voltage drop across the resistor, then the part may be damaged.

The schematic shows two connections to the top of the stack, one for VBAT and one for VC12. This is OK, however, check to see if there is a fault condition. If the BATsenB wire is broken, it could affect the measurement accuracy, however, this would also show up as an open VBAT fault.

Another recommendation we make on the input filters is that the time constants on all inputs be the same (or about the same). In this case, the cell input time constant is about 16 times the VBAT time constant. If there are high voltage transients on the pack voltage, the differential time constants will result in high voltage differentials on the IC input pins. To minimize this, we recommend different filter values, as shown in RED in [Figure 1 on page 2](#).

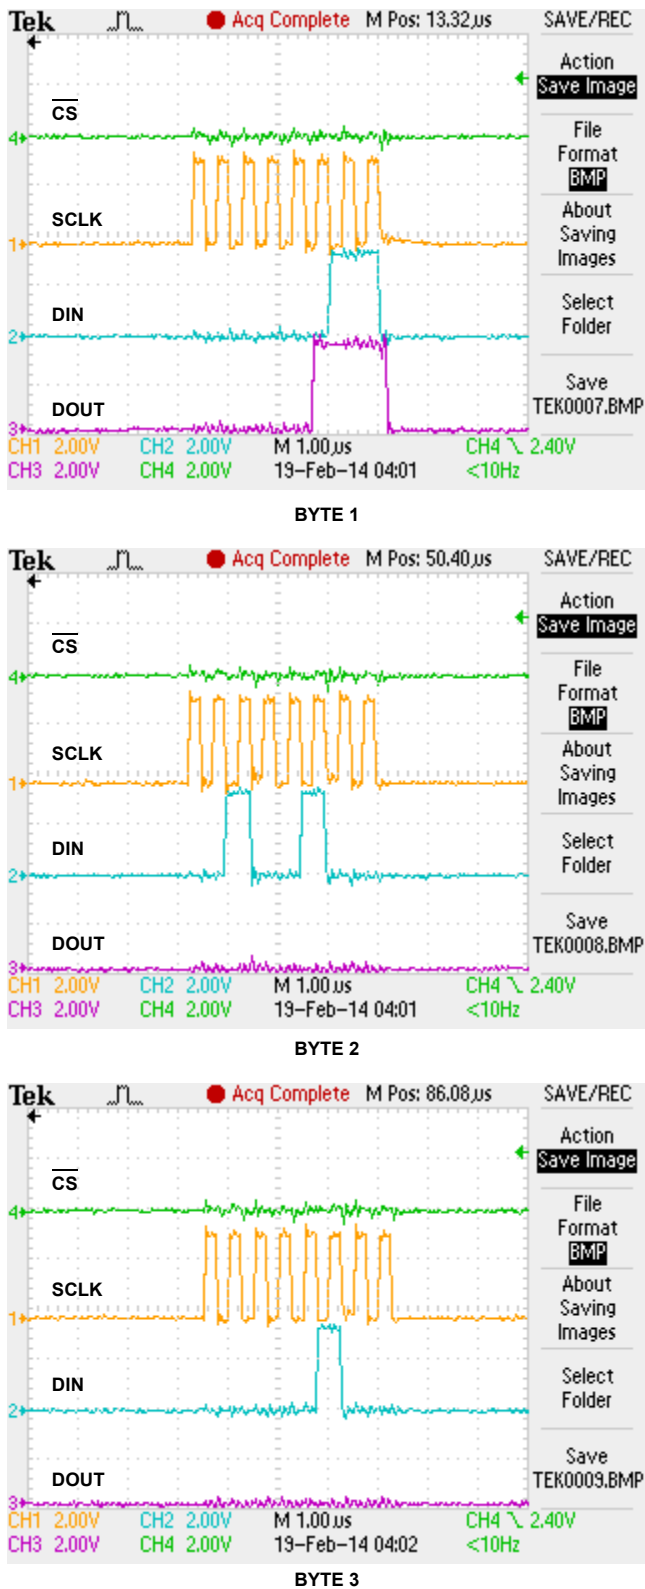
FIGURE 8. CUSTOMER REPORTED CORRECT STAND-ALONE COMMUNICATION

[Figure 8 on page 9](#) shows the SPI Identify command. The MISO data looks like 0x070000 but that's nothing valid to the best of my knowledge. If I send this command a few times in a row, I can get the MISO data to be 0x133800, which looks like a Comms Failure to me.

A: The fact that the upper device does not recognize the sleep/wake commands and there is no movement on the daisy chain lines means that there is something wrong with the daisy chain. *Nothing else matters until this can be cleared up.*

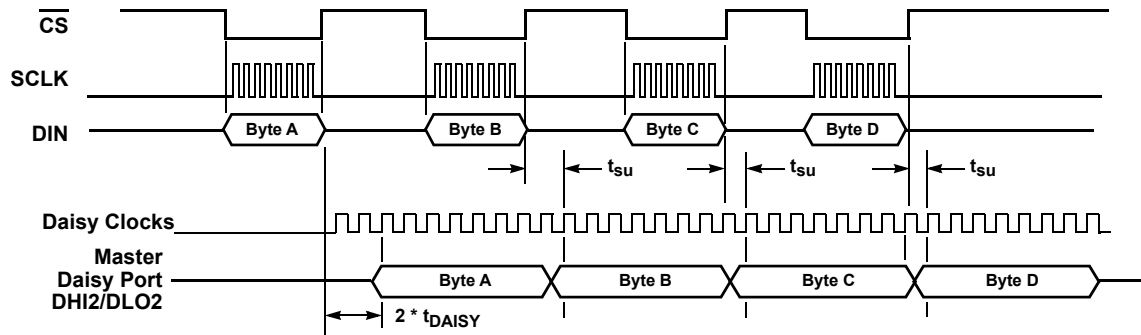
FIGURE 15. COMMAND TIMING TO AVOID DAISY BUFFER UNDERFLOW

Note: A command byte needs to be clocked into the SPI port at least one Daisy Chain clock prior to the first Daisy clock placing that byte on the DHI2/DLO2 port. ($t_{su} > 1 * t_{DAISY}$)

IMPORTANT: The host microcontroller must continue to feed the buffer with command bytes before all bytes have been clocked out on the Daisy Chain. If the Host MCU cannot keep the buffer full with proper command bytes, the Daisy Chain sends bad data to the devices on the Daisy Chain. This results in the Daisy Chain device receiving a command with a bad CRC and that device responds with a NAK.
