Applilet3 for RL78 V1.09.00 Release Note

This chapter describes changes from Applilet3 for RL78 V1.08.00 to V1.09.00.

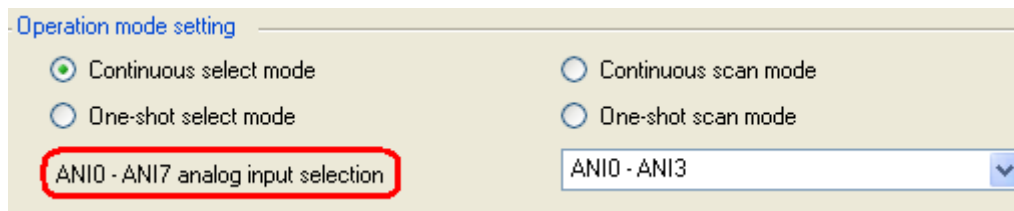
4.1.6 GUI correction of an A/D converter

In the A/D converter, it corrected so that the message displayed with the fixed value as the number of analog input channels might be dynamically displayed according to a number of channels.

This issue has been corrected

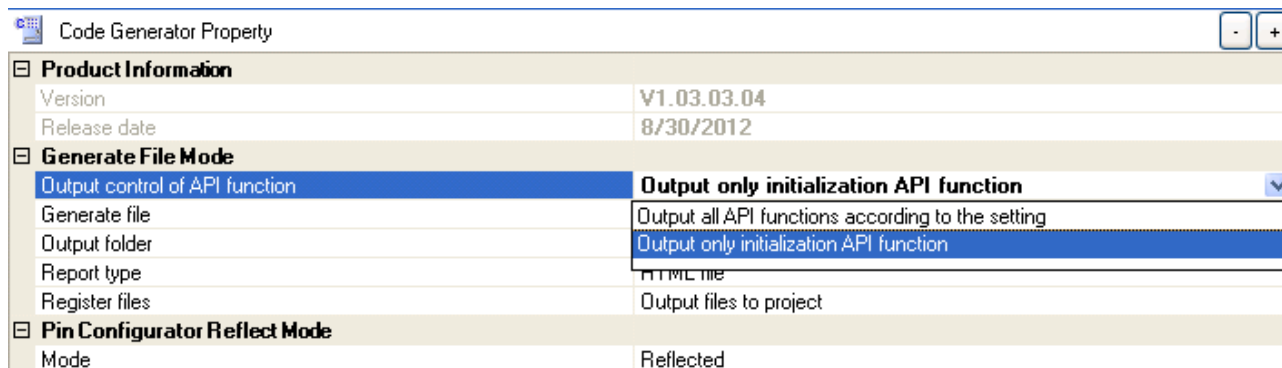
4.1.14 Additional function generation file mode

"Output control of API function" has been added to the Applilet3 Property for RL78.

"Output all API functions according to the setting": Outputs necessary API functions according to the GUI settings (conventional output method).

"Output only initialization API function": Outputs only initialization functions (Create functions) regardless of the GUI settings.

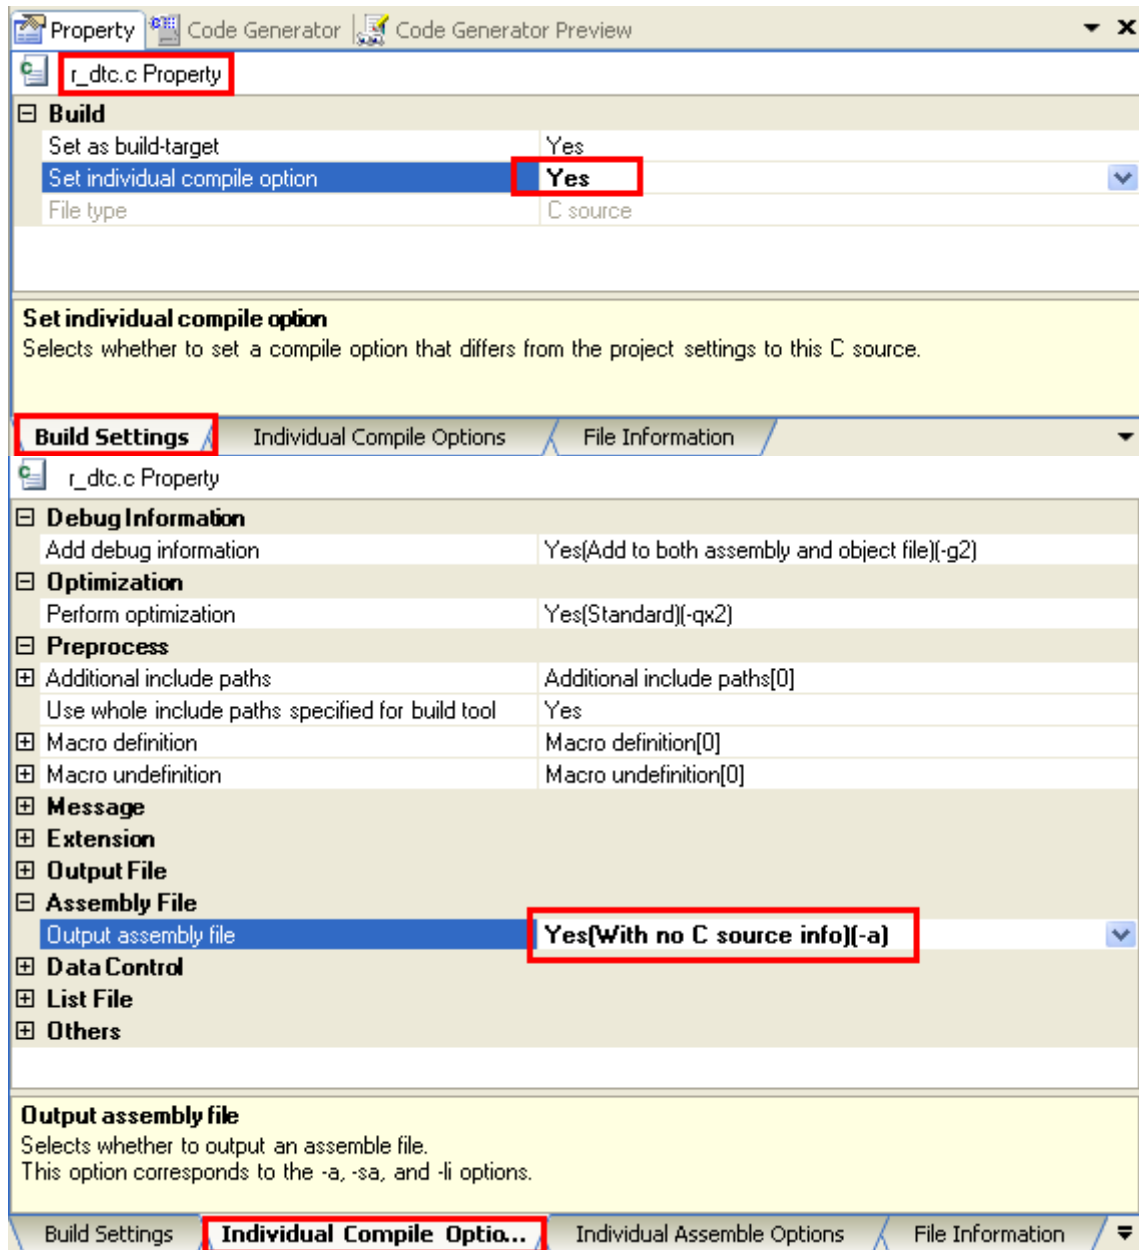
When DTC is used, please set up the following individual option of building. The DATA section is added for DTC to output source file "r_cg_dtc.c." Unless the individual option is set up, the following warning message is displayed and an object file is not generated.

(CC78K0R warning W0837: Output assembler source file , not object file)

[Workaround] There is no workaround
