Applilet3 for RL78 V1.10.00 Release Note

This chapter describes changes from Applilet3 for RL78 V1.09.00 to V1.10.00.

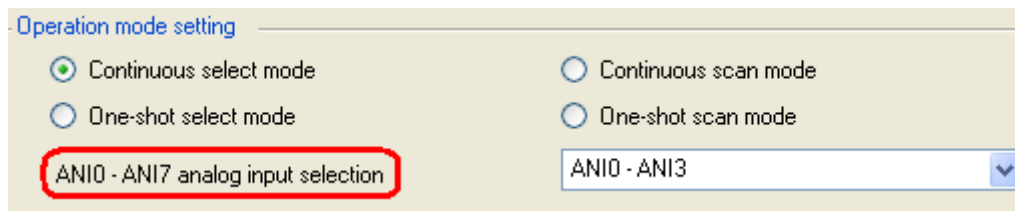
4.1.6 GUI correction of an A/D converter

In the A/D converter, it corrected so that the message displayed with the fixed value as the number of analog input channels might be dynamically displayed according to a number of channels.

This issue has been corrected

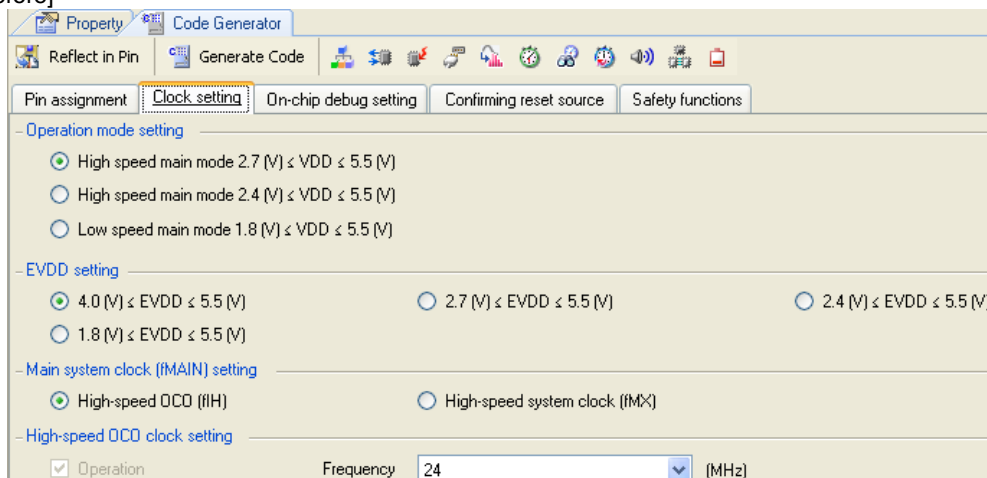
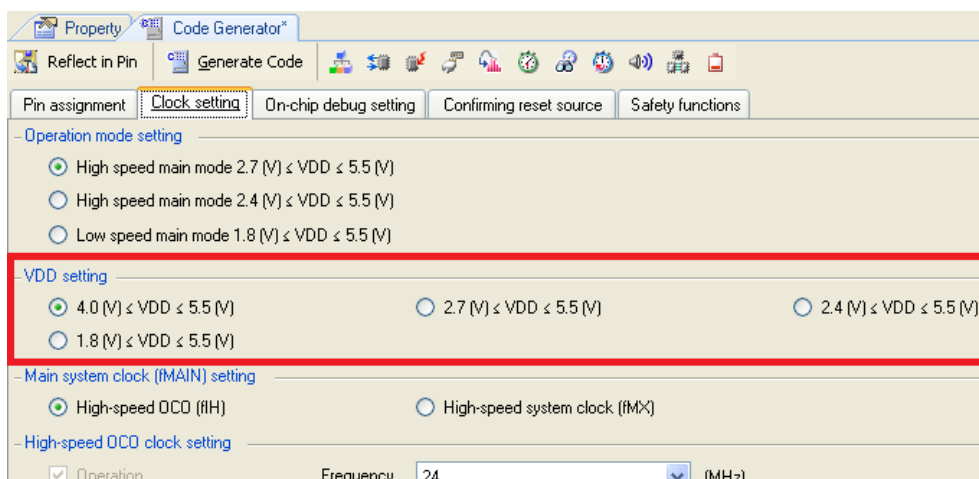
Although there was not EVDD in RL78/G12 device, it corrected that the notation remained on GUI.

This issue has been corrected in Applilet3 for RL78,78K0R,78K0 V2.00.00.

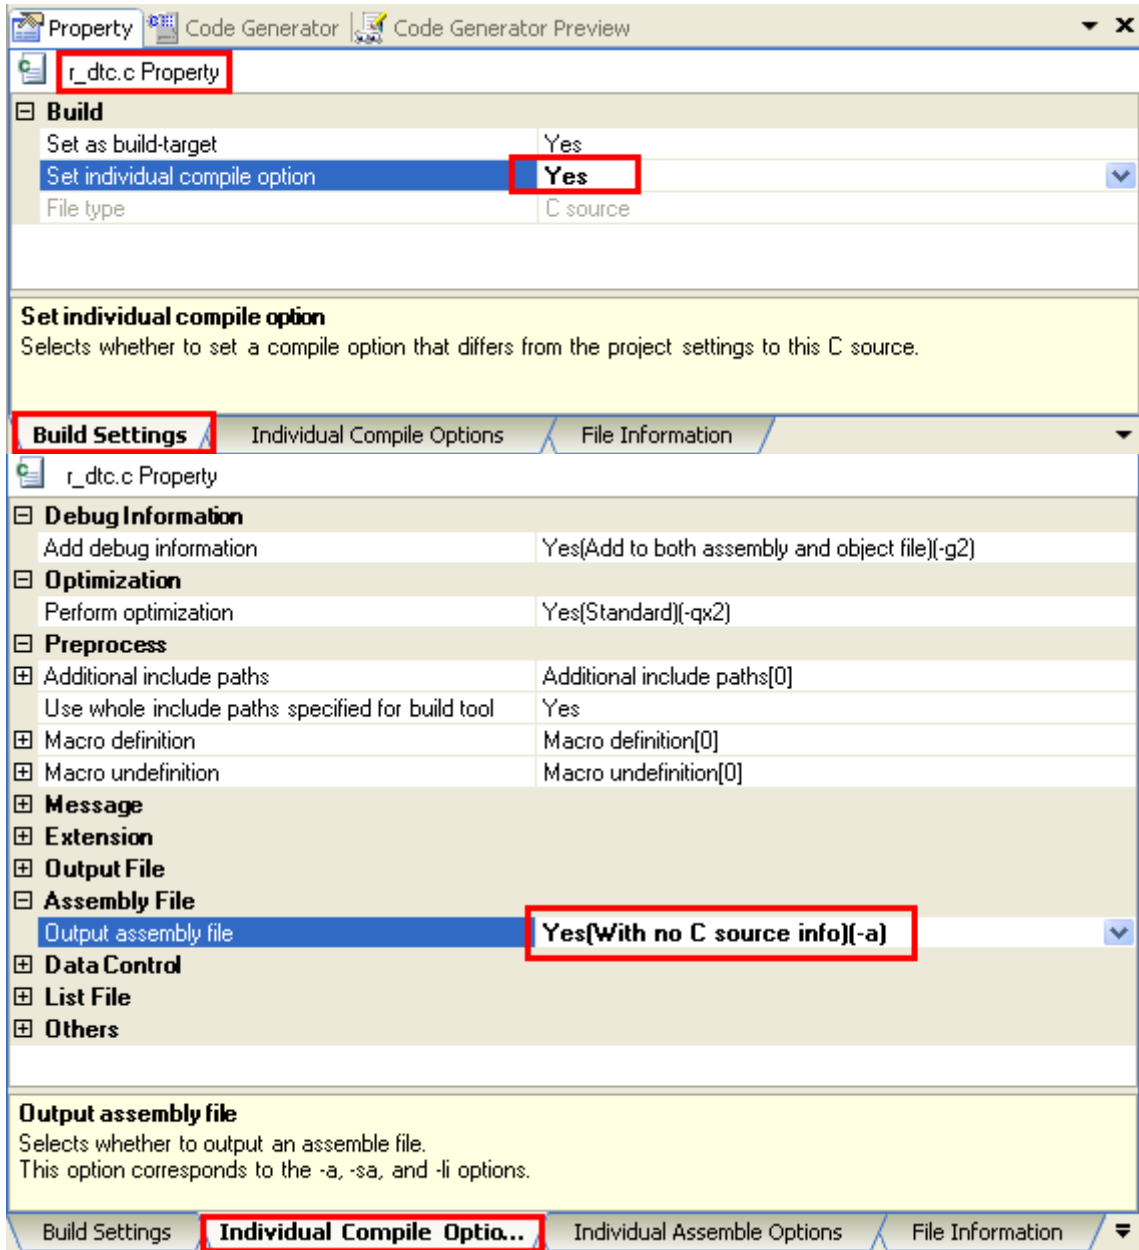
When DTC is used, please set up the following individual option of building. The DATA section is added for DTC to output source file "r_cg_dtc.c." Unless the individual option is set up, the following warning message is displayed and an object file is not generated.

(CC78K0R warning W0837: Output assembler source file , not object file)

[Workaround] There is no workaround
