Chapter 1. Target Devices

Chapter 4. Changes

This chapter describes change from Code Generator for RL78 (CS+ for CA,CX) V2.10.00 to V2.11.00

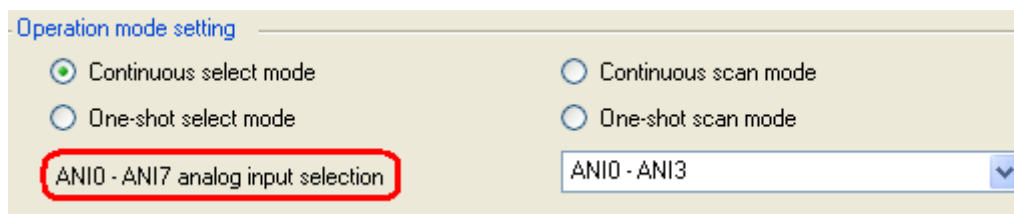
4.1.6 GUI correction of an A/D converter

In the A/D converter, it corrected so that the message displayed with the fixed value as the number of analog input channels might be dynamically displayed according to a number of channels.

This issue has been corrected in CubeSuite+ Code Generator for RL78,78K0R,78K0 V1.00.03

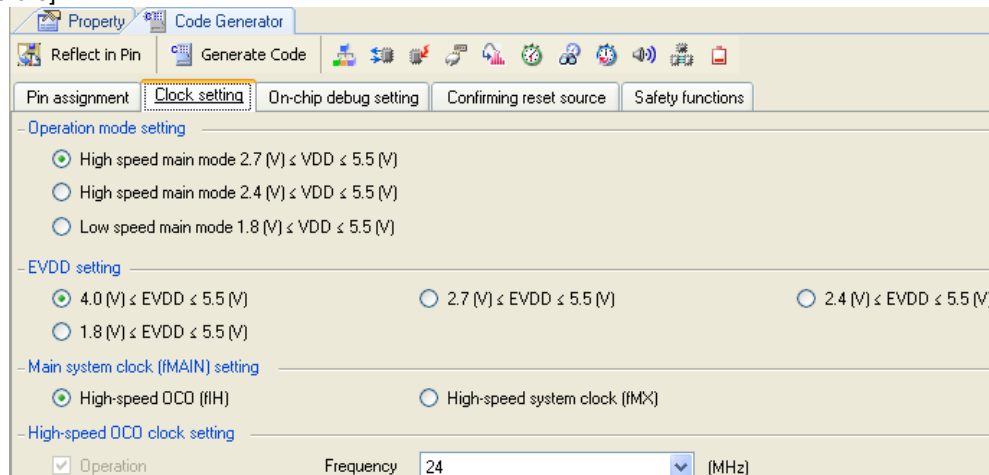
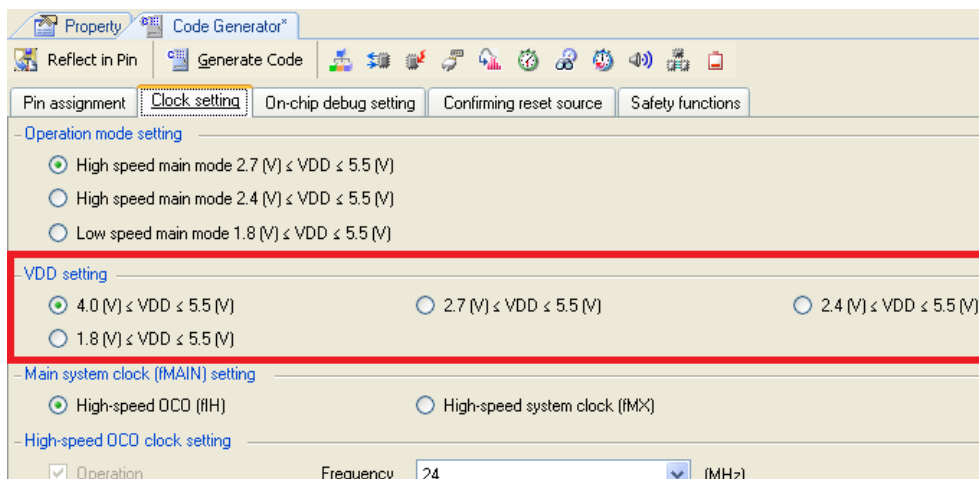
Although there was not EVDD in RL78/G12 device, it corrected that the notation remained on GUI.

This issue has been corrected in CubeSuite+ Code Generator for RL78,78K0R,78K0 V2.00.00.

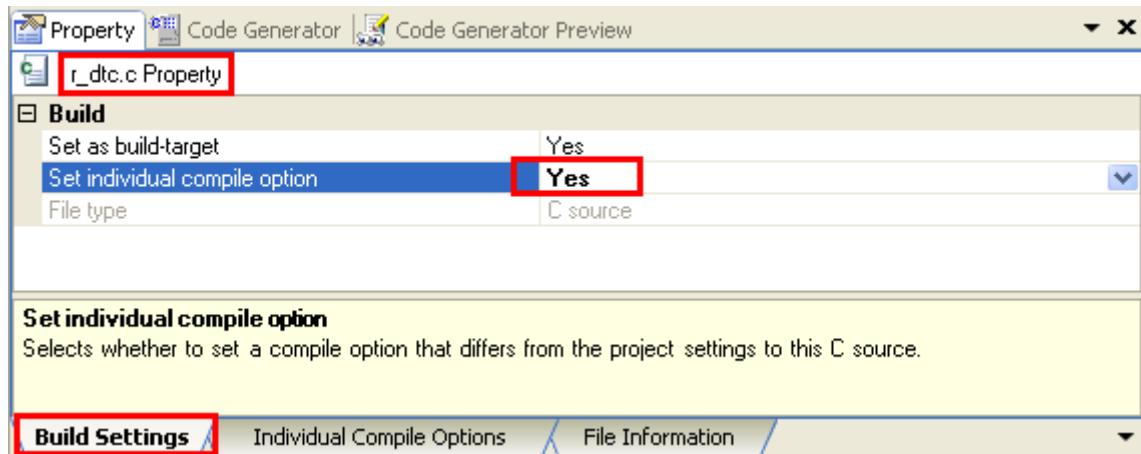
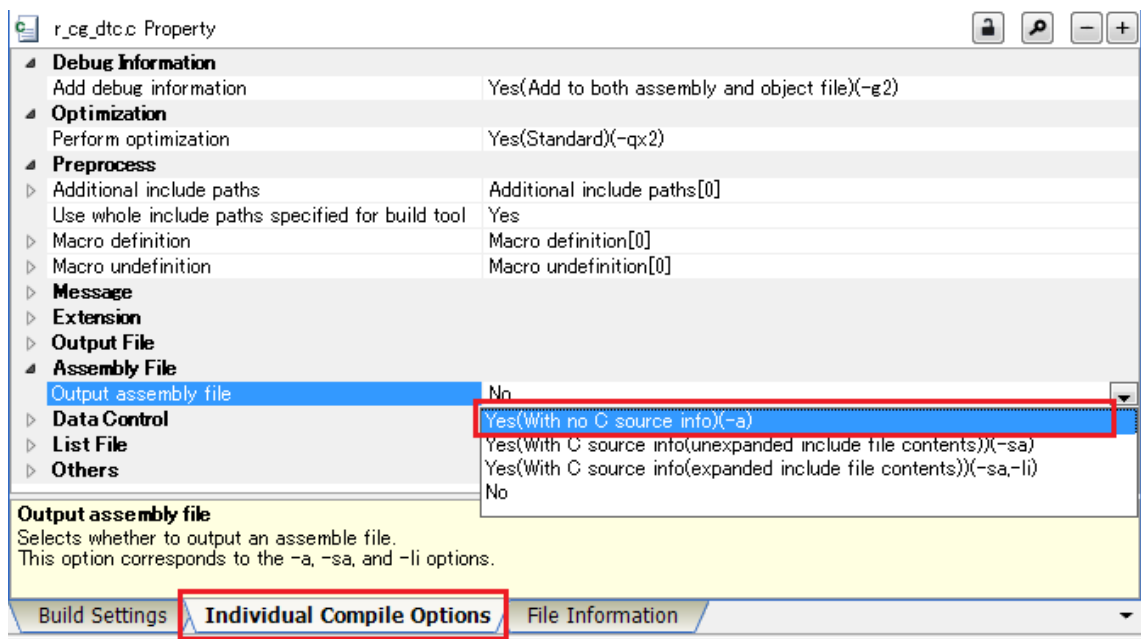
When DTC is used, please set up the following individual option of building. The DATA section is added for DTC to output source file "r_cg_dtc.c." Unless the individual option is set up, the following warning message is displayed and an object file is not generated.

(CC78K0R warning W0837: Output assembler source file , not object file)

[Workaround] There is no workaround

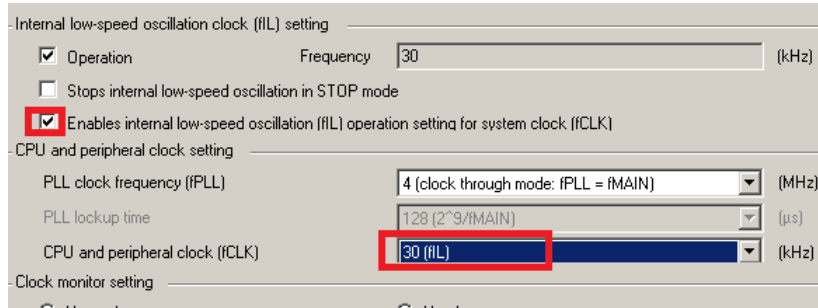
a) Clock

- Check in the two following items.

There is no workaround. CS+ RL78 Code Generator is corrected in V2.00.01

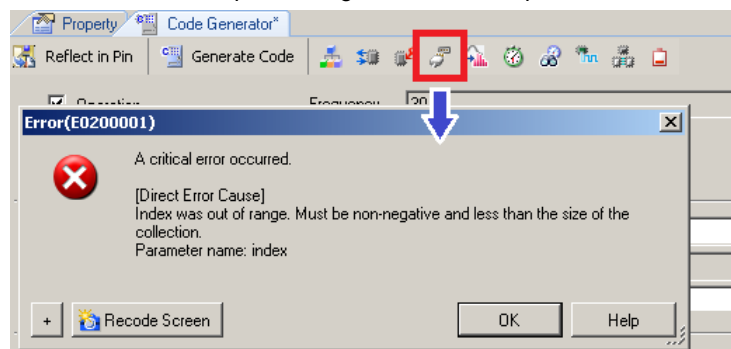
- Selection of a serial panel will generate an exception.

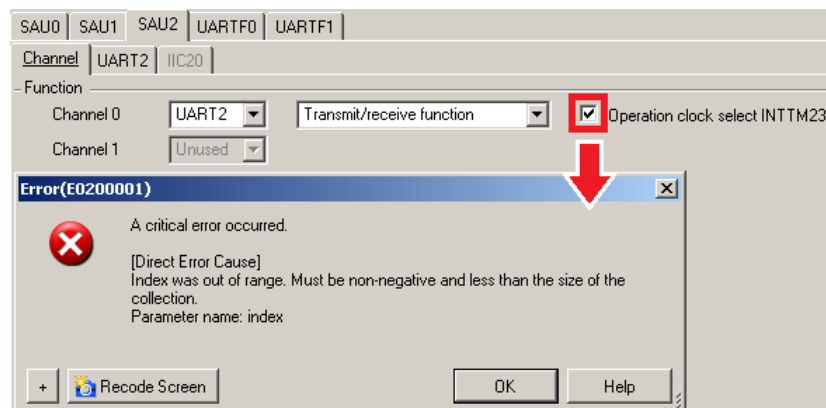
b) Timer and serial

- Use interruption for the channel 3 of timer TAU2 in a certain mode.

- If a clock of operation checks one serial of serial SAU0, SAU1, and SAU2 "Operation clock select INTTM23", an exception will occur.

There is no workaround. CS+ RL78 Code Generator is corrected in V2.00.01

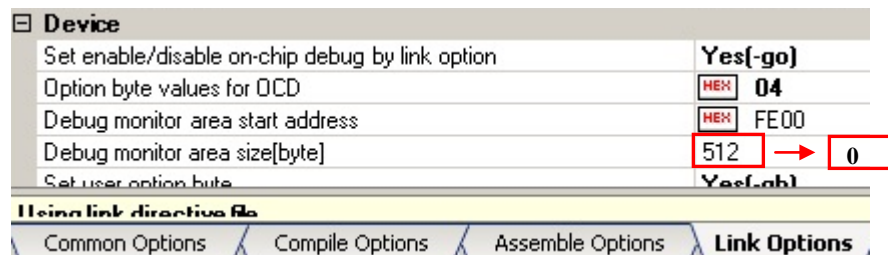
Even if it checks by on-chip debugging operation setup "for it not to be used", debugging monitor area size will be secured.

[Workaround] Please write 0 to the debugging monitor area size of Link Options.

CS+ Code Generator for RL78(CA, CX) is corrected in V2.08.00
