RENESAS TECHNICAL UPDATE

Product Category	MPU & MCU	Document No.	TN-16C-A207A/E	Rev.	1.00
Title	Errata to R32C/121 Group Hardware Manual		Information Category	Technical Notification	
Applicable Product	R32C/121 Group	Lot No.	Reference Document	R32C/121 Group Hardware Manual Rev. 1.10 (REJ09B0477-0110)

This document describes corrections to the R32C/121 Group Hardware Manual, Rev. 1.10.
The corrections are indicated in red in the list below.

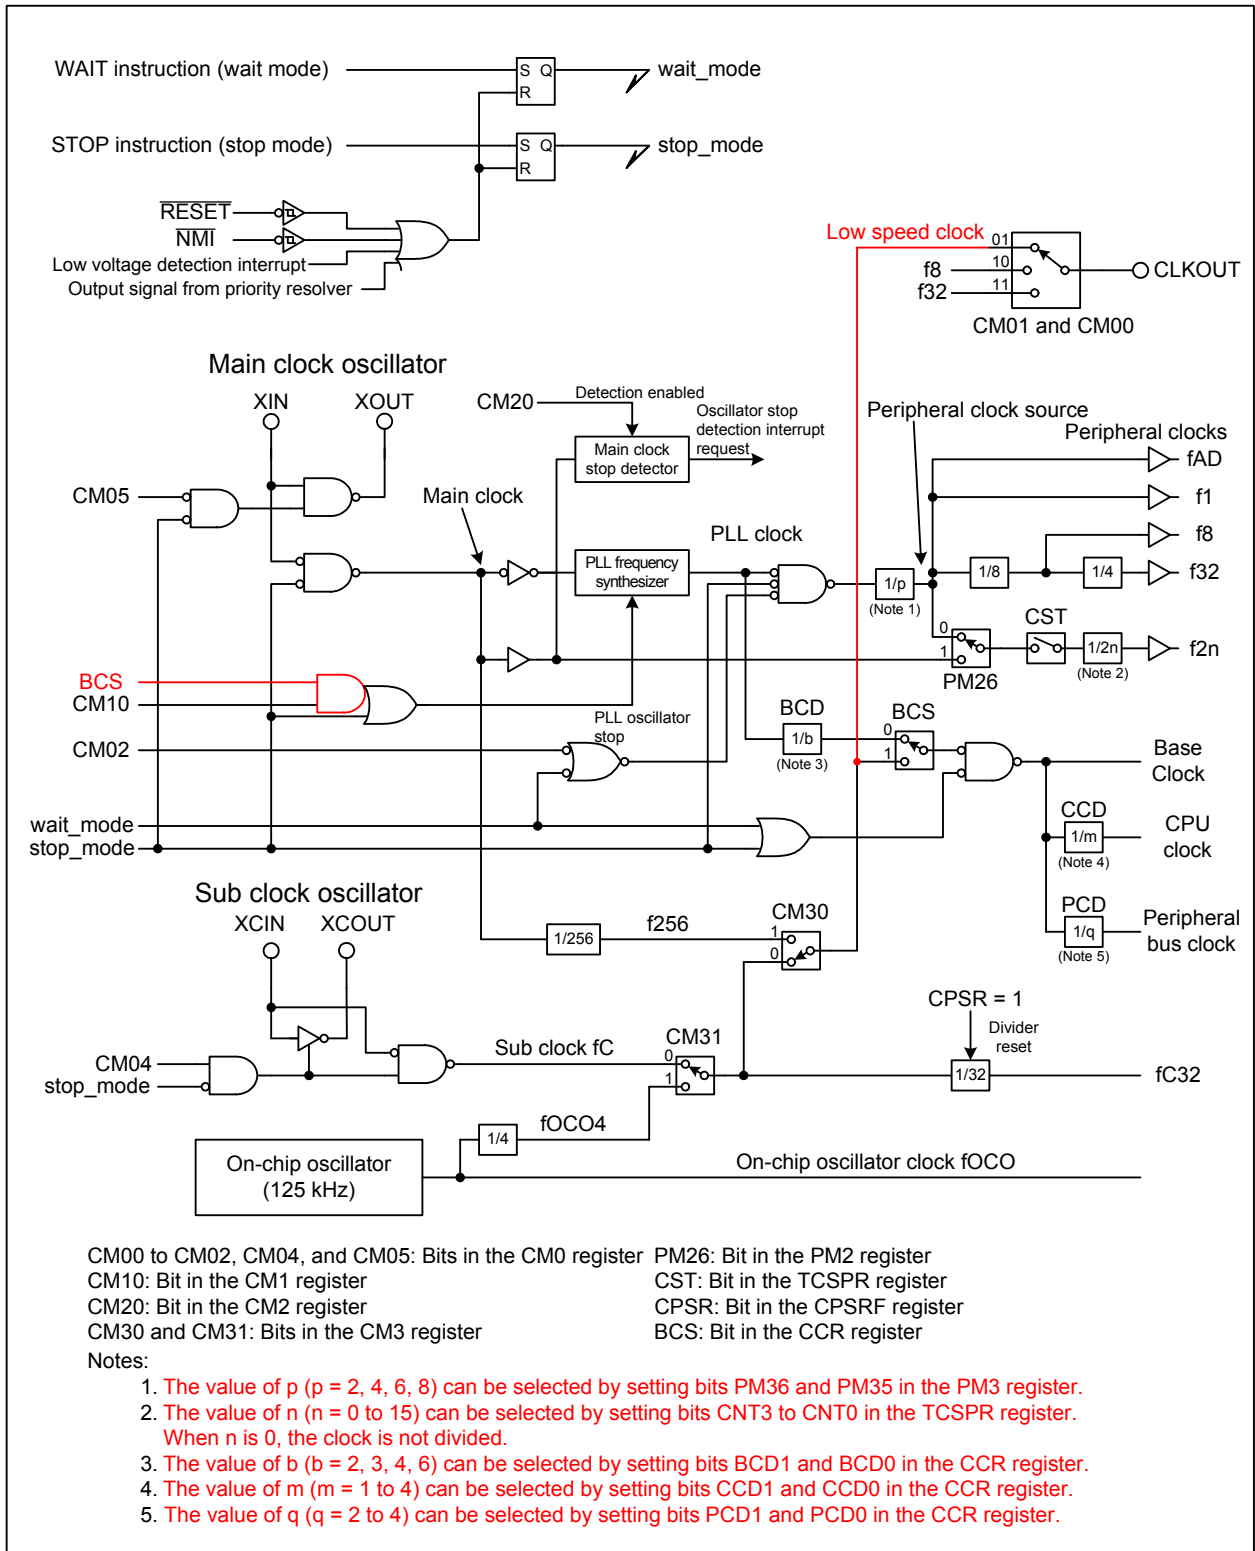
Figure 7.1 Clock Generation Circuitry

•Page 87 of 604, Figure 7.1 is corrected as follows:

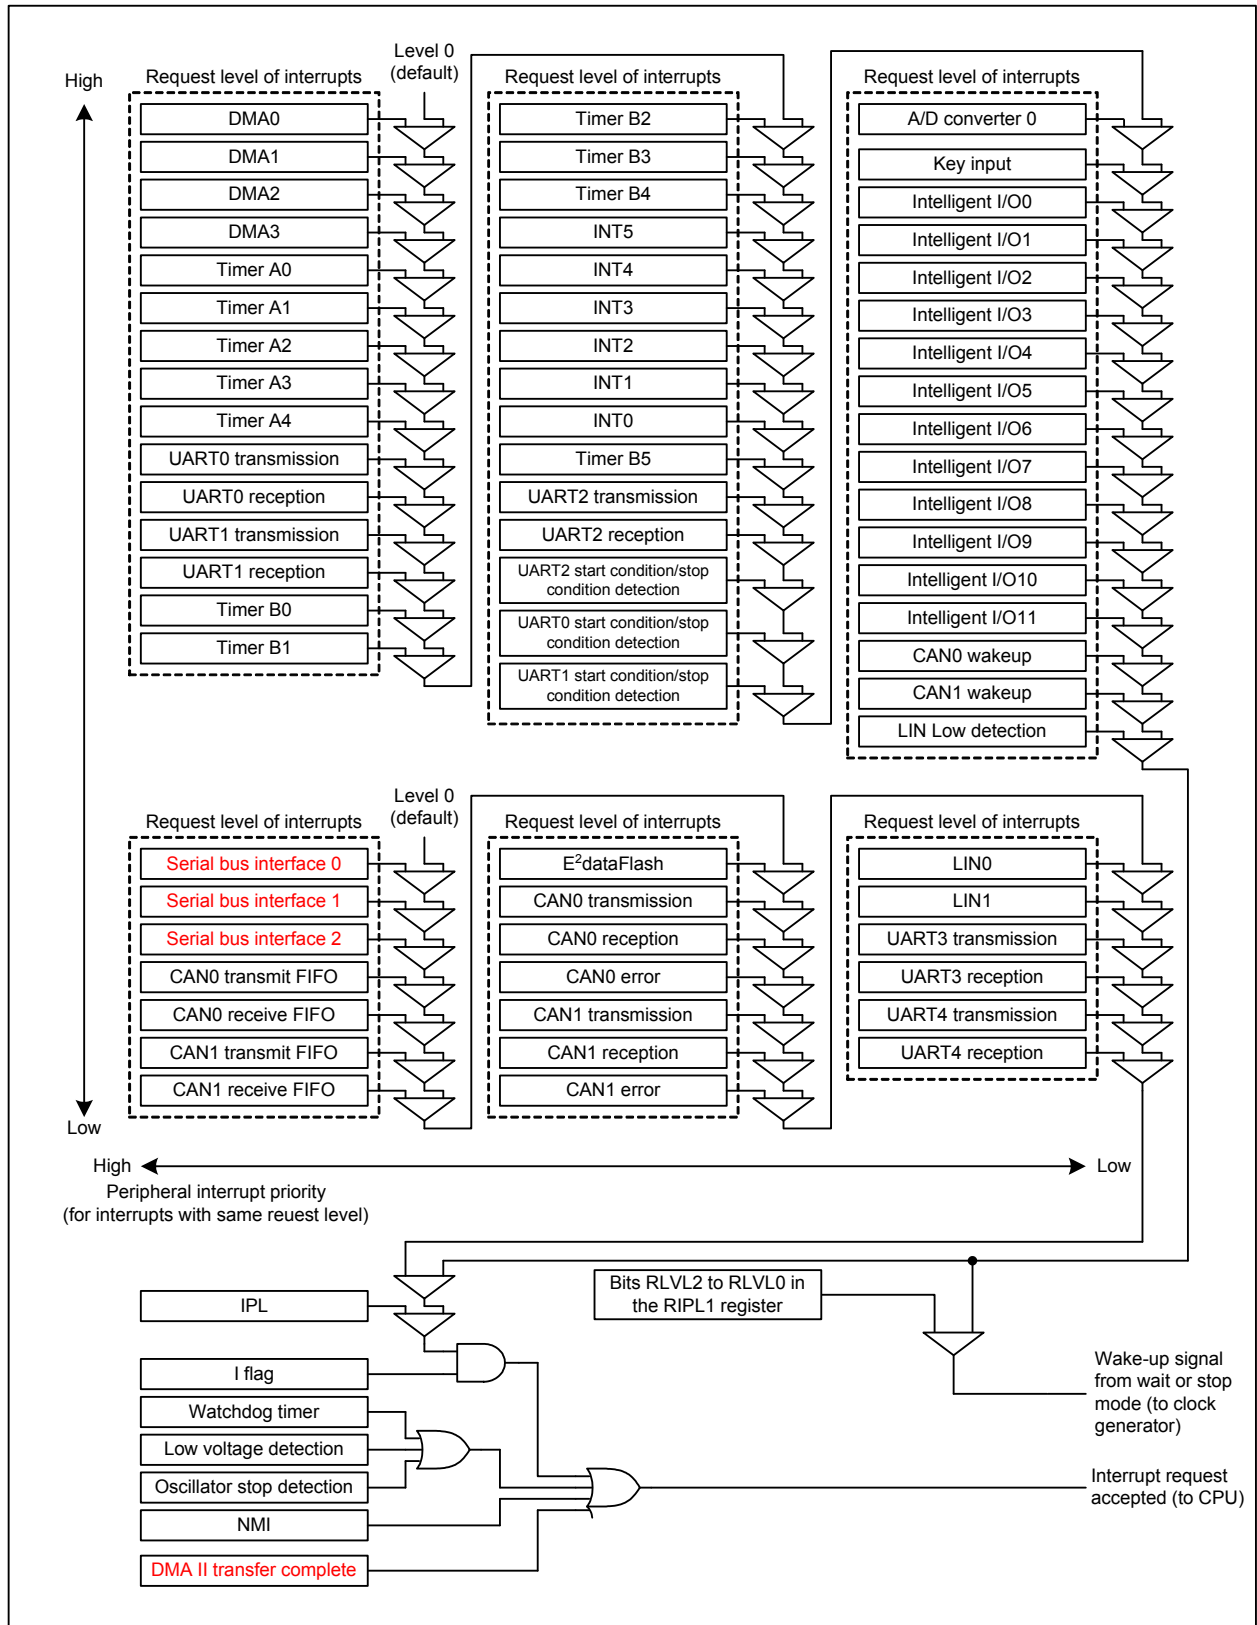
Figure 10.8 Priority Resolver

•Page 139 of 604, Figure 10.8 is corrected as follows:

(Description "Bits RLVL2 to RLVL0 in the RIPL2 register" and associated signal lines are deleted from Figure 10.8)

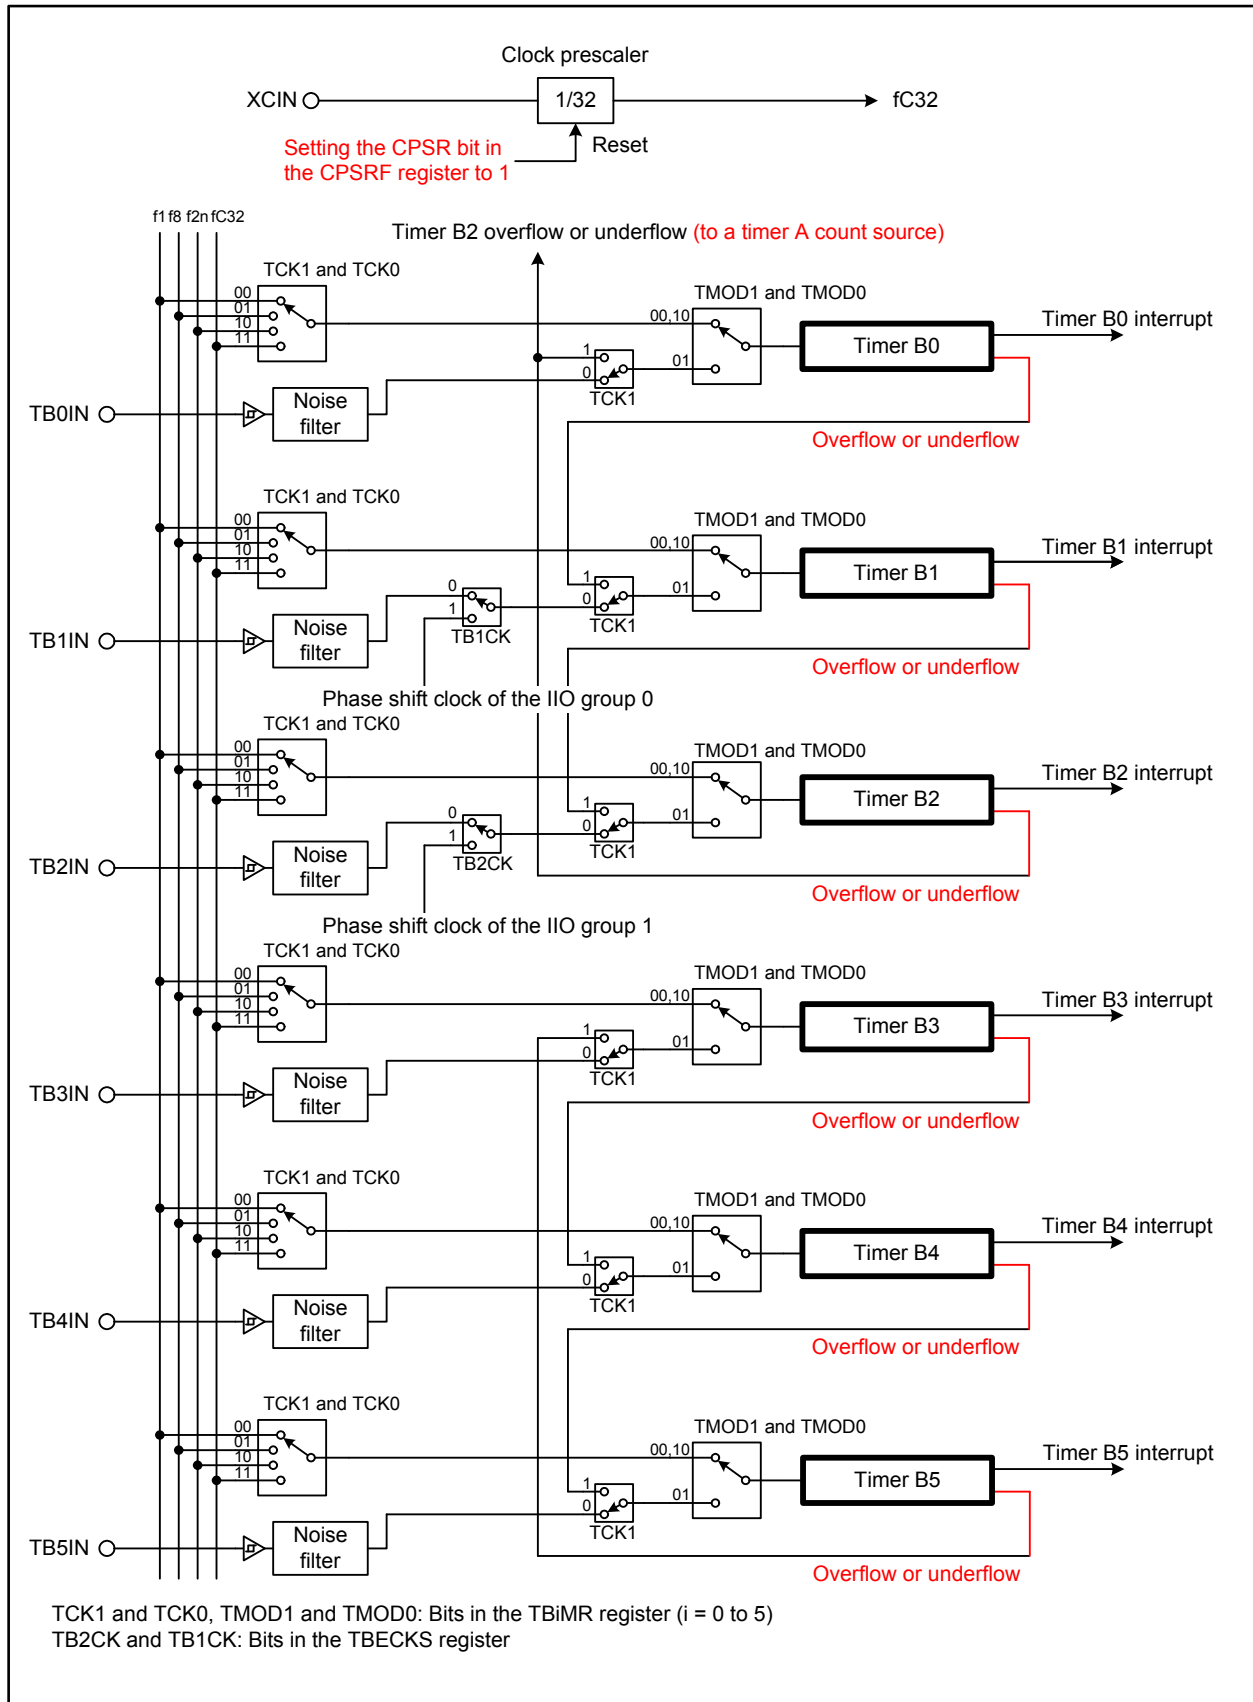
Figure 15.2 Timer B Configuration

•Page 179 of 604, Figure 15.2 is corrected as follows:

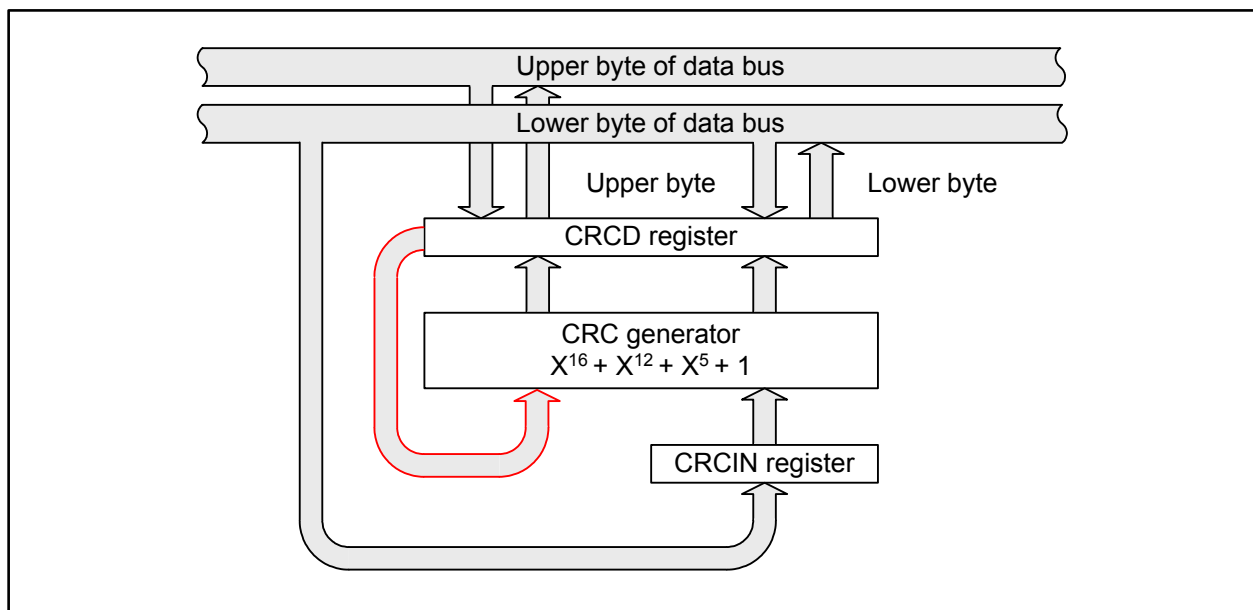
Figure 20.1 CRC Calculator Block Diagram

- Page 304 of 604, Figure 20.1 is corrected as follows:

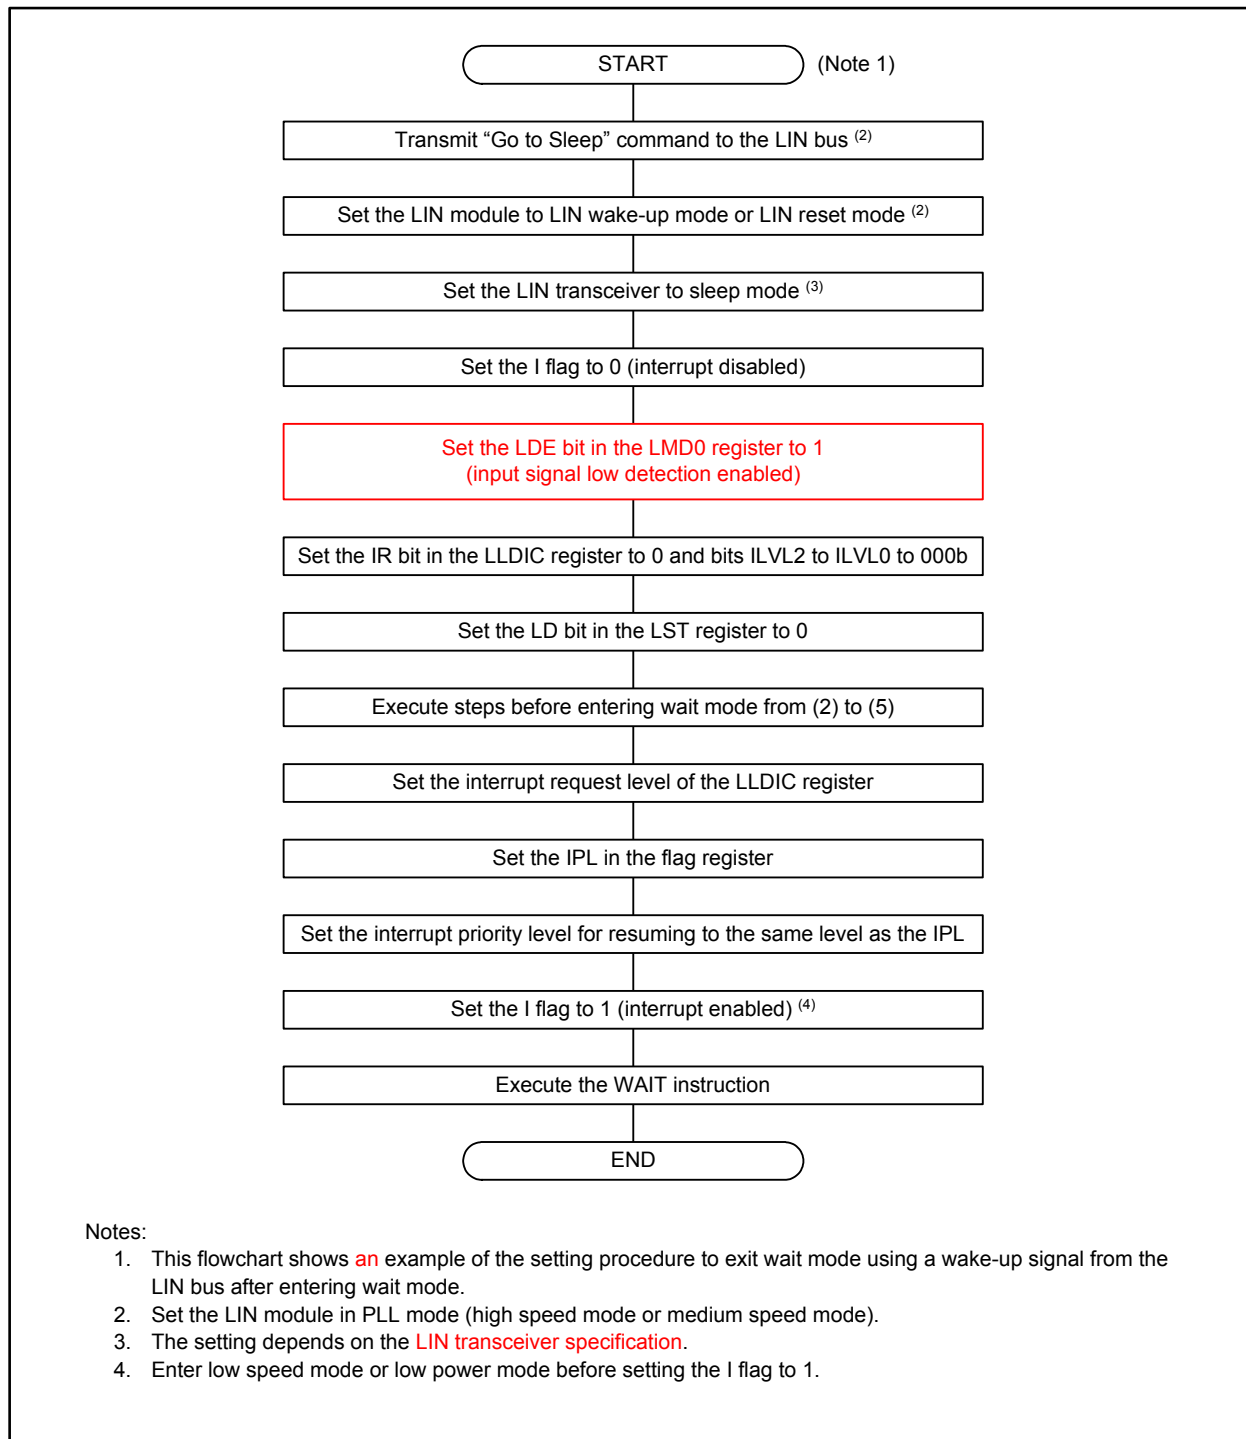
Figure 24.30 Example of Setting Before Transition to Wait Mode

•Page 409 of 604, Figure 24.30 is corrected as follows:

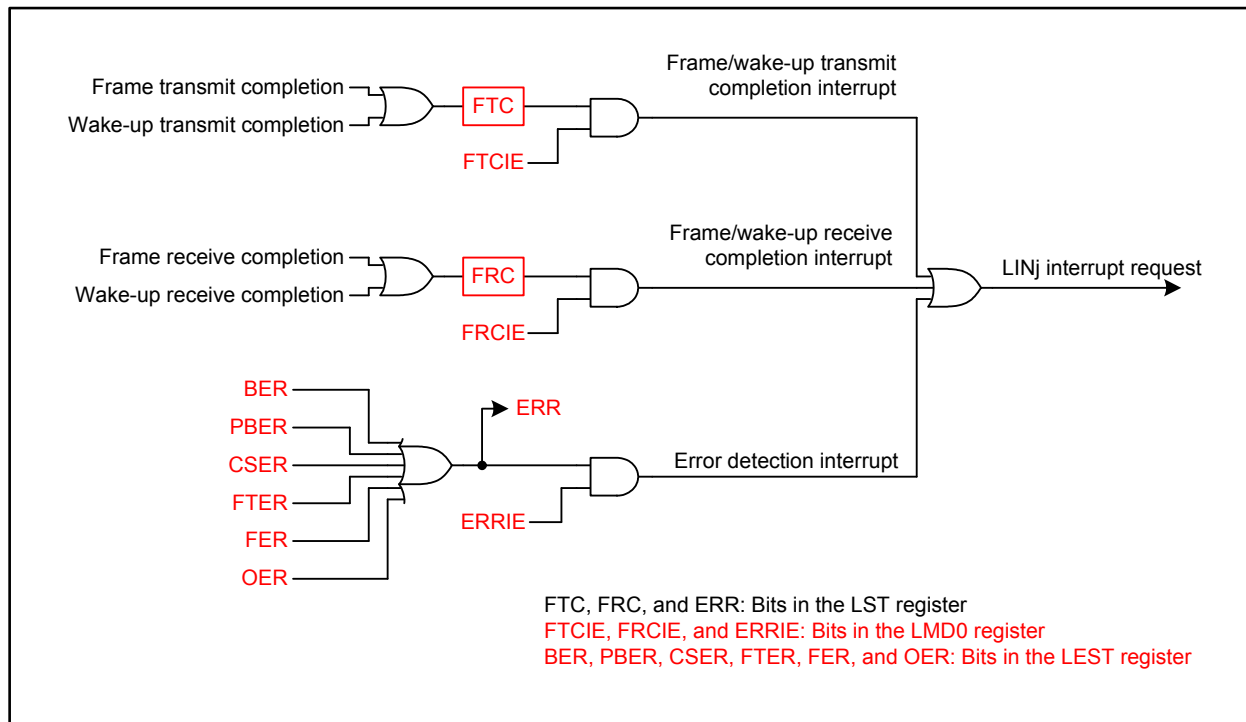
Figure 24.32 LINj Interrupt Block Diagram (j = 0, 1)

•Page 413 of 604, Figure 24.32 is corrected as follows:

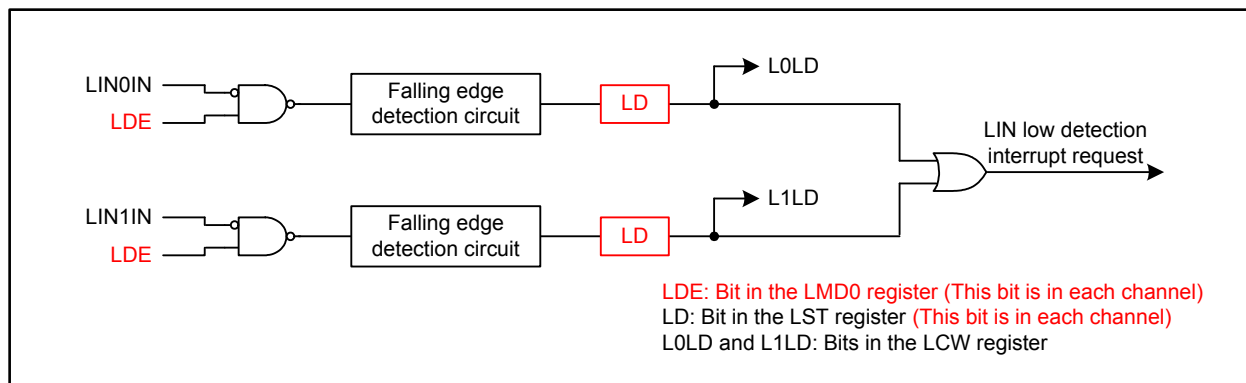
Figure 24.33 LIN Low Detection Interrupt Block Diagram

•Page 413 of 604, Figure 24.33 is corrected as follows:

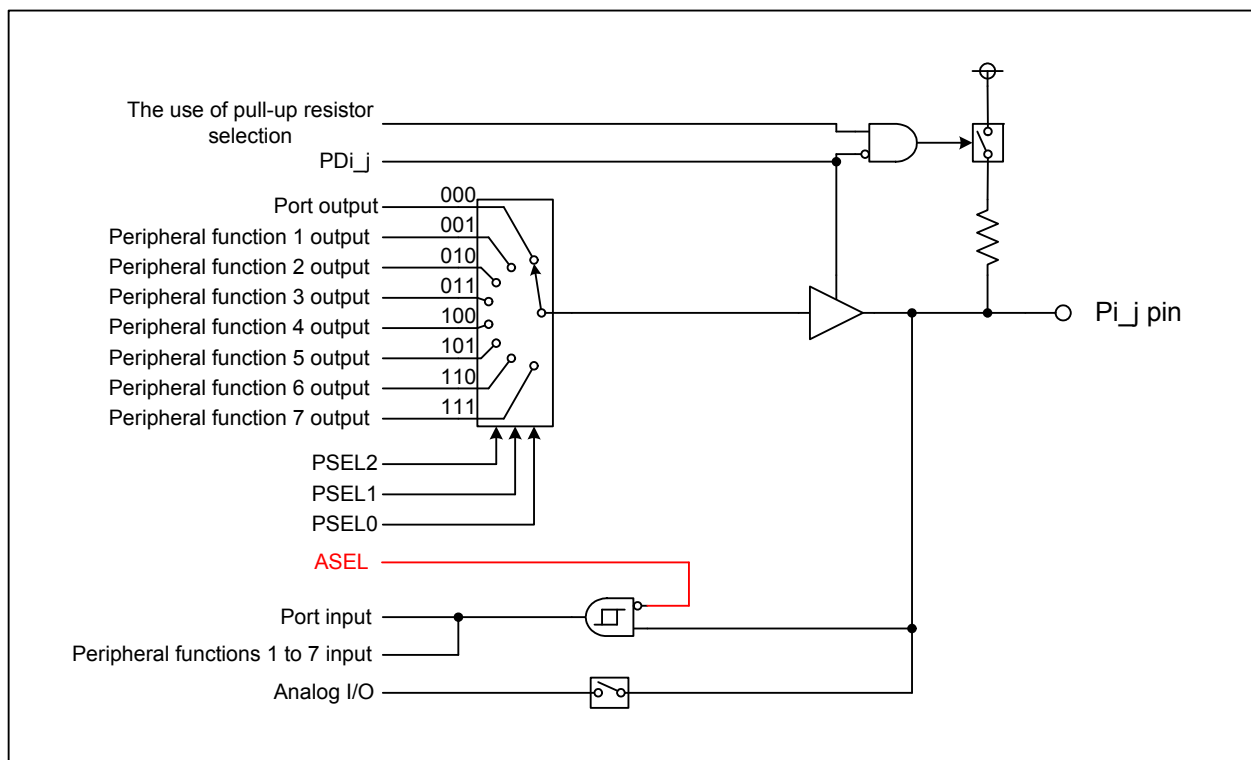
Figure 26.1 Typical I/O Pin Block Diagram (i = 0 to 10; j = 0 to 7)

- Page 483 of 604, Figure 26.1 is corrected as follows (refer to TN_16C_A198A/E):

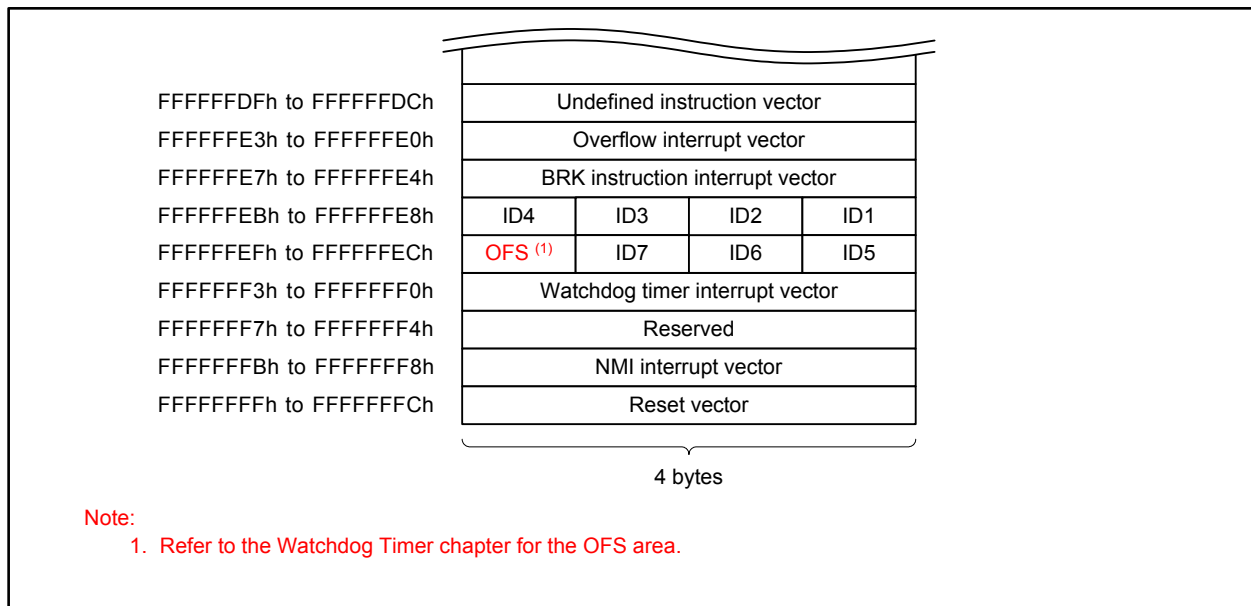
Figure 27.2 Addresses for ID Code Stored

- Page 509 of 604, description “use the serial programmer to” is deleted from line 3 of 27.2.2.
- Page 510 of 604, Figure 27.2 is corrected as follows:

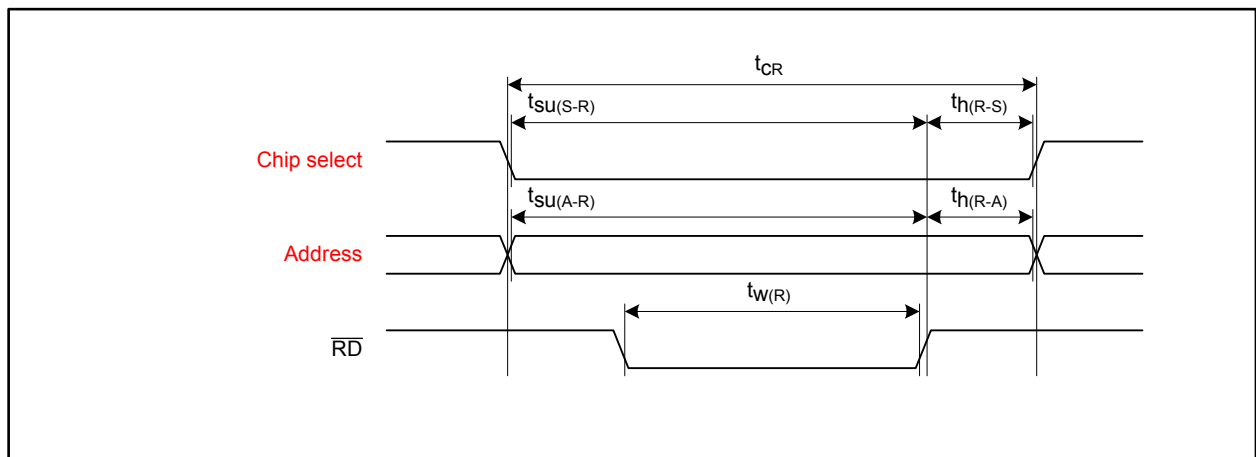
Figure 27.12 Read Timing

•Pages 518 and 520 of 604, descriptions in Figures 27.12 and 27.13 are corrected as follows:

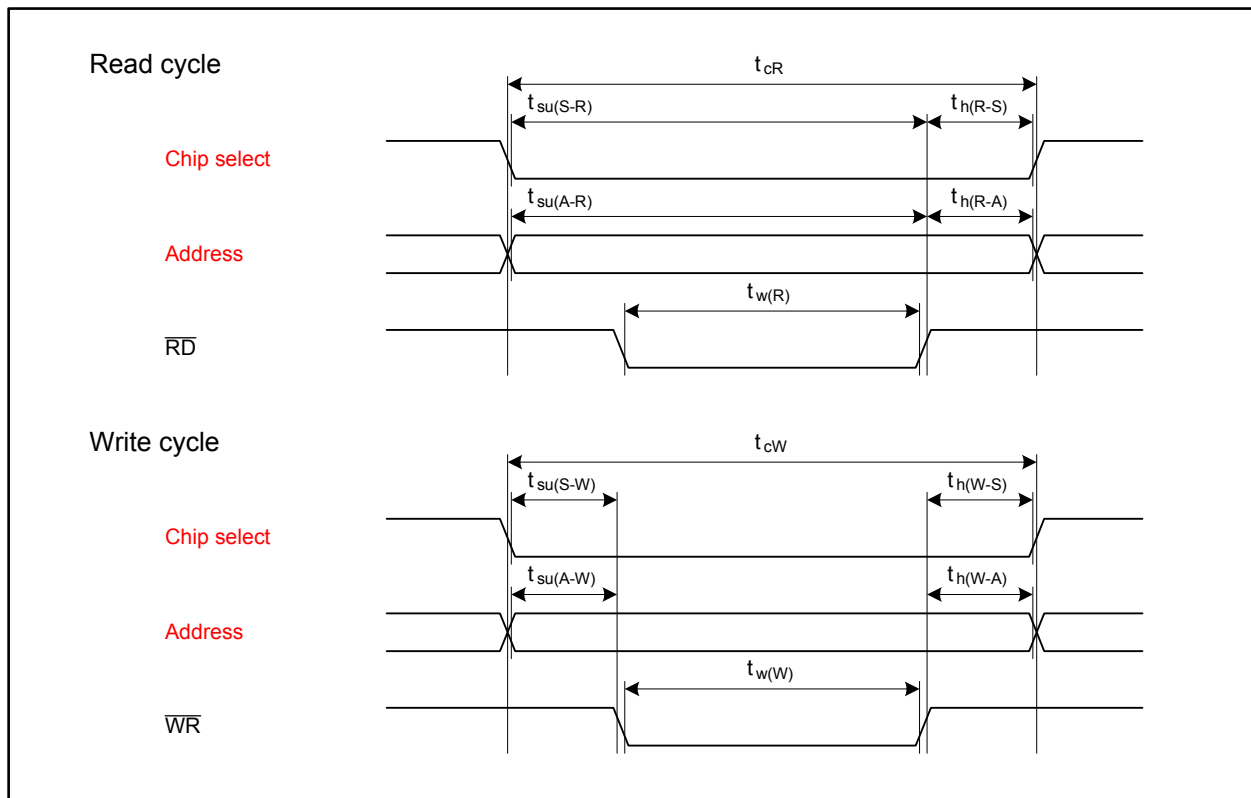
Figure 29.5 Flash Memory CPU Rewrite Mode Timing

- Page 538 of 604, the following description is added to Note 3 of Figure 28.2:
 “However, the registers are not initialized.”
- Page 538 of 604, description “This mode setting prevents data from being overwritten if a program goes out of control.” is deleted from Note 5 in Figure 28.2.
- Page 544 of 604, description “EERR bit in the E2FS0 register is 1?” in Figure 28.12 is corrected as follows:
 “EERR bit in the E2FS0 register is 0?”
- Pages 553 and 554 of 604, description “Programming and erasure endurance of flash memory” in Tables 29.8 and 29.9 is changed as follows:
 “Program and erase cycles”
- Pages 553 and 554 of 604, unit “times” for “Programming and erasure endurance of flash memory” in Tables 29.8 and 29.9 and Note 1 is corrected as follows:
 “Cycles”
- Page 557 of 604, descriptions in Figure 29.5 are corrected as follows:
