RENESAS TECHNICAL UPDATE

Product Category	MPU & MCU	Document No.	TN-16C-A197A/E	Rev.	1.00
Title	Errata to R32C/157 Group Hardware Manual		Information Category	Technical Notification	
Applicable Product	R32C/157 Group	Lot No.	Reference Document	R32C/157 Group Hardware Manual Rev. 1.03 (REJ09B0507-0103)

This document describes corrections to the R32C/157 Group Hardware Manual, Rev. 1.03.
The corrections are indicated in red in the list below.

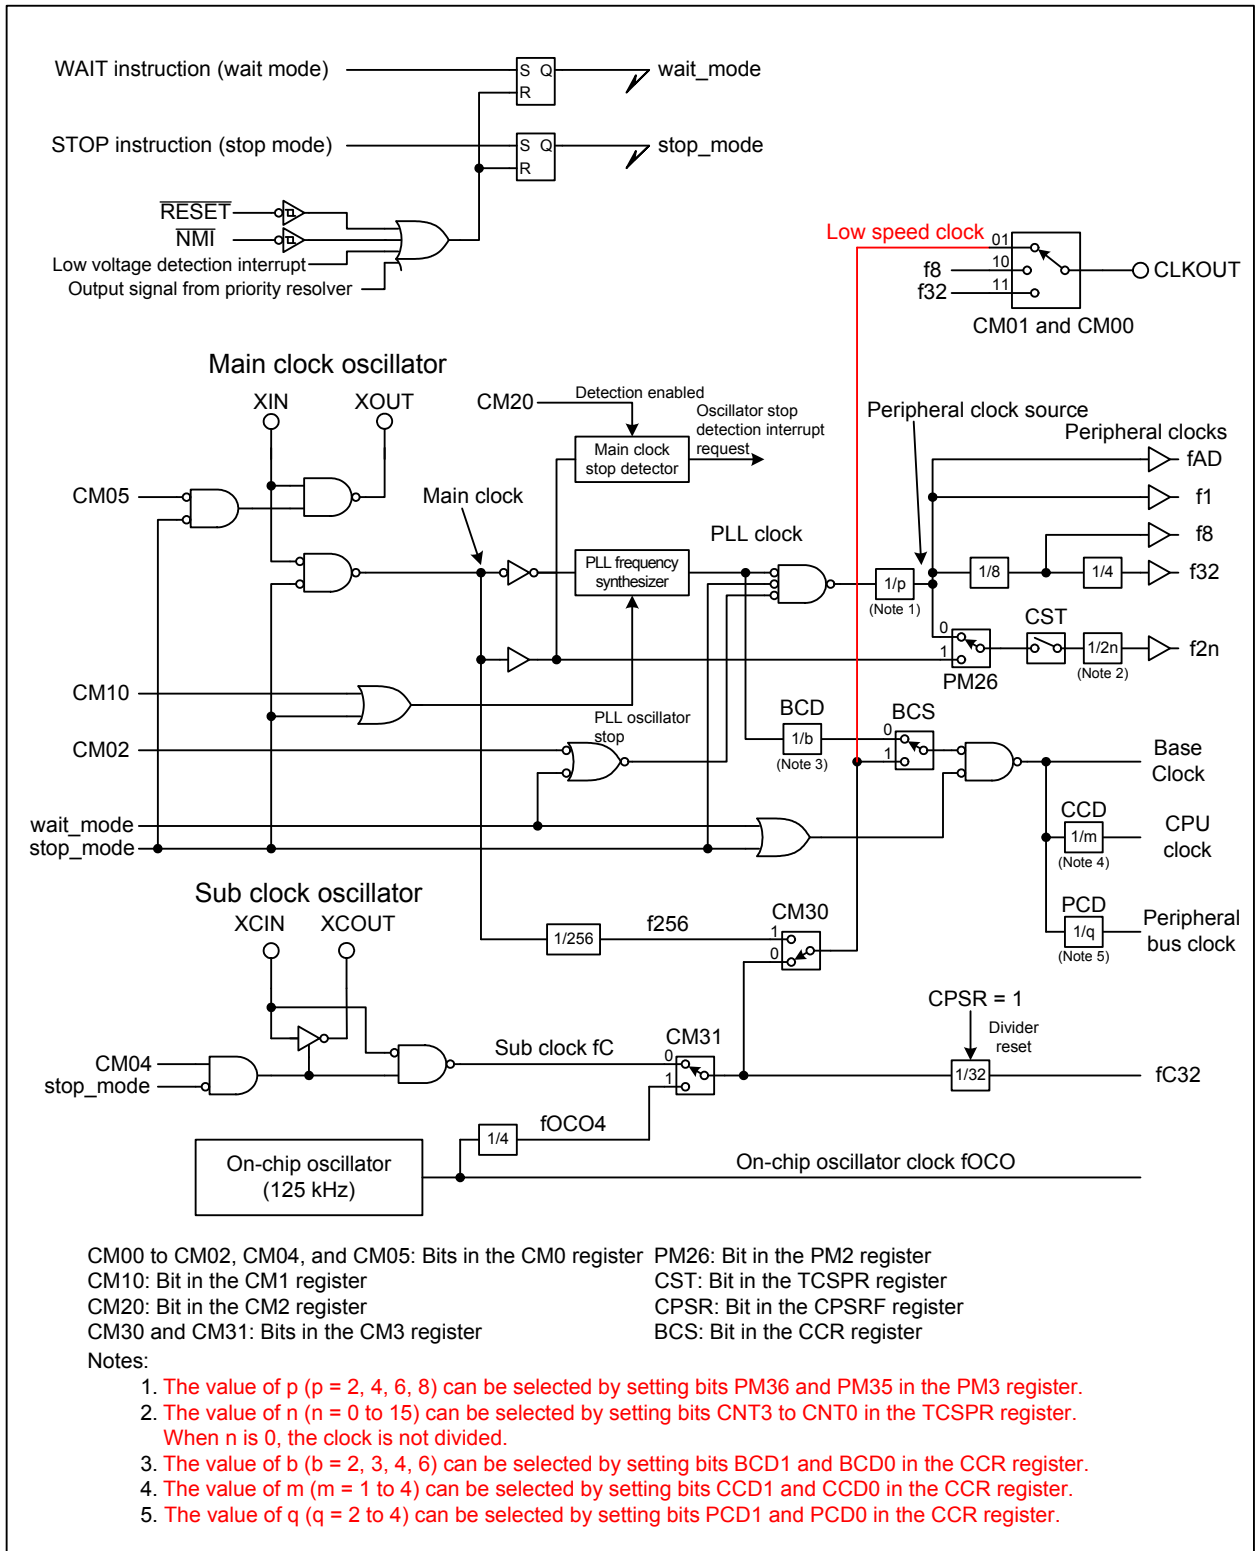
Figure 7.1 Clock Generation Circuitry

•Page 104 of 636, Figure 7.1 is corrected as follows:

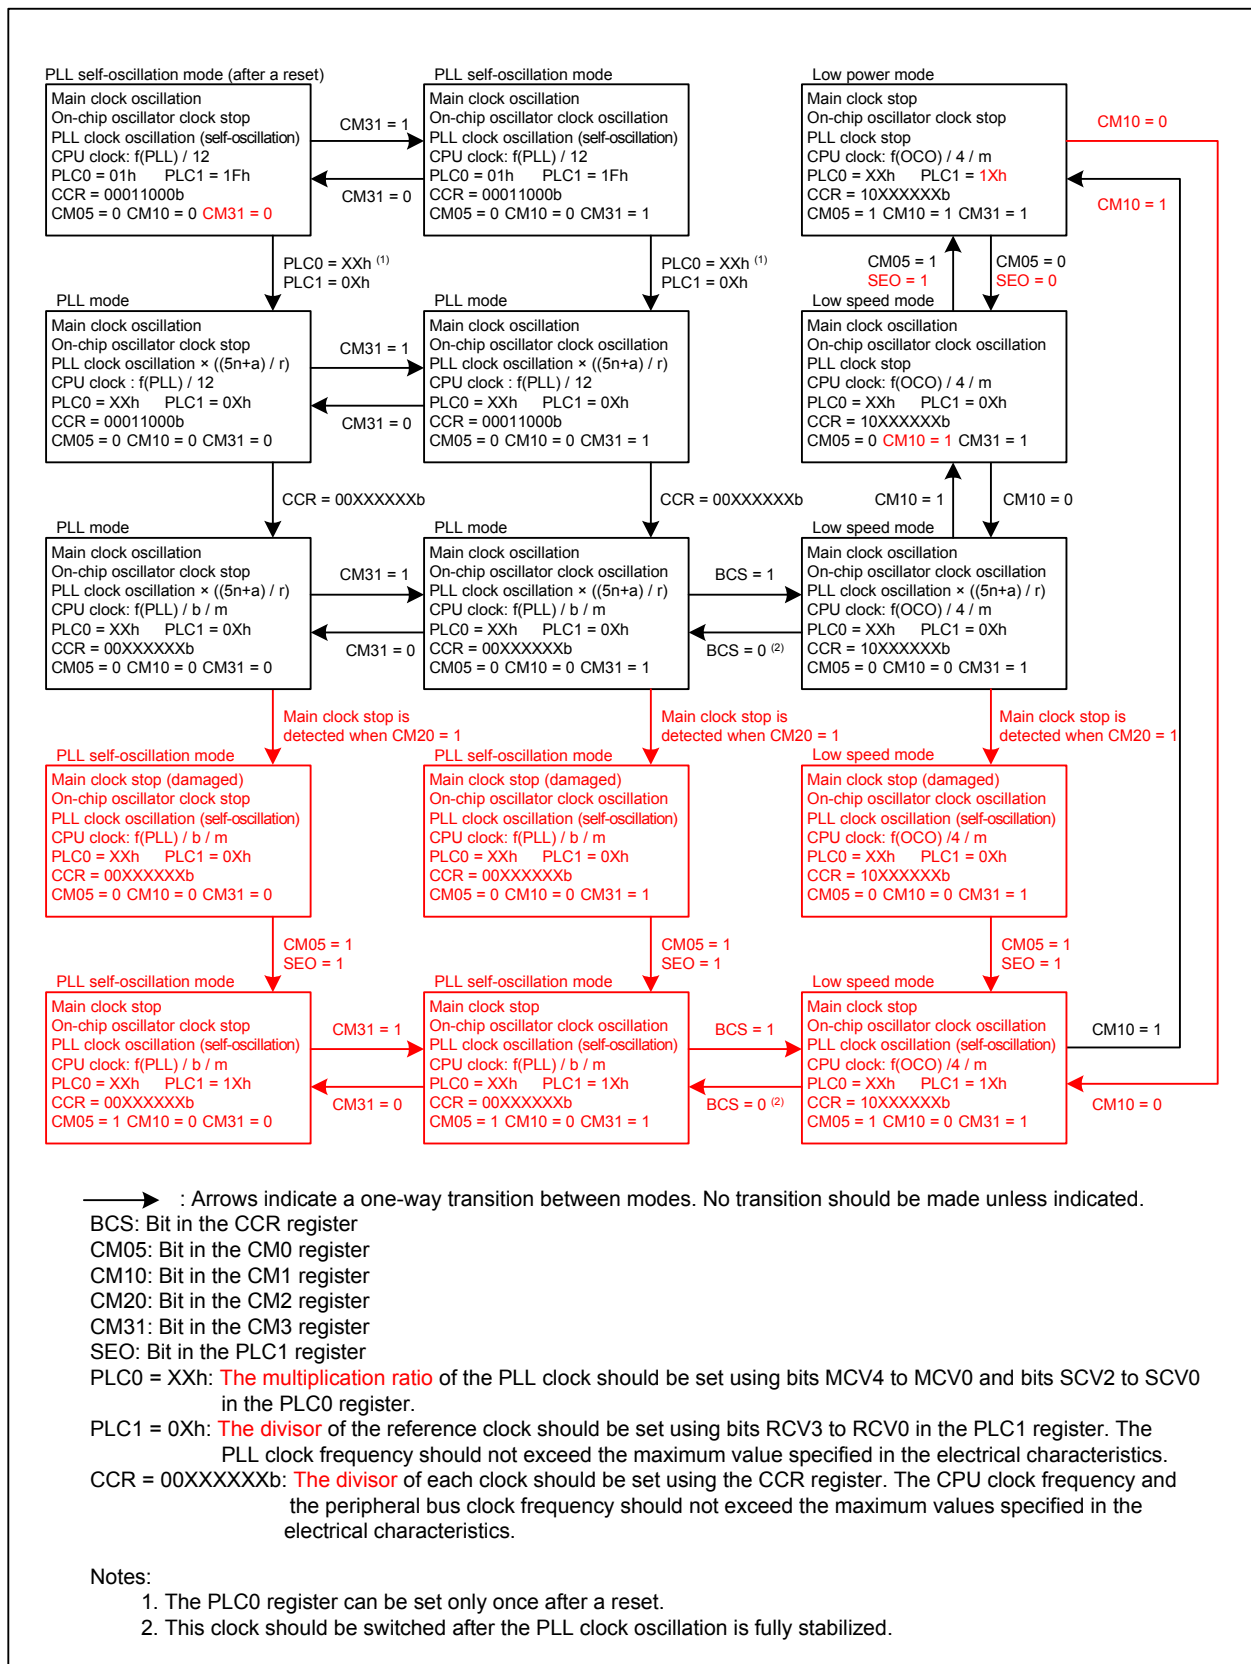
Figure 7.20 State Transition (when the on-chip oscillator clock is used)

•Page 124 of 636, descriptions “CM31 = 1” in the first row and “CM10 = 0” in the second row in Figure 7.20 are corrected, and the state transition is modified as follows:

(Note 3 “The CM05 bit is not set to 1 when an oscillator stop is detected through the oscillation stop detector.” is deleted from Figure 7.20)

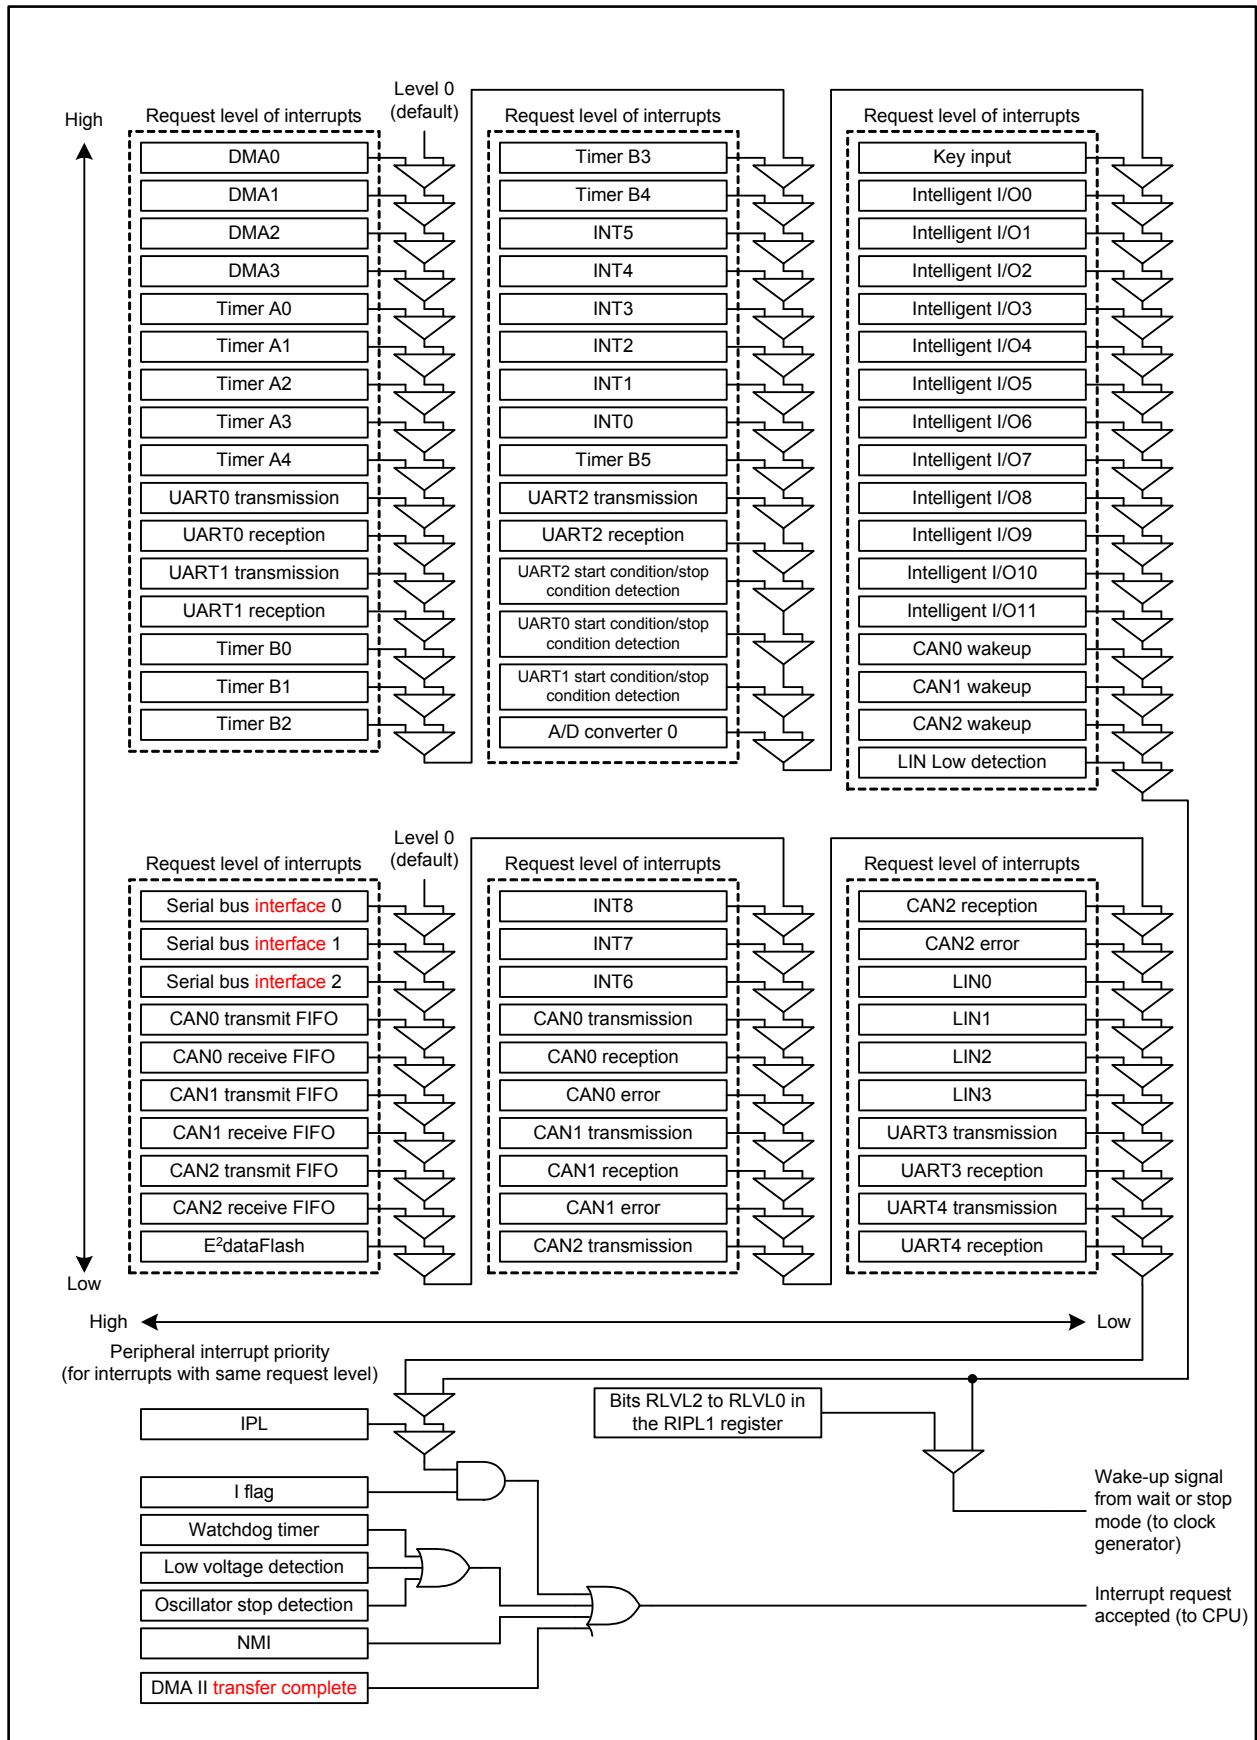
Figure 10.8 Priority Resolver

•Page 156 of 636, Figure 10.8 is corrected as follows:

(Description “Bits RLV2 to RLV0 in the RIPL2 register” and associated signal lines are deleted from Figure 10.8)

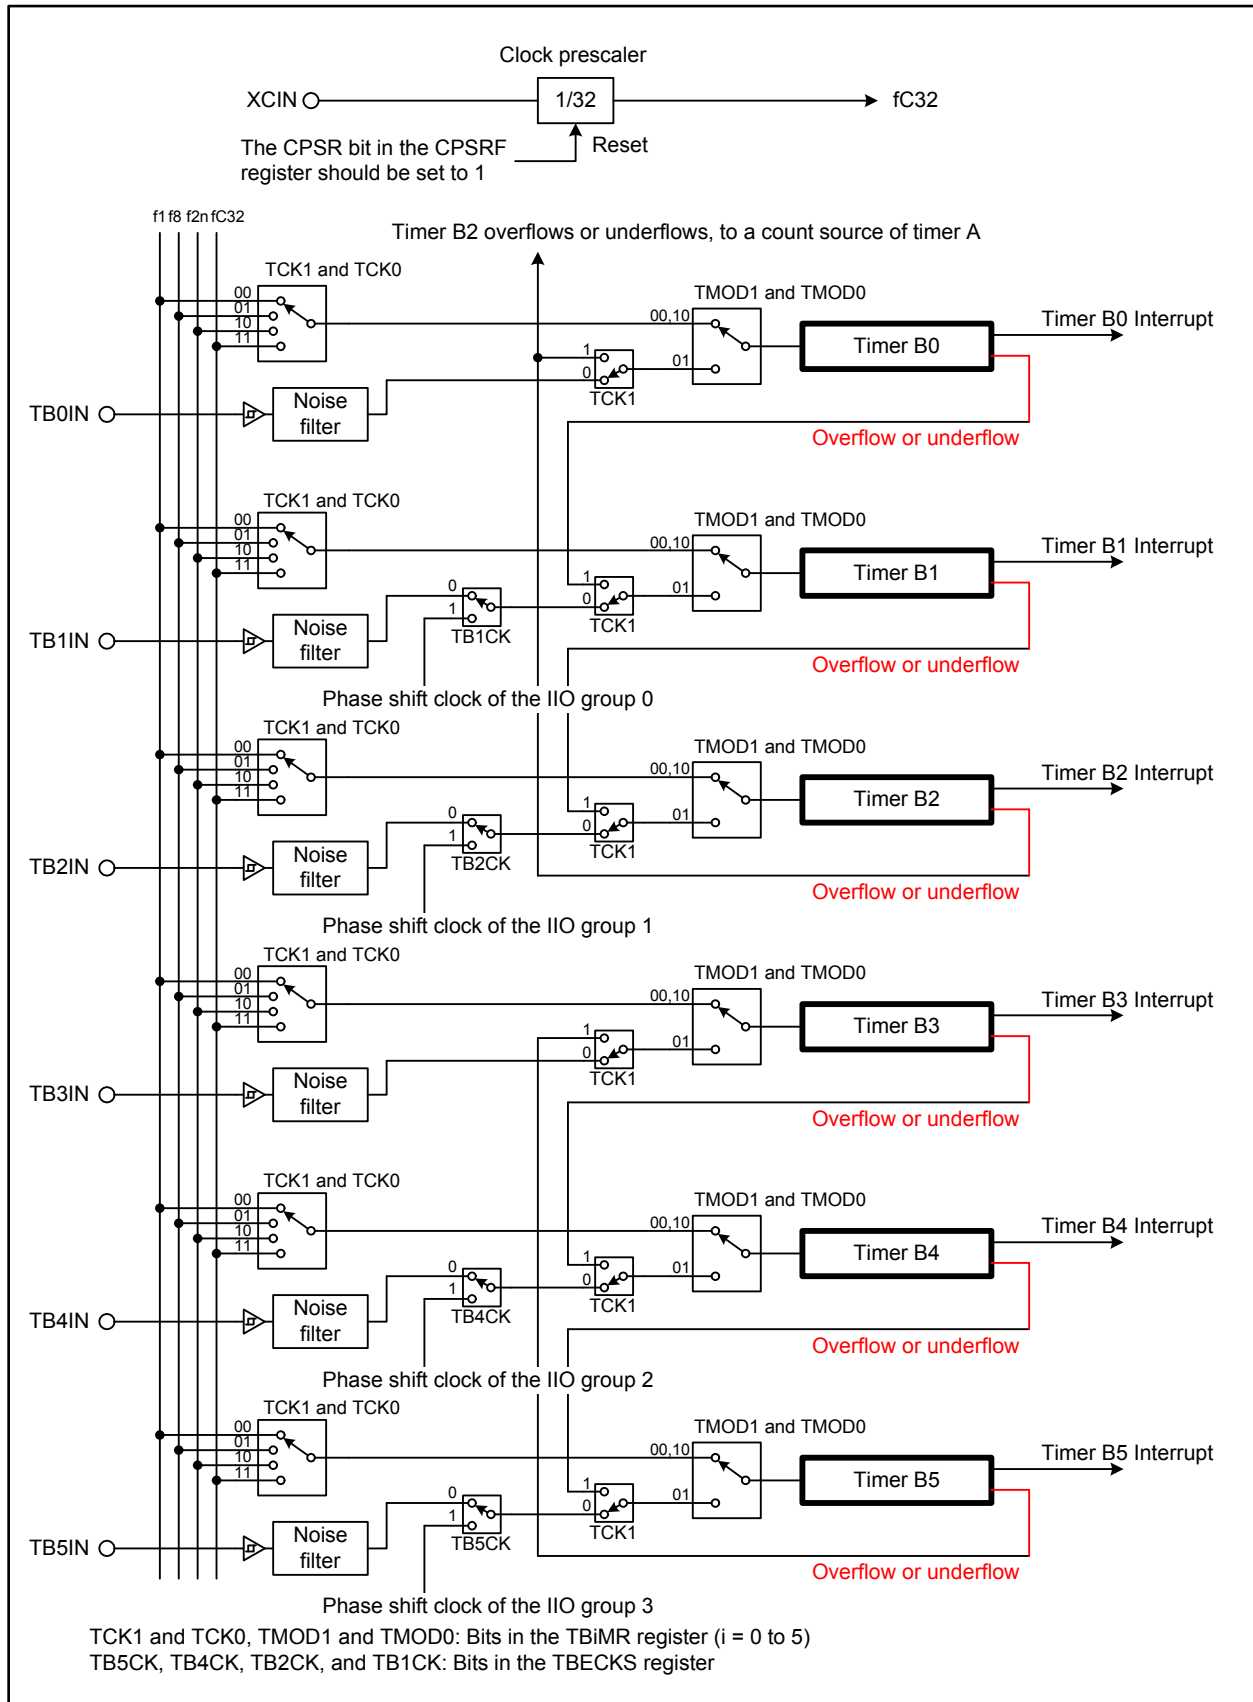
Figure 15.2 Timer B Configuration

•Page 198 of 636, Figure 15.2 is corrected as follows:

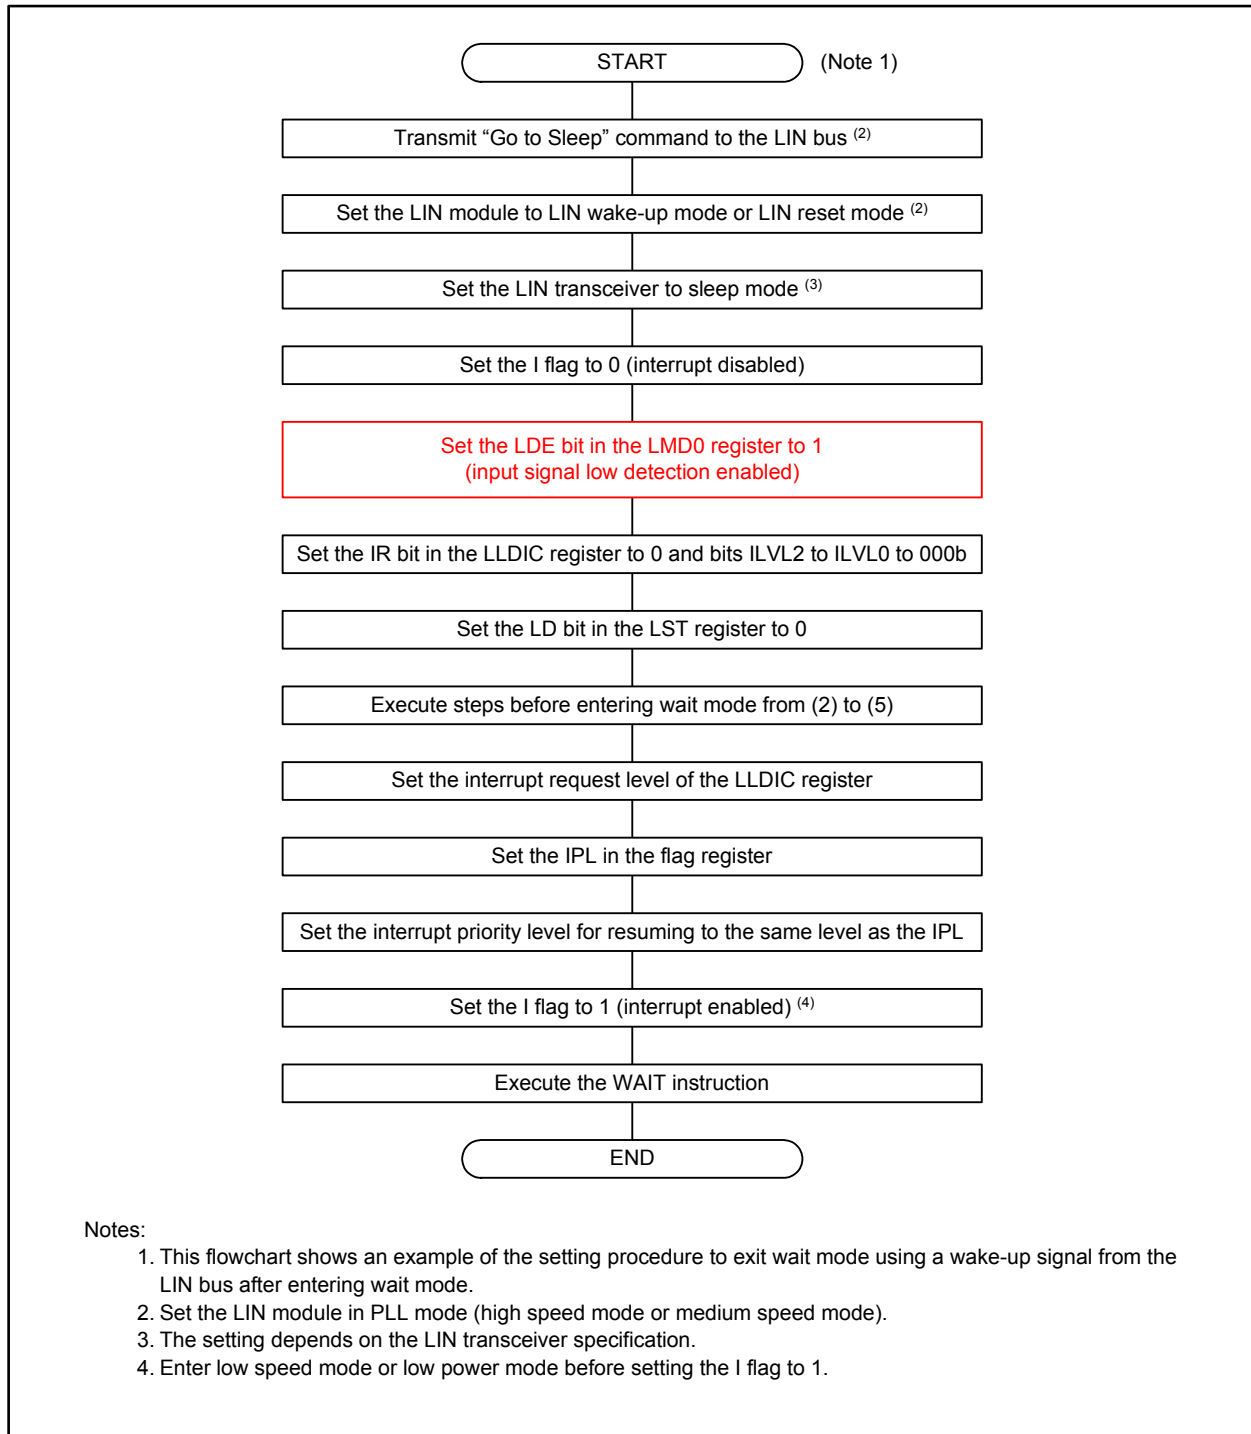
Figure 24.30 Example of Setting Before Transition to Wait Mode

•Page 432 of 636, Figure 24.30 is corrected as follows:

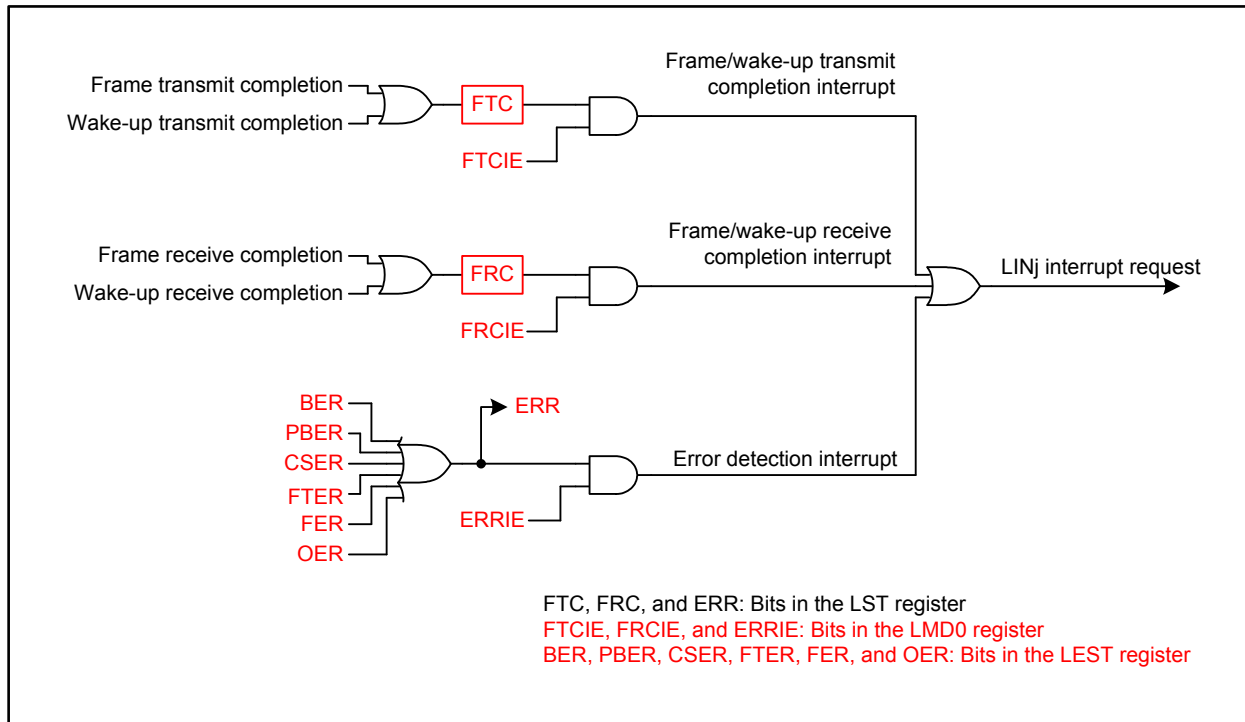
Figure 24.32 LINj Interrupt Block Diagram (j = 0 to 3)

- Page 436 of 636, Figure 24.32 is corrected as follows:

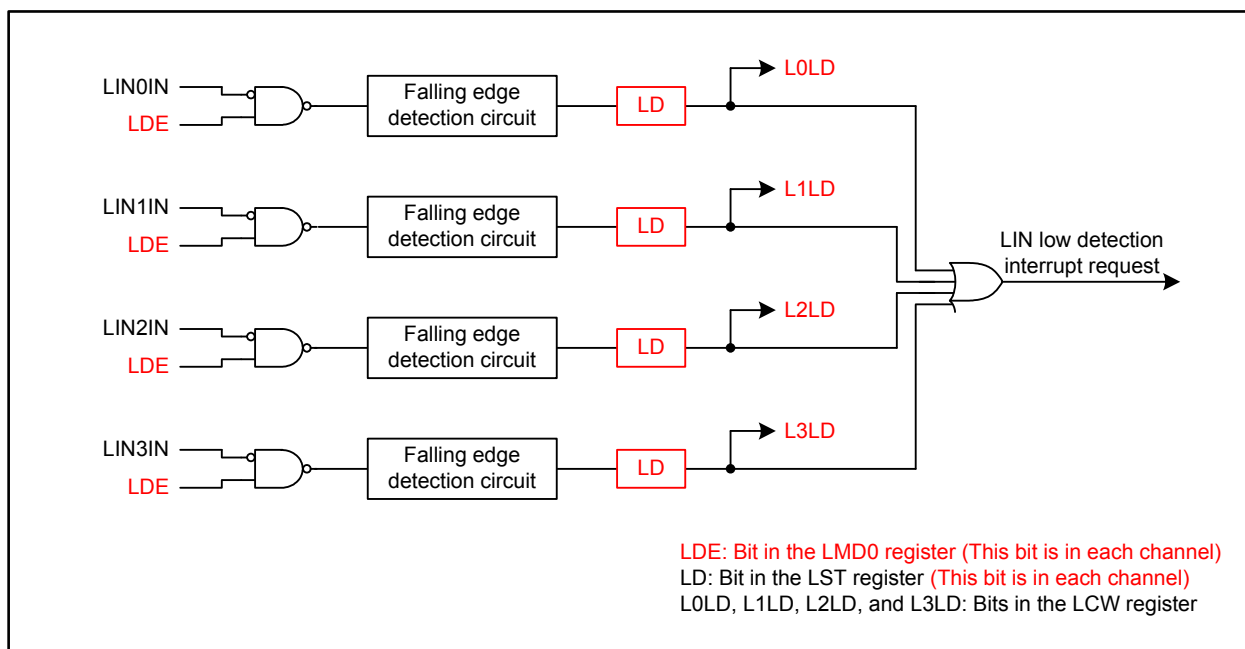
Figure 24.33 LIN Low Detection Interrupt Block Diagram

- Page 437 of 636, Figure 24.33 is corrected as follows:

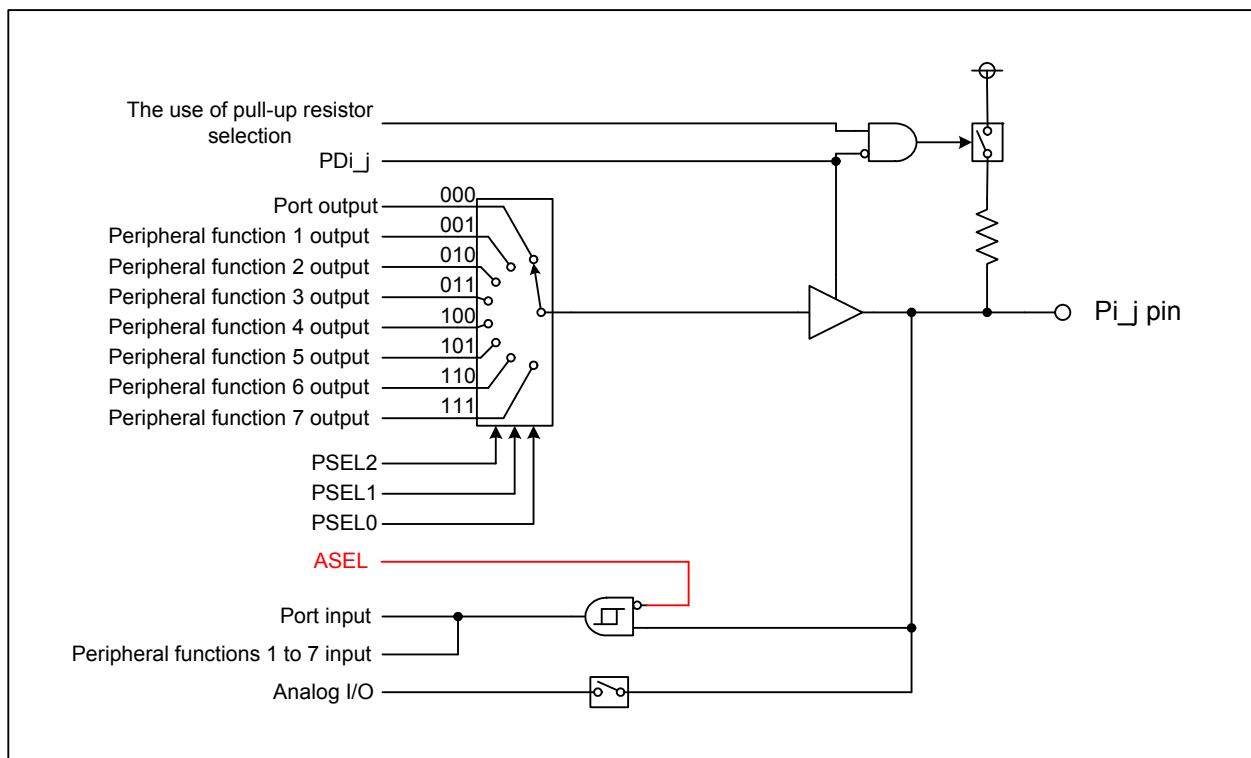
Figure 26.1 Typical I/O Pin Block Diagram (i = 0 to 15; j = 0 to 7)

- Page 507 of 636, Figure 26.1 is corrected as follows:

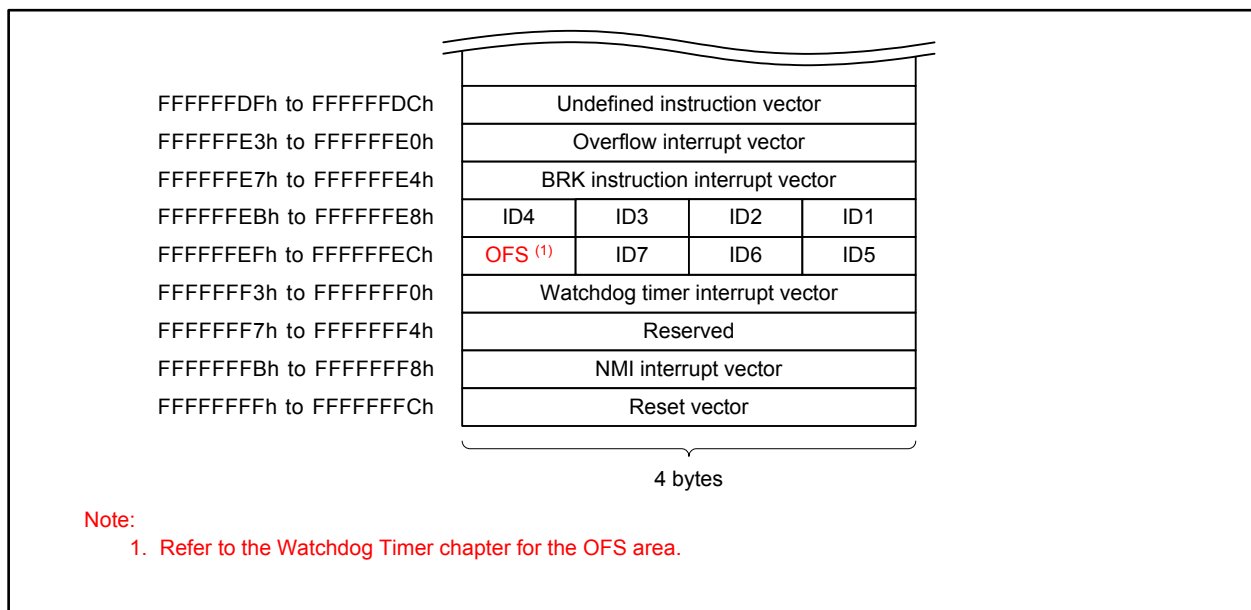
Figure 27.2 Addresses for ID Code Stored

•Page 541 of 636, Figure 27.2 is corrected as follows:

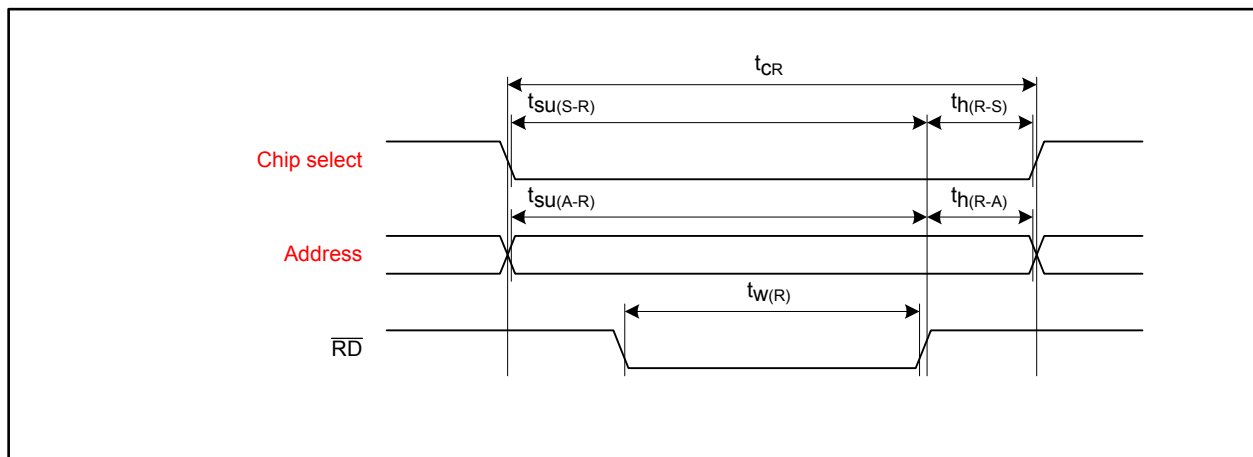
Figure 27.12 Read Timing

•Pages 549 and 551 of 636, descriptions in Figures 27.12 and 27.13 are corrected as follows:

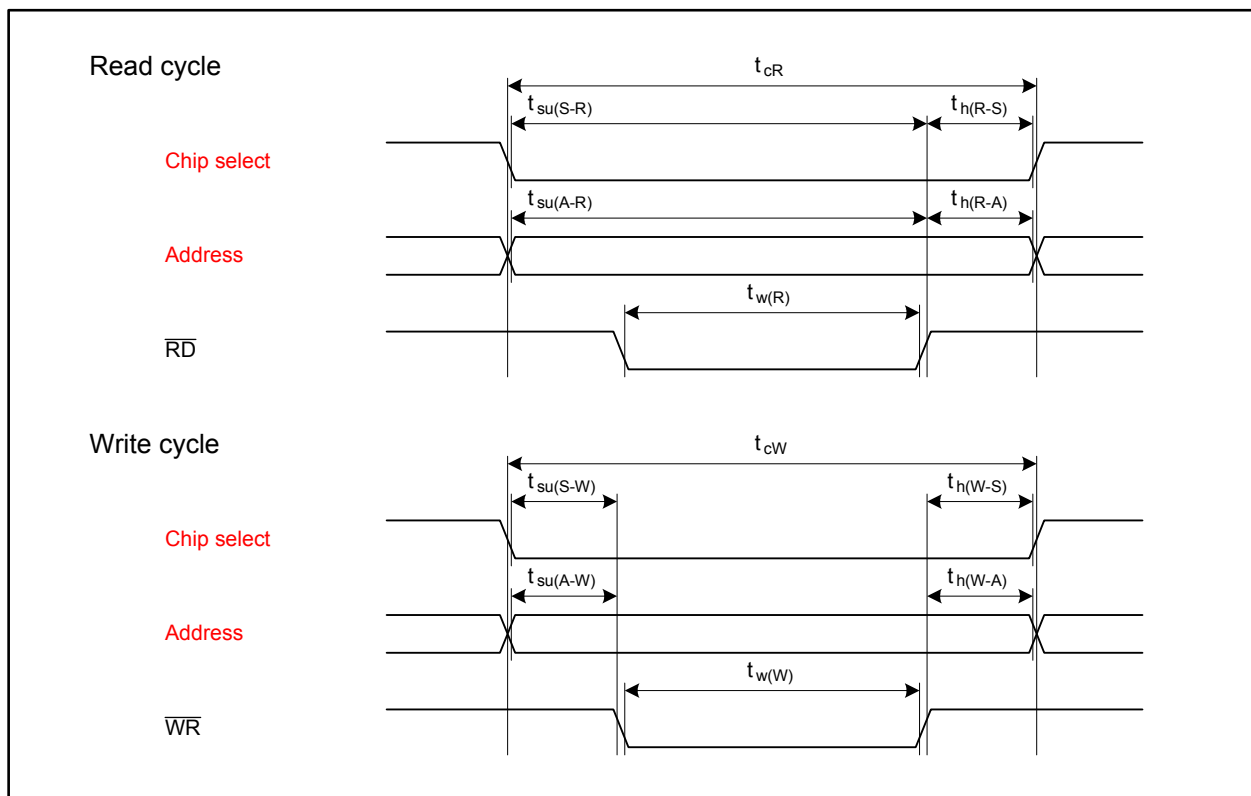
Figure 29.5 Flash Memory CPU Rewrite Mode Timing

- Page 569 of 636, description of Note 3 in Figure 28.2 is corrected as follows:
 “When this bit is set to 1, the module stops ongoing operations to enter its initial state. However, the registers are not initialized.”
- Page 569 of 636, description “This mode setting prevents data from being overwritten if a program goes out of control.” is deleted from Note 5 of Figure 28.2.
- Page 571 of 636, figure title “F2FI Register” for Figure 28.7 is corrected as follows:
 “E2FI Register”
- Page 575 of 636, description for EERR bit setting in Figure 28.12 is corrected as follows:
 “EERR bit in the E2FS0 register is 0?”
- Page 588 of 636, descriptions in Figure 29.5 are corrected as follows:
