R20TS0622EC0100  
Rev.1.00  
Oct. 01, 2020

CS+ Code Generator for RH850,  
AP4 Coding Assistance Tool for RH850

Outline

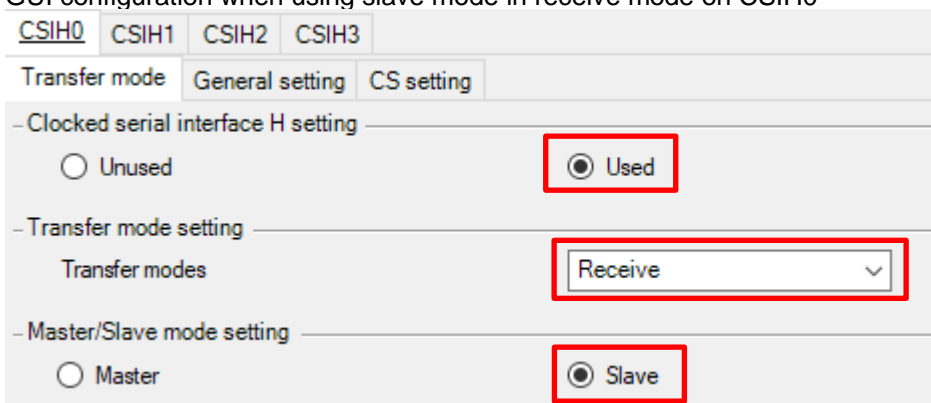
■ GUI configuration when using slave mode in receive mode on CSIH0

When using CSIH with slave mode and receive mode or transmit/receive mode selected on the following peripherals, transmission processing will not work from the second time because the variable of receive count initialization is incorrect.

- RH850/F1K:  
CSIH0, CSIH1, CSIH2, CSIH3

Manually modify the variable name of receive count from “g\_<csihn>\_tx\_num” to “g\_<csihn>\_rx\_num” in the following source file <sup>(Note)</sup>. <csihn> varies depending on the selected peripheral.

- Source file: “r\_cg\_csih.c”.
- Function: “MD\_STATUS R\_<CSIHn>\_Slave\_Receive (uint16\_t\* rx\_buf, uint16\_t rx\_num)”

Note: If code is generated again, the previous state is restored. Modification is necessary each time you perform code generation.

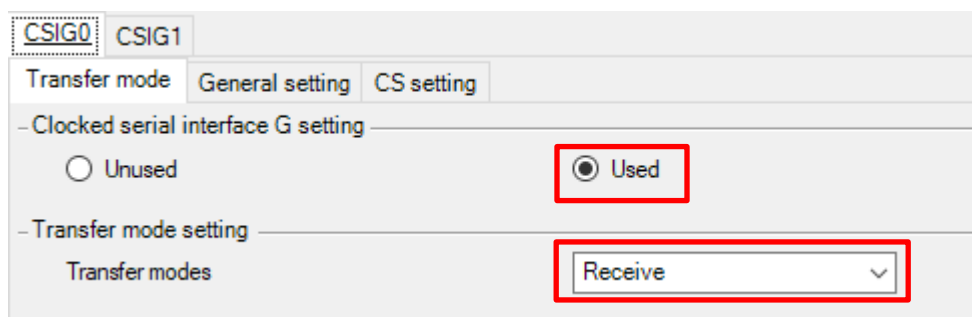
#### ■ GUI configuration when using receive mode on CSIG0

When using CSIG and receive mode or transmit/receive mode selected on the following peripherals, transmission processing will not work from the second time because the variable of receive count initialization is incorrect.

- RH850/F1K: 100-pin products  
CSIG0
- RH850/F1K: 144-pin, 176-pin products  
CSIG0, CSIG1

Manually modify the variable name of receive count from “g\_<csign>\_tx\_num” to “g\_<csign>\_rx\_num” in the following source file <sup>(Note)</sup>. <csign> varies depending on the selected peripheral.

- Source file: “r\_cg\_csig.c”.
- Function: “MD\_STATUS R\_<CSIGn>\_Receive (uint16\_t\* rx\_buf, uint16\_t rx\_num)”

Note: If code is generated again, the previous state is restored. Modification is necessary each time you perform code generation.
