R20TS0622EC0100

# CS+ Code Generator for RH850, AP4 Coding Assistance Tool for RH850

## Outline

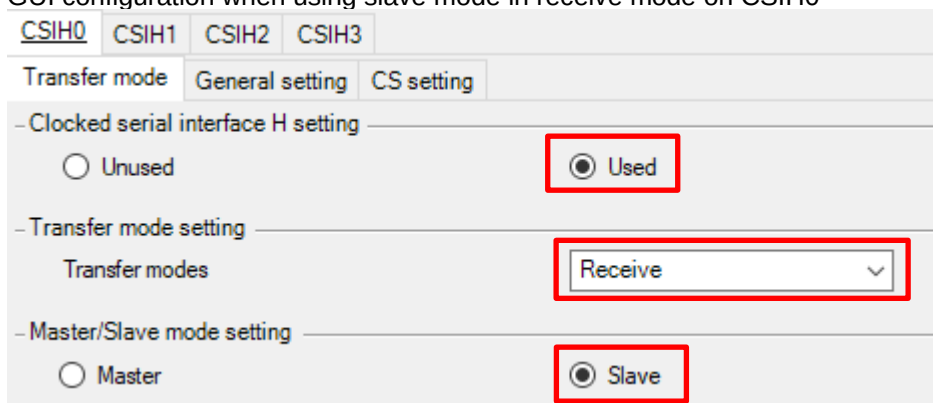
#### ■ GUI configuration when using slave mode in receive mode on CSH0

When using CSIH with slave mode and receive mode or transmit/receive mode selected on the following peripherals, transmission processing will not work from the second time because the variable of receive count initialization is incorrect.

- RH850/F1K:  
CSIH0, CSH1, CSH2, CSH3

Manually modify the variable name of receive count from “g\_<csihn>\_tx\_num” to “g\_<csihn>\_rx\_num” in the following source file <sup>(Note)</sup>. <csihn> varies depending on the selected peripheral.

- Source file: “r\_cg\_csih.c”.
- Function: “MD\_STATUS R\_<CSIHn>\_Slave\_Receive (uint16\_t\* rx\_buf, uint16\_t rx\_num)”

The following is an example of the required modification when <CSIHn> is CSIH0. Manually modify the wrong code in red to correct code in blue.
