R20TS0669EJ0100

CS+ Code Generator for RX,  
e<sup>2</sup> studio Code Generator Plug-in,  
AP4 Coding Assistance Tool for RX

## 1. Notes on using external pin interrupt (IRQ)

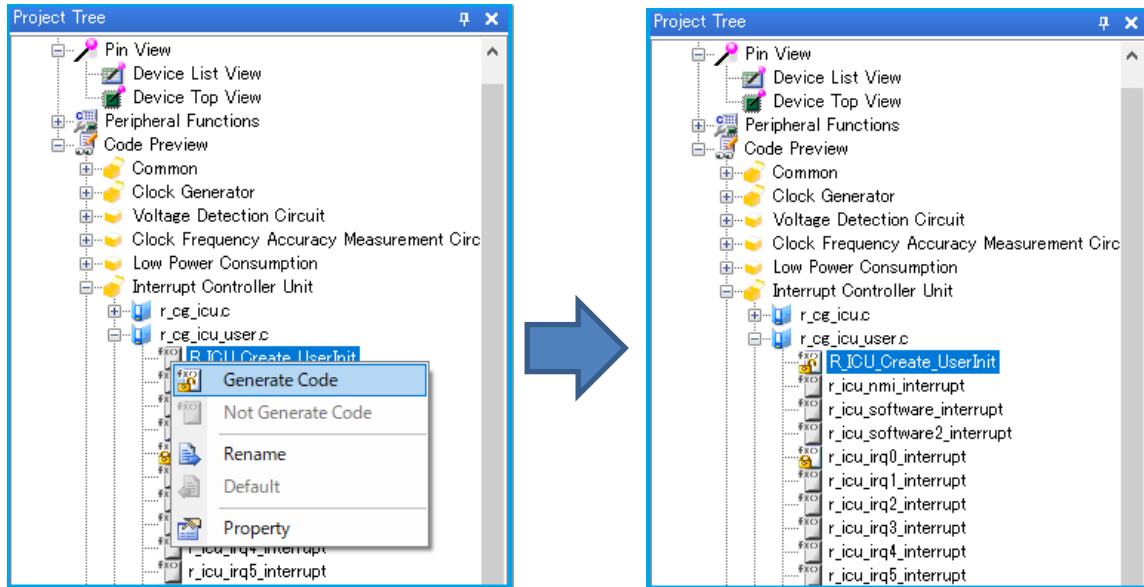
Figure 1-1 Adding a generated code (R\_ICU\_Create\_UserInit)

When external pin interrupts (IRQ) are used, an interrupt request (IR) is not cleared in the generated code after a port is set up. Therefore, an external pin interrupt (IRQ) may occur when interrupts are enabled.

- (a) External pin interrupt (IRQ) detection is set to low level, falling edge, or both edge.
- (b) The external pin holds a low-level input.

In the Project Tree, expand [Code Preview] – [Interrupt Controller Unit] – [r\_cg\_icu\_user.c], right-click [R\_ICU\_Create\_UserInit], and then select [Generate Code] from the context menu. This generates the R\_ICU\_Create\_UserInit function.

Add the code in **red** to clear the interrupt request flag for the external pin interrupt used for the R\_ICU\_Create\_UserInit function generated by code generation.
