[Notes]

R20TS0669EJ0100

CS+ Code Generator for RX,  
e<sup>2</sup> studio Code Generator Plug-in,  
AP4 Coding Assistance Tool for RX

## 1. Notes on using external pin interrupt (IRQ)

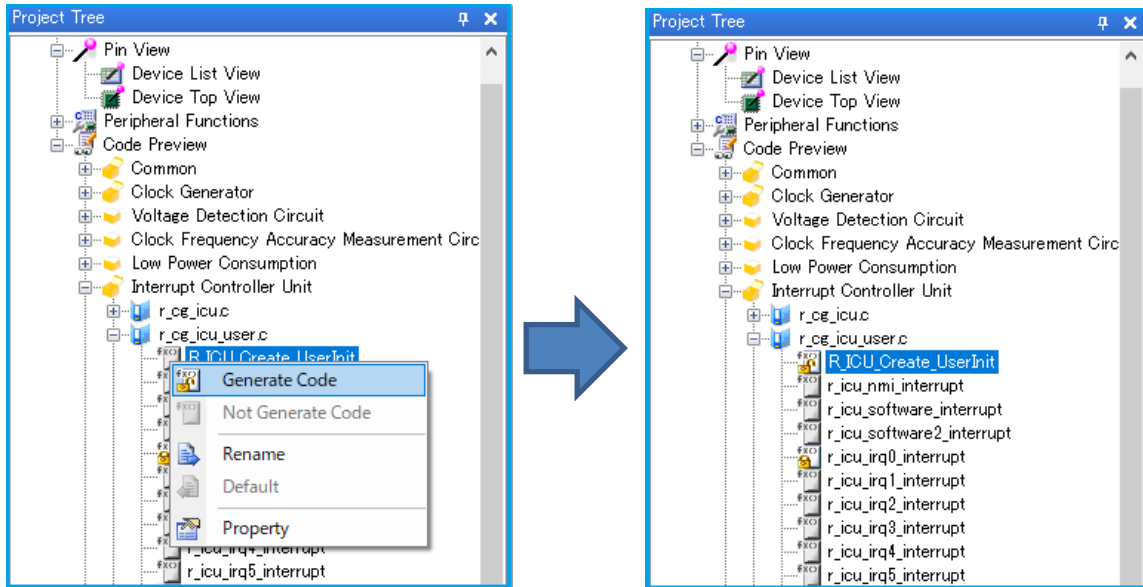
Figure 1-1 Adding a generated code (R\_ICU\_Create\_UserInit)

When external pin interrupts (IRQ) are used, an interrupt request (IR) is not cleared in the generated code after a port is set up. Therefore, an external pin interrupt (IRQ) may occur when interrupts are enabled.

- (a) External pin interrupt (IRQ) detection is set to low level, falling edge, or both edge.
- (b) The external pin holds a low-level input.

In the Project Tree, expand [Code Preview] – [Interrupt Controller Unit] – [r\_cg\_icu\_user.c], right-click [R\_ICU\_Create\_UserInit], and then select [Generate Code] from the context menu. This generates the R\_ICU\_Create\_UserInit function.

Add the code in **red** to clear the interrupt request flag for the external pin interrupt used for the R\_ICU\_Create\_UserInit function generated by code generation.
