[Notes]

R20TS0733ES0100

# CS+ Code Generator for RX, e<sup>2</sup> studio Code Generator Plug-in, AP4 Coding Assistance Tool for RX

1. When using RSPI2 as resource in SPI Operation (four-wire method) or in Clock synchronous operation (three-wire method)

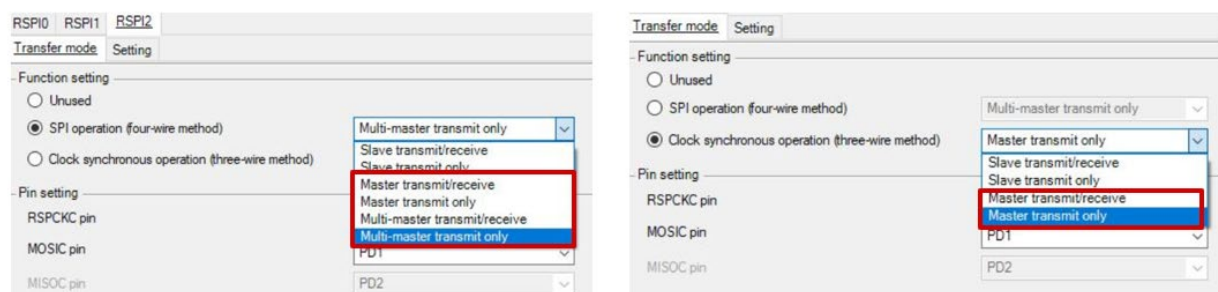
**Figure 1: Affected function setting and operation mode**

#### 1.3.1 The generated code for enabling SPI2 idle interrupt (SPII2) is wrong

The generated code for enabling SPII2 interrupt should be "ICU.GENAL0.BIT.EN20 = 1U" in the "void R\_RSPI2\_Create(void)" initialization API, but the actual generated code is "ICU.GENAL0.BIT.EN20 = 0U" instead, thus SPII2 interrupt will not be triggered and r\_rspi2\_callback\_transmitend function will not be executed after data transfer completion even it is configured to be used on the settings GUI tab.

The affected function setting and operation mode are shown in **Figure 1**.

- Affected function setting: SPI Operation (four-wire method) or Clock synchronous operation (three-wire method).
- Affected Operation mode: All Master mode with transmit function.

### 1.5 Workaround

The development of CS+ Code Generator for RX is completed. Kindly switch to the new tools Smart Configurator for your development.
