R20TS0820ES0100

# e<sup>2</sup> studio Smart Configurator Plug-in, Smart Configurator for RX

## Outline

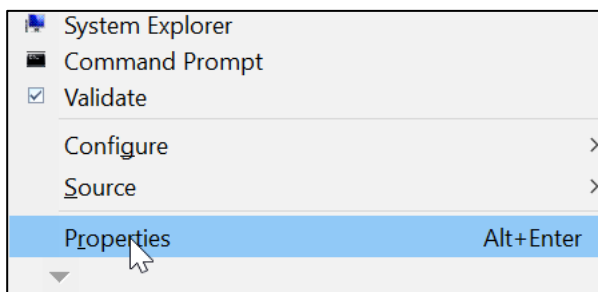
**Figure 2.1: Context menu of properties**

When build or clean e<sup>2</sup> studio Smart Configurator project, source files will be re-generated.

When build or clean e<sup>2</sup> studio Smart Configurator project in e<sup>2</sup> studio 2021-10 onwards, all source files will be re-generated when any of the following condition is met.

No good workaround, but code generation related to build and clean operation can be disabled by the following steps:

- (1) Right click the project on the project tree and click “Properties” from the popup menu.

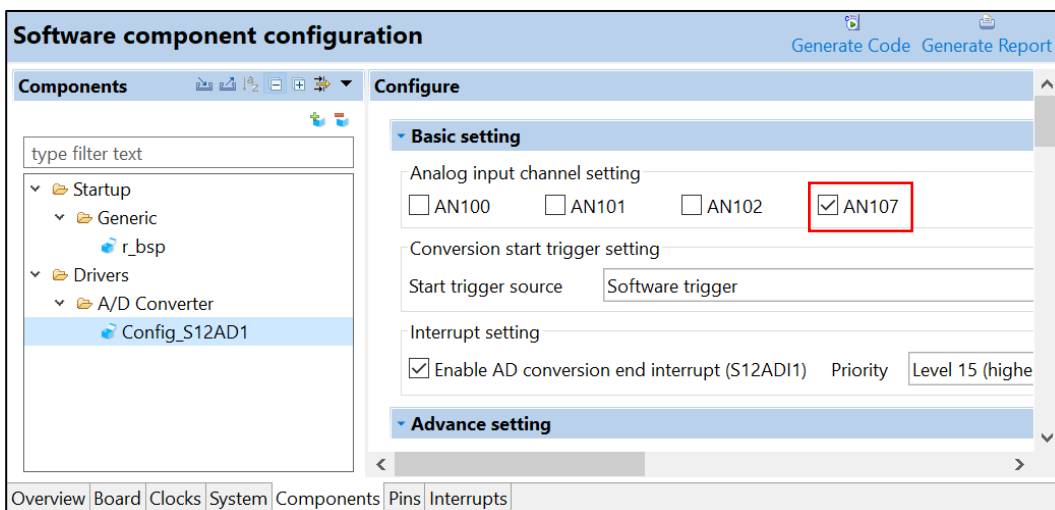
**Figure 3.1: Using AN107 in the S12AD Continuous Scan Mode component**

When using AN107 in S12AD Continuous Scan Mode component, after generating codes and build, there will be a build error saying “E0520136: Struct “<unnamed>” has no field “ANSA107”” in the output console.

When using AN107 in S12AD Continuous Scan Mode component and then build the generated codes

Please manually correct the generated codes from “ANSA107” to “ANSA007” in the initialization API.

Note: When code is generated again, generated code returns to the state before correction. Therefore, correct the source file each time you generate code.
