[Notes]

R20TS0895EC0100

e² studio Smart Configurator for RL78 Plug-in,
Smart Configurator for RL78

1. Notes when changing version of BSP or RL78 SIS modules

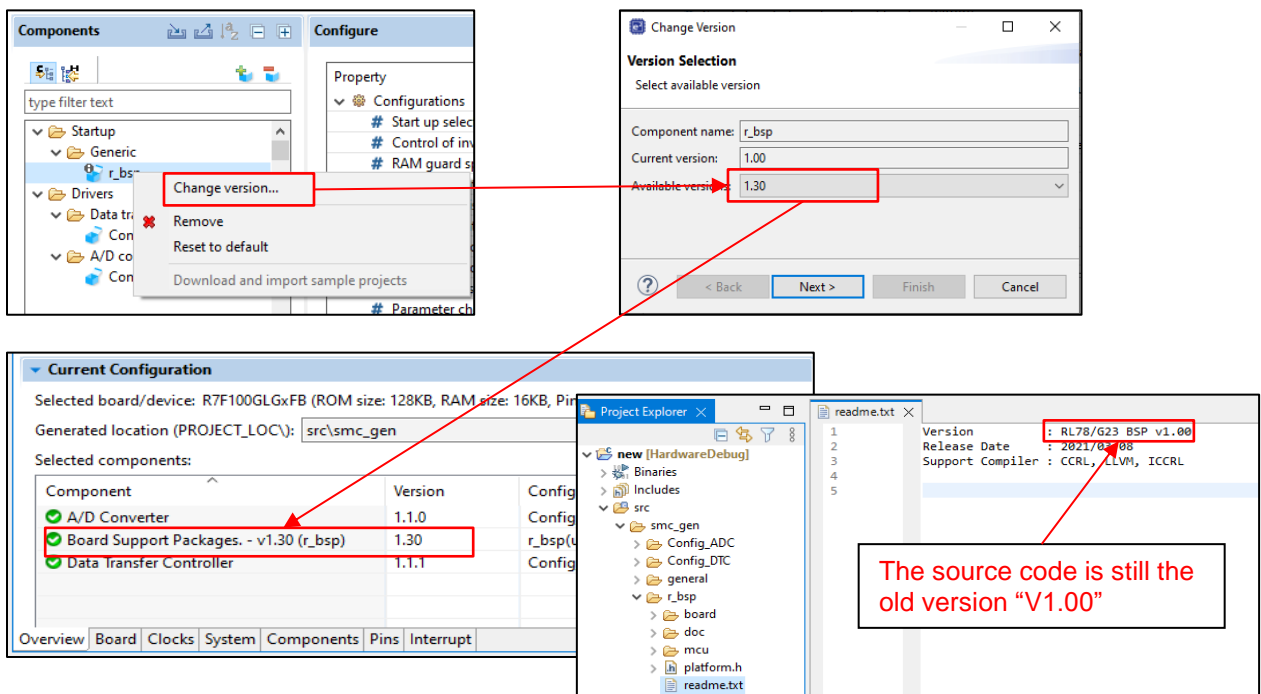
Figure 1-1 BSP/RL78 SIS module [Change version...] operation

After performing [Change version...], version seems to be changed successfully in the "Overview" summary. But actually some of the source code files are still the old version. (Refer to Figure 1-1). As a result, user can't be aware the version is unchanged and it may cause build errors in some cases.

1.5 Workaround

For the above 2 occurred conditions described in [1.4 Condition](#), the workaround steps are recommended as below:

<1> Delete the specified configuration file under “r_config” folder which want to perform [Change version...].

<2> Change preferences [Smart Configurator] > [Component] > [Generating code] to select “Overwrite existing component”. (Refer to [Figure1-2](#))

<3> Click [Change version...] menu.

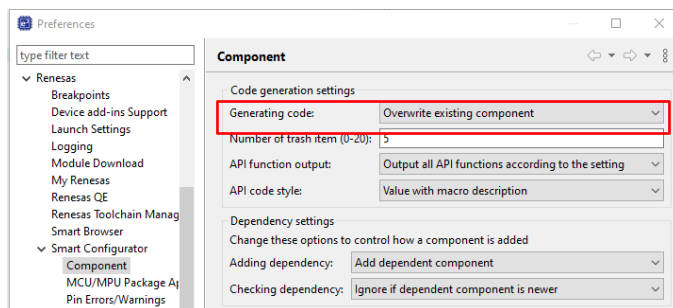
Figure 1-2 “Overwrite existing component” setting

1. When using Smart Configurator for RL78 V1.4.0 and preferences setting [Smart Configurator] > [Component] > [Generating code] selects “Overwrite existing component”

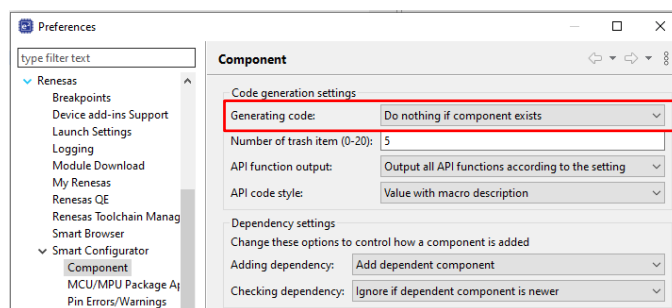
Figure 1-3 “Do nothing if component exists” setting

2. When using Smart Configurator (V1.0.1 or later) and preferences setting [Smart Configurator] > [Component] > [Generating code] selects “Do nothing if component exists”
