[Notes]

R20TS1168ES0100

## e<sup>2</sup> studio Smart Configurator Plug-in, Smart Configurator for RX

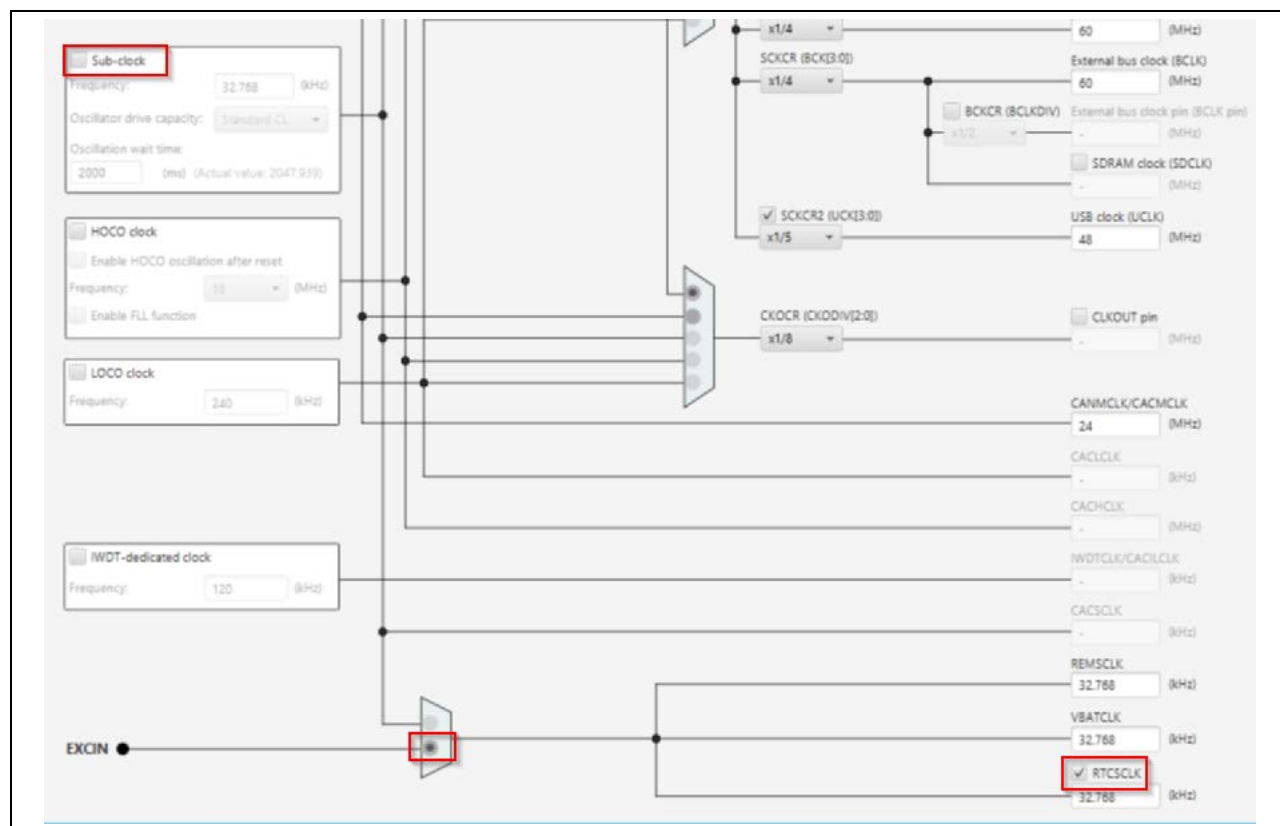
Incorrect code is generated in R\_Config\_RTC\_Create() function when the conditions specified in section 1.4 are met.

- Create an RX671 project
- Add Real Time Clock component
- Select EXCIN as clock source for RTC at Clocks tab (note: sub-clock is not used)
- Generate Code

Figure 1. Select EXCIN as clock source for RTC at Clocks tab

When using EXCIN with RTC component, open Config\_RTC.c file, go to R\_Config\_RTC\_Create() function, comment out the code setting RTCEN bit as follows.

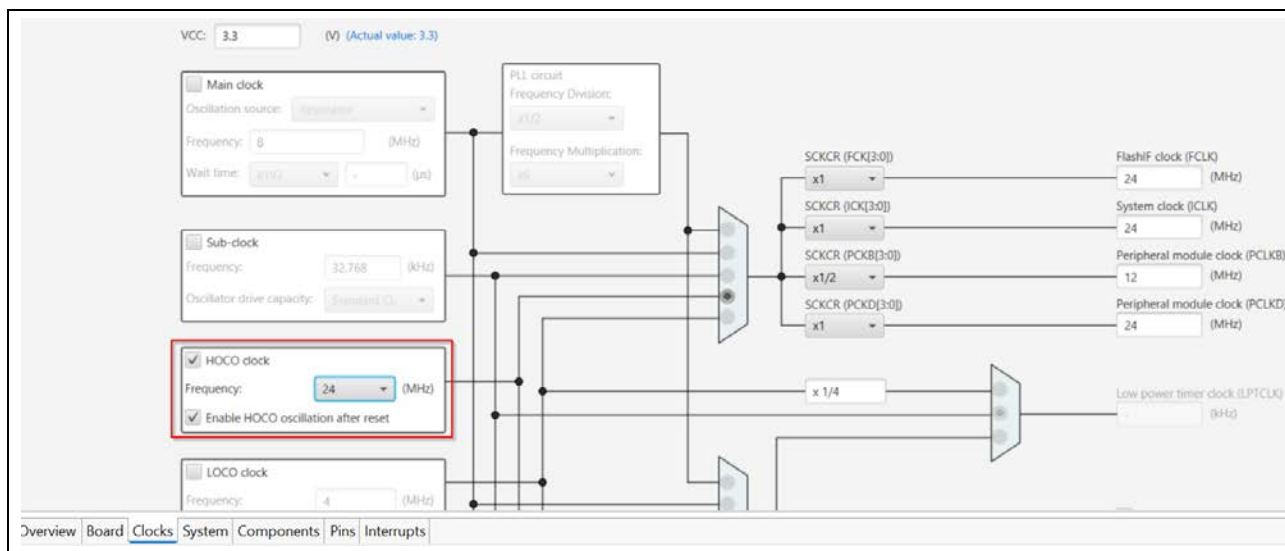
- Create an RX140 or RX260 or RX261 project
- Go to Clocks tab
- Select "HOCO clock"
- Change Frequency value
- Select "Enable HOCO oscillation after reset"
- Save and close project
- Reopen Smart Configurator project

**Figure 4. Change HOCO frequency and select "Enable HOCO oscillation after reset" and**

When reopening the Smart Configurator project under the conditions specified in section 2.4, set HOCO frequency again if it has changed.

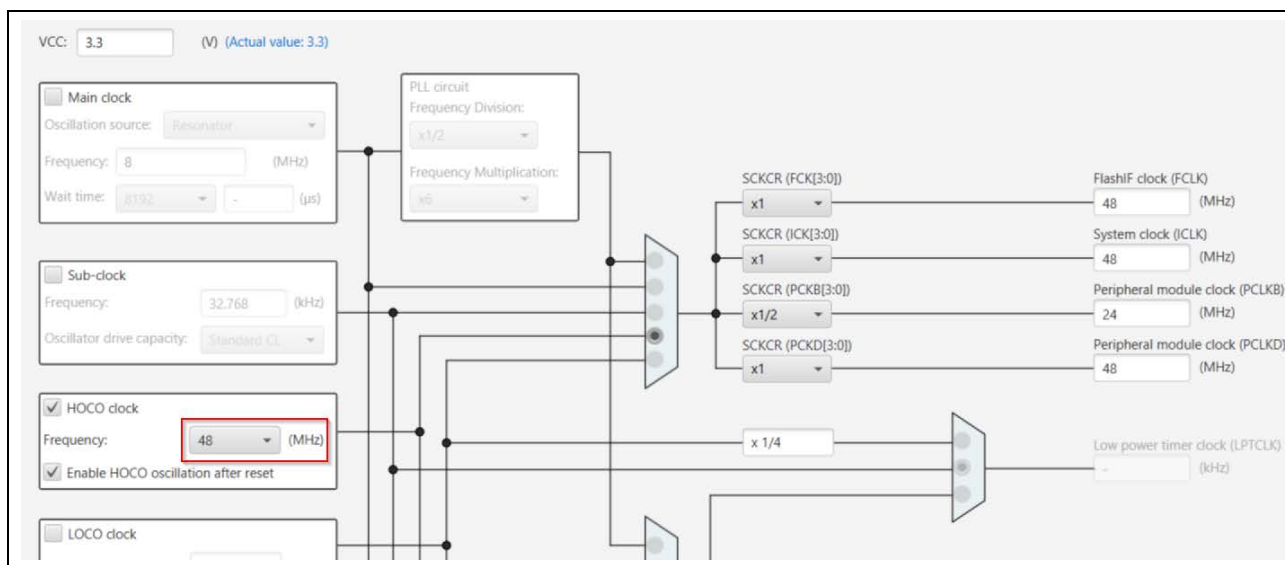
HOCO frequency is changed when reopening the Smart Configurator project under the conditions specified in section 2.4.

**Figure 5. HOCO frequency is changed when reopening the project**
