R20TS0881EJ0100

Integrated Development Environment for Capacitive Touch

Workbench6

Notes on R_Set_Cap_Touch_Initial_Tuning

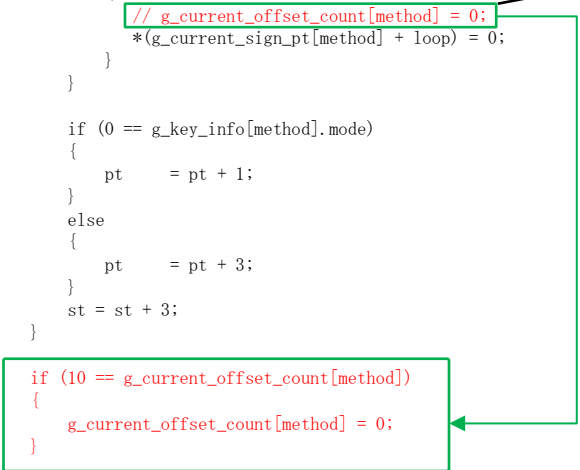
End condition that might cause a problem Because the continuation determination counter and integration of increased/decreased amount of CTSUSO0.CTSUSO bit are not cleared, the counter and integrated value might overflow.

The CTSUSO bit is updated. Adjustment is determined to be completed while the measurement value is unchecked.

During the loops (the number of valid channels), the continuation determination counter is cleared by the result of the channel being determined. As a result, determination of the next channel is suspended for the next 10 calls, thus extending the time for initialization.

Delete this

After modification: "initial_offset_tuning" of "r_ctsu.c". Add the processing shown in red.
