[Notes]

R20TS0679EC0100

Smart Configurator for RH850

Outline

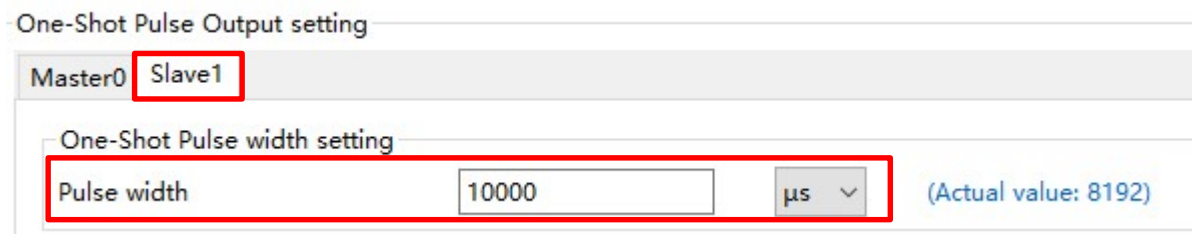
Figure 4-1 Setting of One-shot pulse width

When using One-Pulse Output and One-Shot Pulse Output on the following peripherals, the actual output pulse width has one count clock cycle error due to wrong value is set to timer data register.

- RH850/F1KM-S1: 48-pin, 64-pin products
TAUD0
- RH850/F1KM-S1: 80-pin, 100-pin products
TAUB0, TAUD0
- RH850/F1KM-S4: 100-pin, 144-pin products
TAUB0, TAUD0
- RH850/F1KM-S4: 176-pin, 233-pin products
TAUB0, TAUB1, TAUD0
- RH850/U2A16 (292-pin and 516-pin products)
TAUD0, TAUD1, TAUD2
- RH850/U2A8 (292-pin product)

Step1: User can config a One-Shot Pulse Output function, including “One-shot pulse width setting” of slave channel (refer to Figure 4-1 Setting of One-shot pulse width).

Step2: Click “Generate Code” and check the following macro value in “Config_TAUB0.h” file, the value in red need to be confirmed.

Step3: If user find the actual One-shot pulse width output in his own system is not as expected 10000 us, user can increase this macro value by “1”, as the following value in blue.

/*****
Macro definitions
*****/
#define _TAUB0_CHANNEL0_COMPARE_VALUE      (0x270FU)
#define _TAUB0_CHANNEL1_COMPARE_VALUE      (0x2710U)

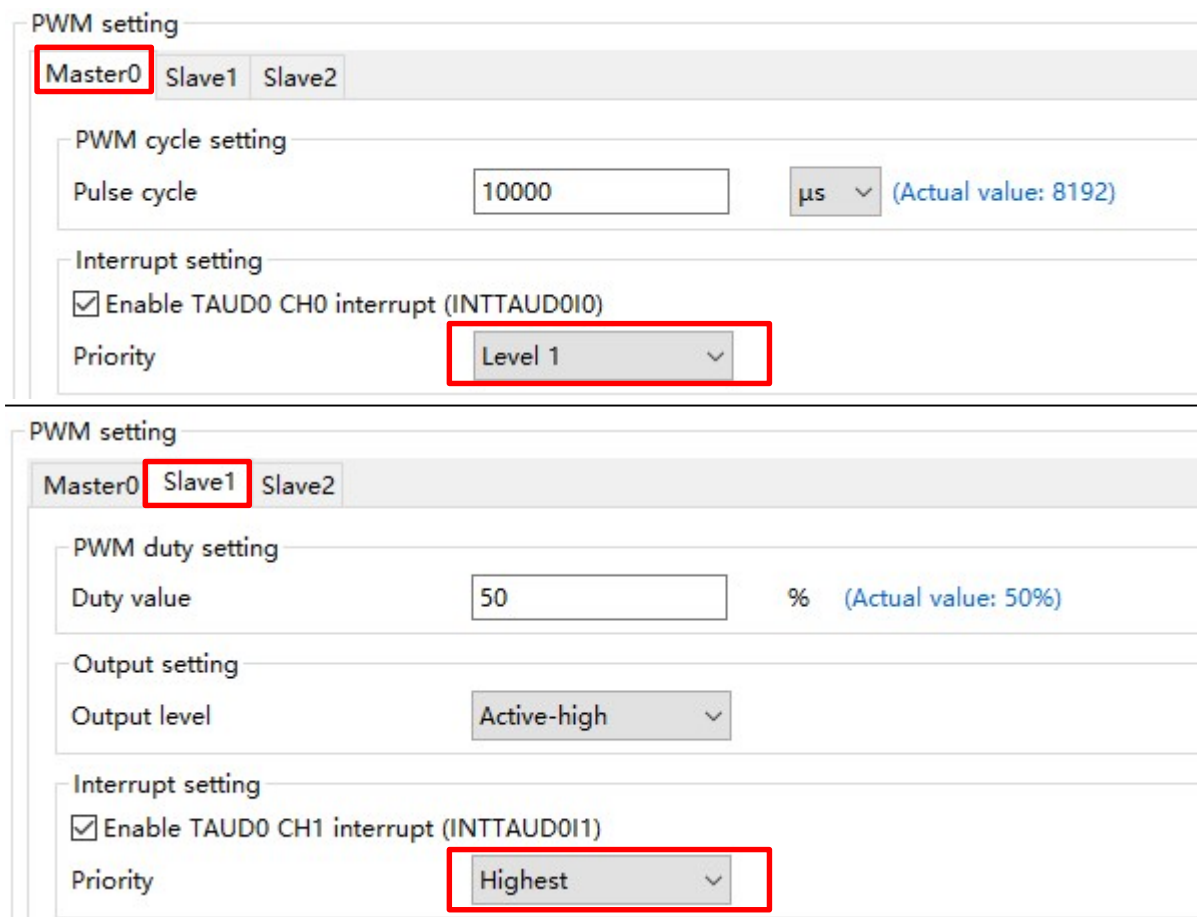
Figure 5-1 Setting of master and slave interrupt priority

When using PWM Output and Triangle PWM Output on the following peripherals, the slave channel interrupt priority is always same as master channel even though user has set different priority level on GUI (refer to Figure 5-1 Setting of master and slave interrupt priority).

- RH850/F1KM-S1: 48-pin, 64-pin, 80-pin, and 100-pin products
TAUD0
- RH850/F1KM-S4: 100-pin, 144-pin, 176-pin, and 233-pin products
TAUD0

User can manually modify the register setting code in the following source file: change the slave channel interrupt priority macro to the priority which is set on GUI. The interrupt priority macro name can be found in “¥smc_gen¥general¥r_cg_macrodriver.h” file.

- Source file: “<Configuration-name>.c”.
- Function: “void R_<Configuration-name>_Create (void)”

The following is an example of the required modification when <Configuration-name> is Config_TAUD0 in the RH850/F1KM group. Manually modify the code in red.

/* Set INTTAUD0I0 setting */
    INTC1.ICTAUD0I0.BIT.TBTAUD0I0 = _INT_TABLE_VECTOR;
    INTC1.ICTAUD0I0.UINT16 &= _INT_PRIORITY_LEVEL1;
    /* Set INTTAUD0I1 setting */
    INTC2.ICTAUD0I1.BIT.TBTAUD0I1 = _INT_TABLE_VECTOR;
    INTC2.ICTAUD0I1.UINT16 &= _INT_PRIORITY_HIGHEST;
