Outline

When using Smart Configurator for RH850, note the following points.

1. Notes on using T&H path self-diagnosis function of A/D Converter
2. Notes on redundant macros and wrong comments in A/D Converter header file

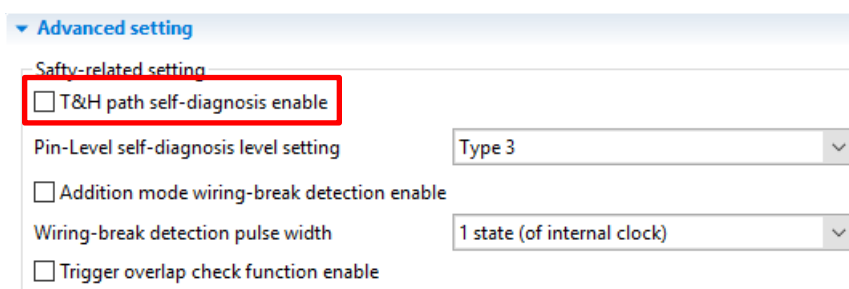
Figure 1-1 T&H path self-diagnosis setting

When using T&H path self-diagnosis function of A/D Converter (refer to Figure1-1) on the following peripherals, the function can't be enabled/disabled correctly even if the T&H path self-diagnosis function is already selected/unselected on GUI. The actual generated code is the opposite of the GUI setting.

- RH850/U2A16 (516-pin product, 292-pin product)
ADCJ0, ADCJ1, ADCJ2
- RH850/U2A8 (292-pin product)
ADCJ0, ADCJ1, ADCJ2

Manually modify the code in the following source file

- Source file: "r_cg_ad.h".
- Macro value: `_ADC_TH_PATH_SELF_DIAGNOSIS_ENABLE`,
`_ADC_TH_PATH_SELF_DIAGNOSIS_DISABLE`

Note: If code is generated again, the previous state will be restored. Modification is necessary each time after performing code generation.

This is an example of the required modification. Manually change the macro values in “r_cg_ad.h”. In the following example, the code in red color is wrong code before modification, while the code in blue color is correct code after modification.
