**M16C/63, 64A, 64C, 65, 65C, 6C, 5LD, 56D, 5L, 56,
5M, and 57 Groups**

R01AN1895EJ0110

Troubleshooting for I²C Mode of Serial Interface in Development

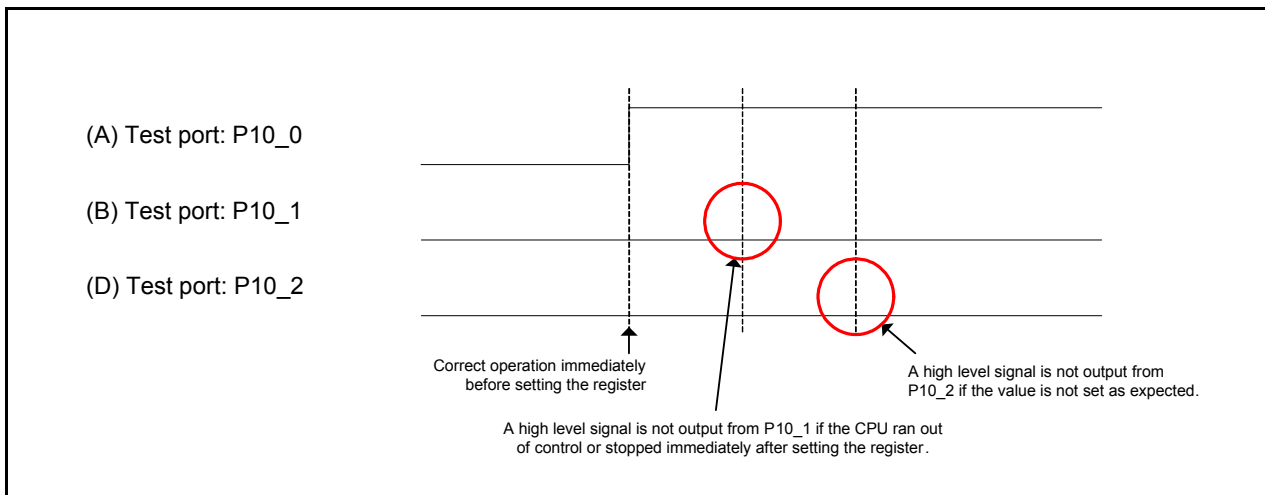
Figure 4.6 Waveform when the Program Stopped or Ran Out of Control after Setting a Register

High level signals may not output from test ports (B) and (D) as shown in Figure 4.6. Refer to the User's Manual: Hardware to check whether the register setting procedure, recommended operating conditions of electrical characteristics, and related notes are correctly followed.

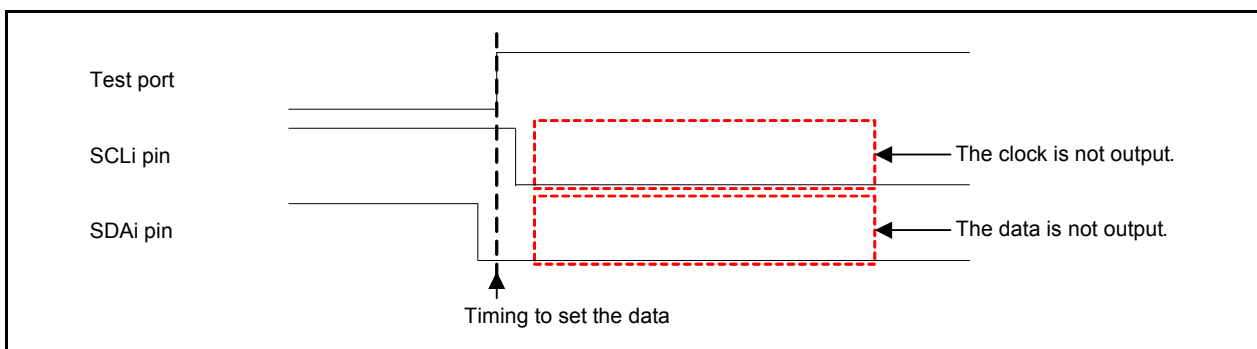
Figure 4.9 Signal Pattern in an Error Operation [A-2]

A signal on the test port is inverted after the start condition is output, then signals on pins SDAi and SCLi remain low. In this case the transmit condition is not satisfied. Check whether the transmission is enabled (TE bit in the UiC1 register is 1).

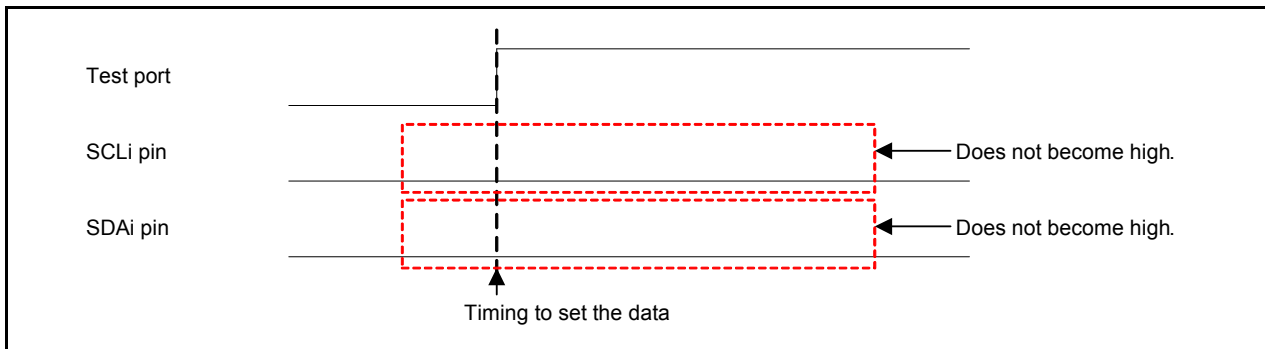
Figure 4.10 Signal Pattern in an Error Operation [A-3]

Low signals on pins SDAi and SCLi do not change after a signal on the test port is inverted. In this case pins SDAi and SCLi are not pulled up. Pull them up with an external circuit.

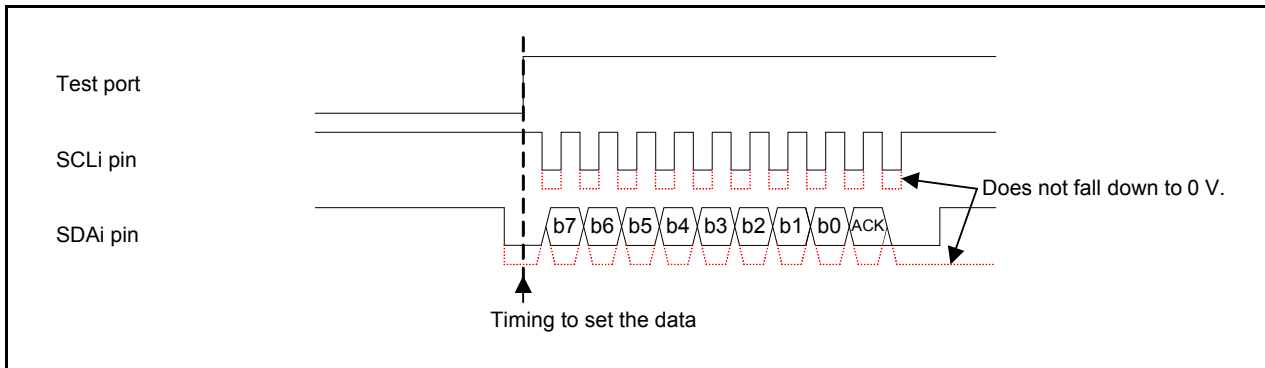
Figure 4.12 Signal Pattern in an Error Operation [A-5]

Furthermore, if adding approximately 100 ohms of resistors does not cause pull-up or pull-down, and pin levels of SDAi and SCLi do not change, then CMOS output may be performed.

Examine the circuit and settings whether signals are output from the target device or pins connected to pins SDAi and SCLi.

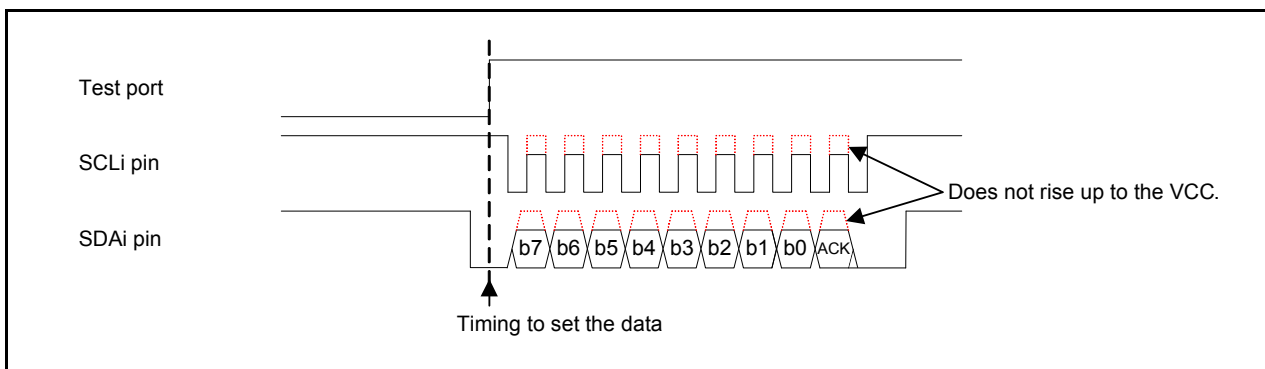
Figure 4.13 Signal Pattern in an Error Operation [A-6]

High level output from pins SDAi and SCLi does not rise up to VCC. In this case the standards may not be satisfied such that the signal level may not rise up to the VIH of the target device or high period is not long enough due to large wiring capacity or too high pull-up resistor connected to pins SDAi and SCLi. Or bit slippage may occur.

Design the circuit with enough margin so the wiring capacity or the pull-up resistor connected to pins SDAi and SCLi becomes appropriate.

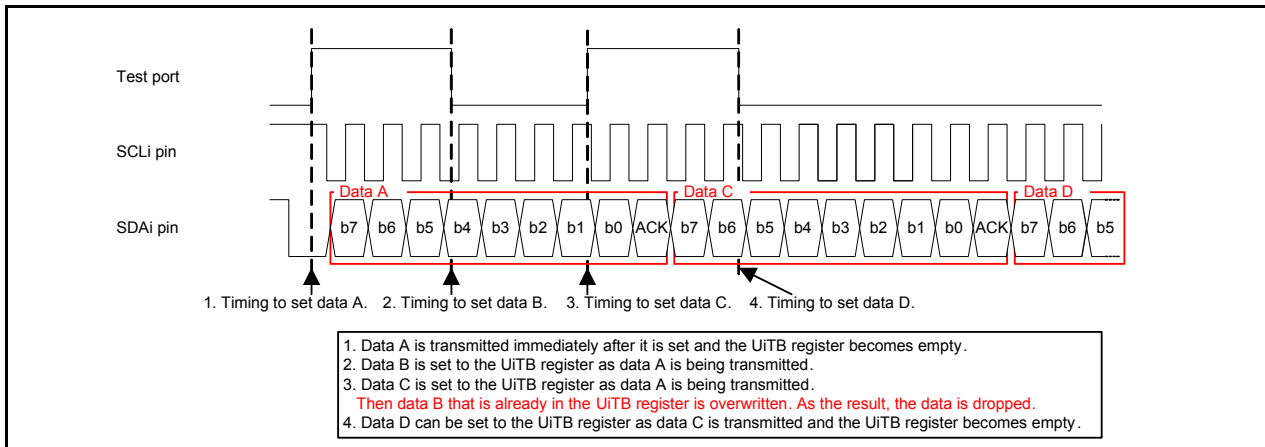
Figure 4.14 Signal Pattern in an Error Operation [A-7]

The test port is inverted multiple times while 1-byte transmit data is output. In this case the next data is set to the UiTB register while the transmit buffer is full (TI bit in the UiC1 register is 0). Then the data in the transmit buffer is overwritten and the data may be dropped.

Set the next transmit data in the interrupt handler for completion of transmission.

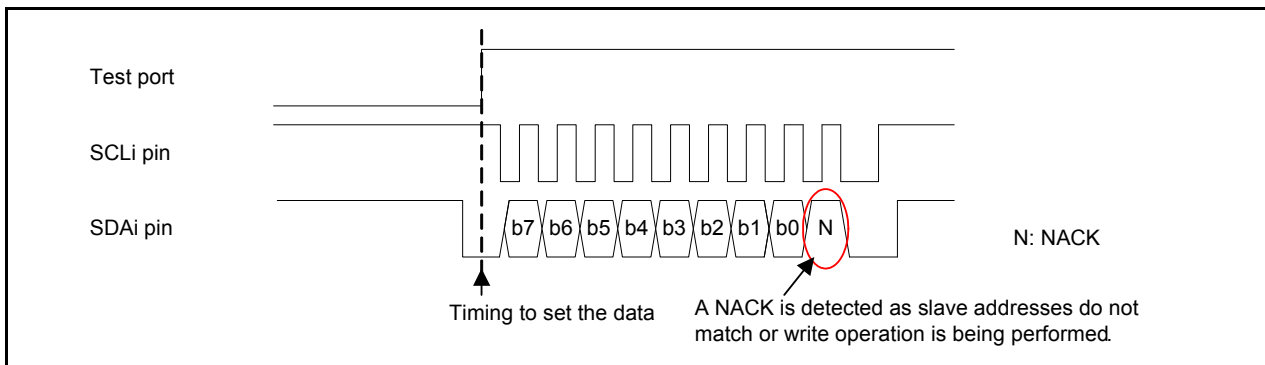
Figure 4.15 Signal Pattern in an Error Operation [A-8]

A NACK is received with the ACK/NACK bit when transmitting the slave address. In this case the transmitted slave address does not match the slave address of the target device. Check the slave address with the specification document for the target device and try to transmit with the right address. The target device is performing write operation and a NACK is returned. Wait until the target device completes write operation and try to transmit the slave address again.

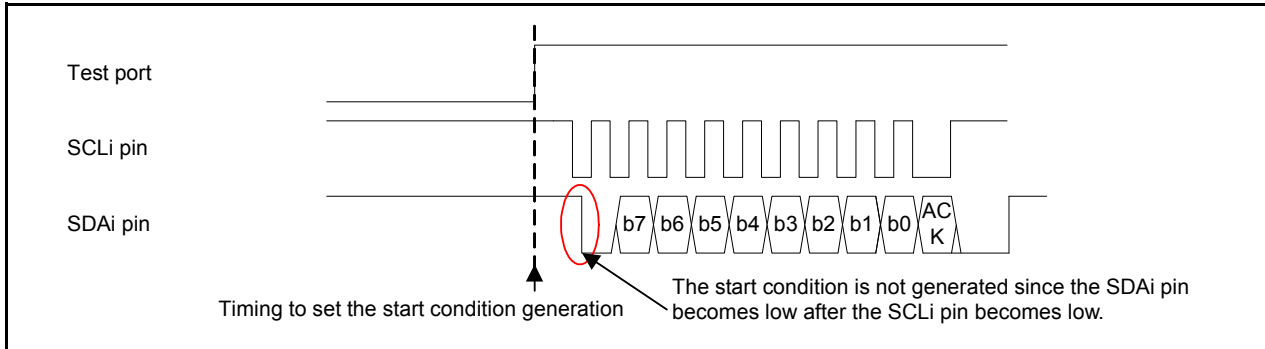
Figure 4.18 Signal Pattern in an Error Operation [B-3]

The SCLi pin becomes low before the SDAi pin becomes low at the start condition generation immediately after the test port is inverted. In this case the delay length of the SDA digital delay function (setting value in bits DL2 to DL0 in the UiSMR3 register) may be too much. Check whether the delay length is set with the appropriate value.

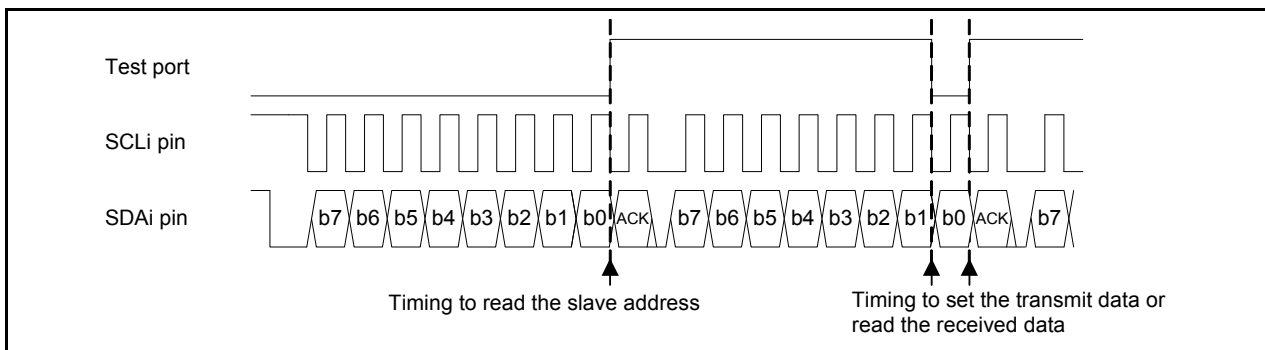
Figure 4.20 Signal Pattern in an Error Operation [C-2]

The test port is inverted at the falling edge of the eighth bit on the SCLi pin when receiving the slave address and then inverted at the falling edges of the eighth and ninth bits on the SCLi pin when transmitting or receiving data. In this case the received data may be read with the receive interrupt.

Orders to store data in the UiRB register are different between the receive interrupt and the transmit interrupt. Check whether the transmit interrupt is used to read data after the slave address reception. If data is read with the receive interrupt, the order to store data has to be changed.
