# RENESAS TECHNICAL UPDATE

Product Category	MPU & MCU	Document No.	TN-16C-A240A/E	Rev.	1.00
Title	Deletion of Specifications and Errata for R32C/118A Group User's Manual: Hardware		Information Category	Technical Notification	
Applicable Product	R32C/118A Group	Lot No.	Reference Document	R32C/118A Group User's Manual: Hardware Rev. 1.10 (R01UH0215EJ0110)

This document describes deletion of specifications and errata for the R32C/118A Group User's Manual: Hardware, Rev. 1.10.

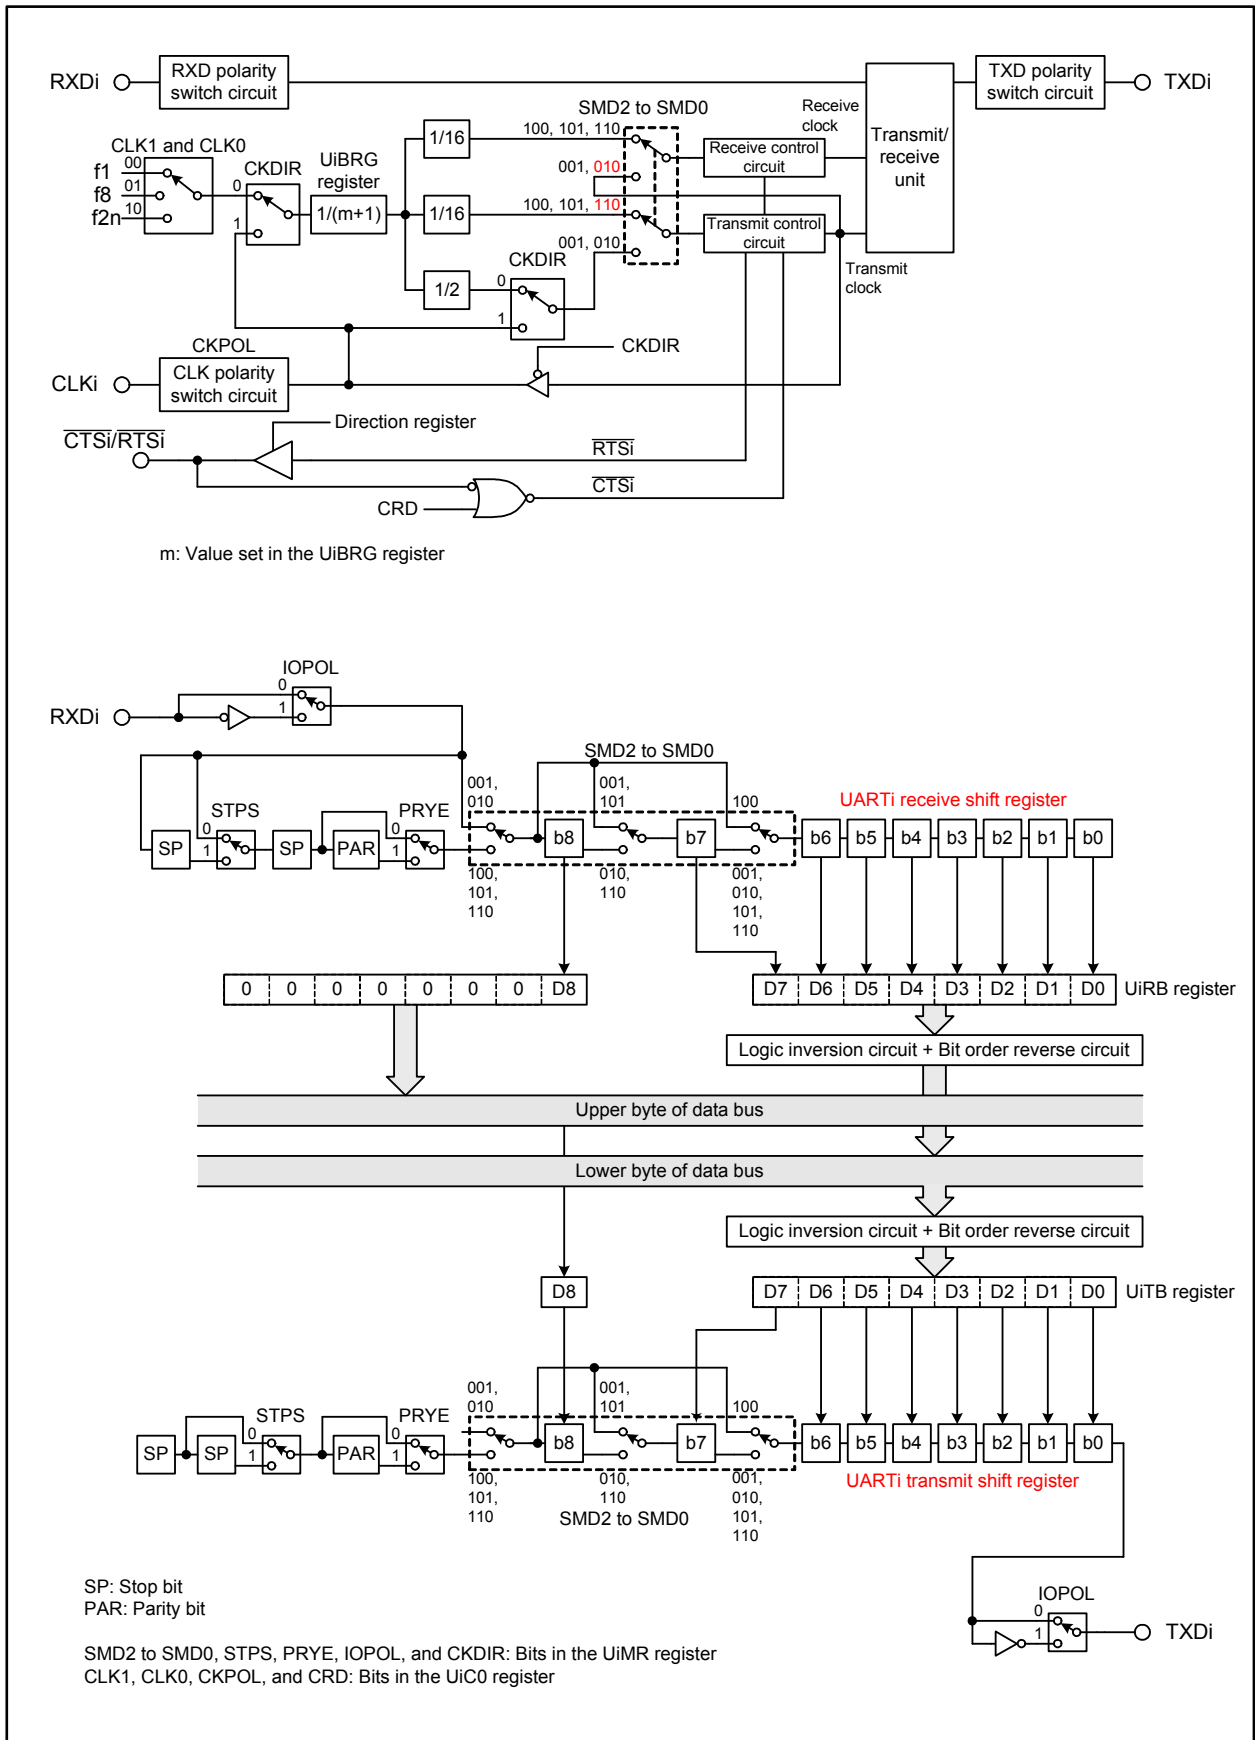
•Page 269 of 639, positions of “010” for bits SMD2 to SMD0 in Figure 18.1 are corrected as follows:

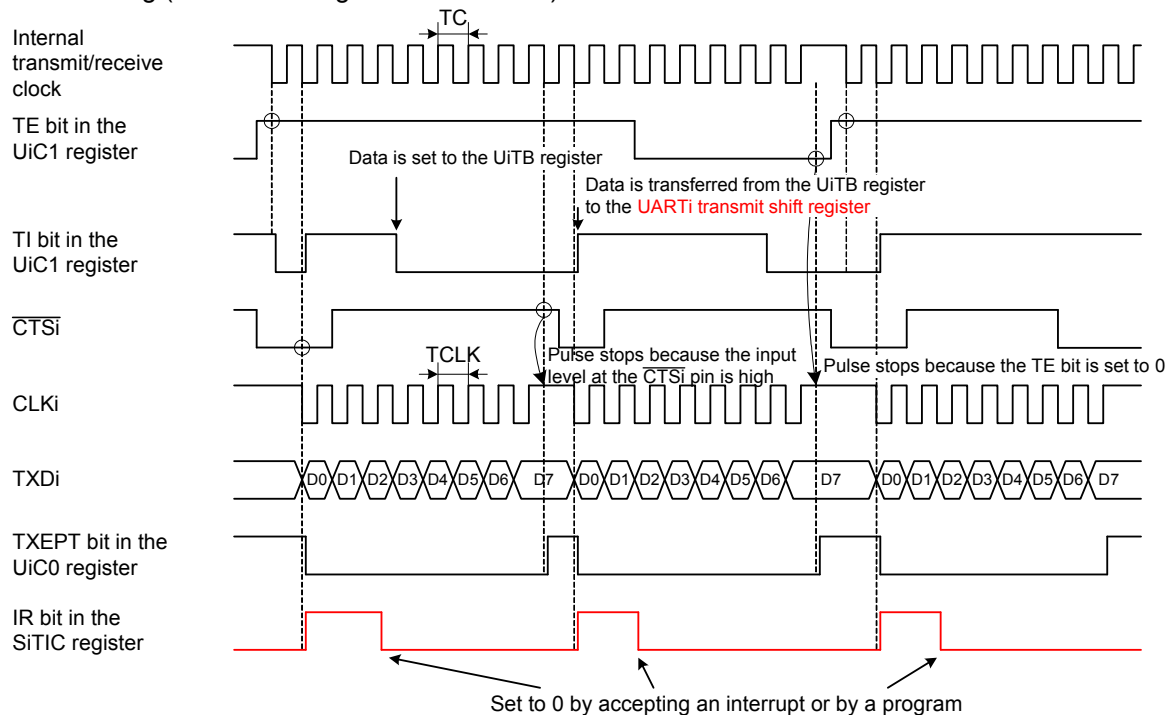
Transmit timing (when selecting an internal clock)

- Page 279 of 639, expression “baud rate generator count source” in the function of bits DL0 to DL2 in Figure 18.13 is corrected as follows:  
 “count source for the UiBRG register”
- Pages 286, 287, 294, 295, 304, 314 of 639, descriptions in Function of the UiBRG register in Tables 18.3, 18.4, 18.6, 18.7, 18.10, and 18.15 are modified as follows:  
 “Set the divide ratio according to the bit rate”
- Pages 287, 295 of 639, description for (b7 to b4) to registers UiC1 and U78CON in Tables 18.4 and 18.7 is added as follows:  
 “(b7 to b4) Set the bits to 0000b”
- Page 288 of 639, waveform of the IR bit in Figure 18.21 is corrected as follows:

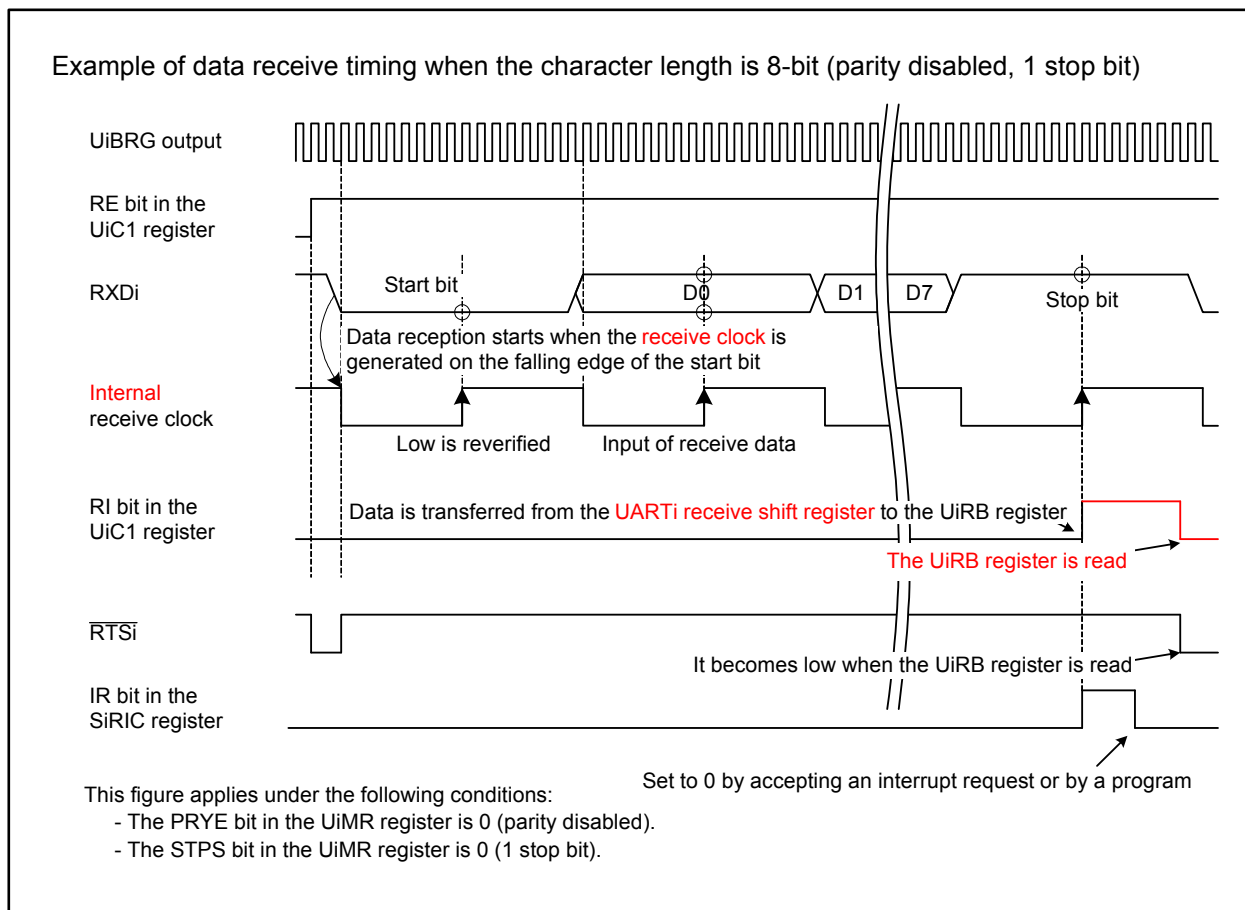
•Page 298 of 639, Figure 18.28 is corrected as follows:
