RENESAS TECHNICAL UPDATE

Product Category	MPU/MCU		Document No.	TN-16C-A198A/E	Rev.	1.00
Title	Errata to R32C/111 Group, R32C/120 Group, R32C/121 Group, R32C/160 Group, R32C/161 Group Hardware Manuals		Information Category	Technical Notification		
Applicable Product	R32C/111 Group R32C/120 Group R32C/121 Group R32C/160 Group R32C/161 Group	Lot No.	Reference Document	R32C/111 Group Hardware Manual Rev. 1.10 (REJ09B0424-0110)		
				R32C/120 Group Hardware Manual Rev. 1.10 (REJ09B0476-0110)		
				R32C/121 Group Hardware Manual Rev. 1.10 (REJ09B0477-0110)		
				R32C/160 Group Hardware Manual Rev. 1.02 (REJ09B0516-0102)		
				R32C/161 Group Hardware Manual Rev. 1.02 (REJ09B0517-0102)

This document describes corrections to the I/O Pins chapter of hardware manuals listed above.

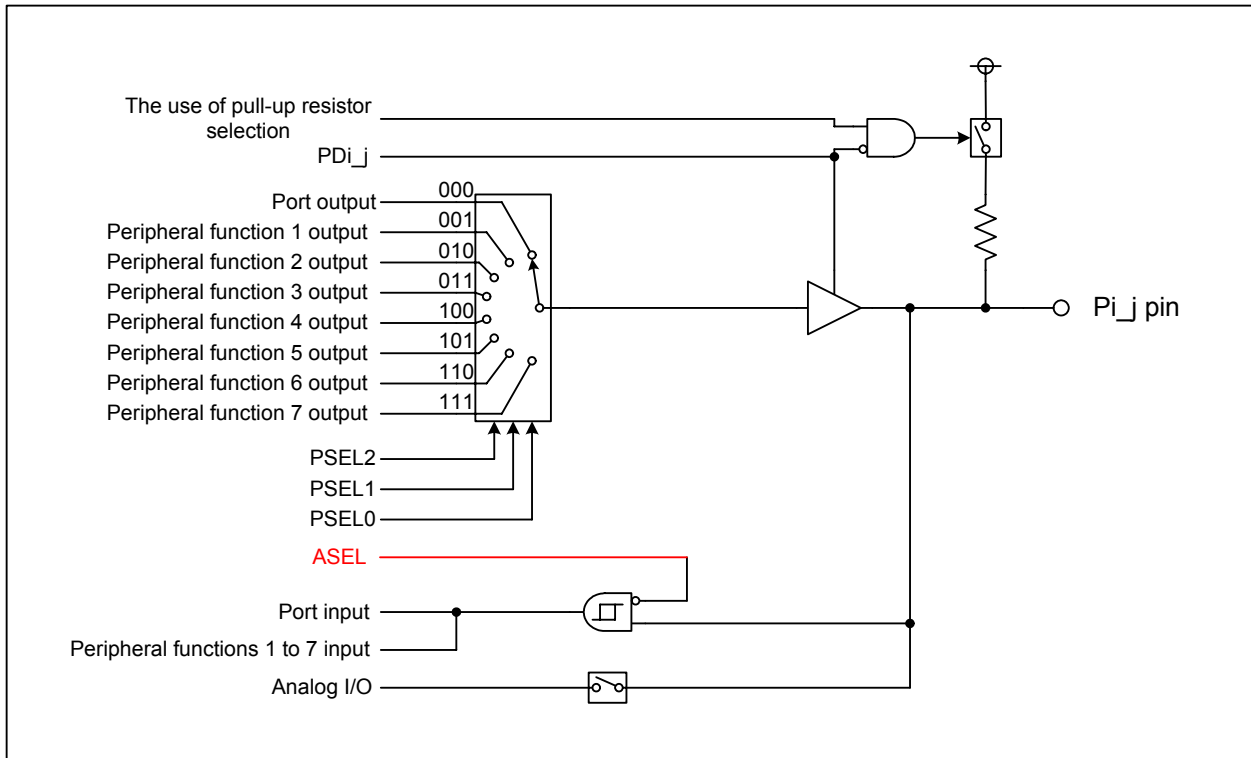
•The typical I/O pin block diagram in the first page of the I/O Pins chapter was corrected as follows:

(The ASEL bit was deleted from conditions for separating a pull-up resistor.)
