RENESAS TECHNICAL UPDATE

Product Category	MPU & MCU	Document No.	TN-16C-A192A/E	Rev.	1.00
Title	Errata to R32C/118 Group Hardware Manual		Information Category	Technical Notification	
Applicable Product	R32C/118 Group	Lot No.	Reference Document	R32C/118 Group Hardware Manual Rev. 1.00 (REJ09B0534-0100)

This document describes corrections to the R32C/118 Group Hardware Manual, Rev. 1.00.
The corrections are indicated in red in the list below.

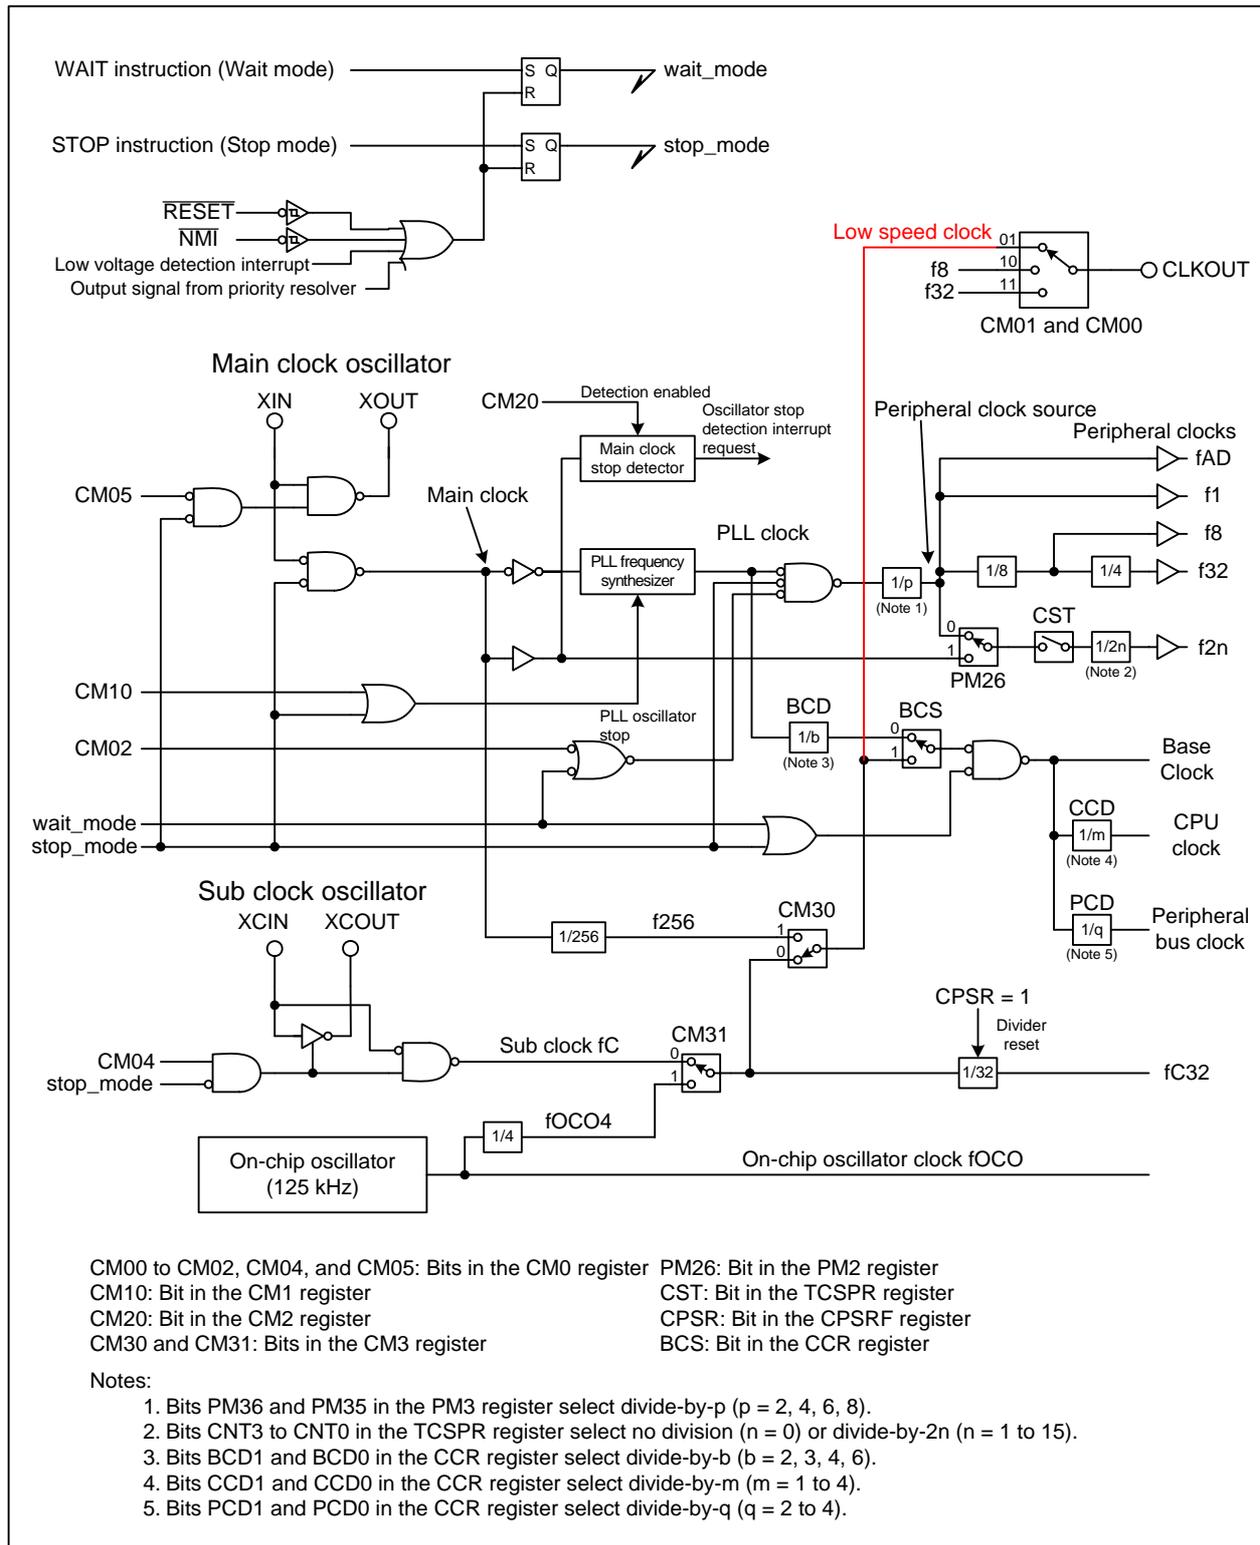
Figure 8.1 Clock Generation Circuitry

•Page 97 of 615, Figure 8.1 is corrected as follows:

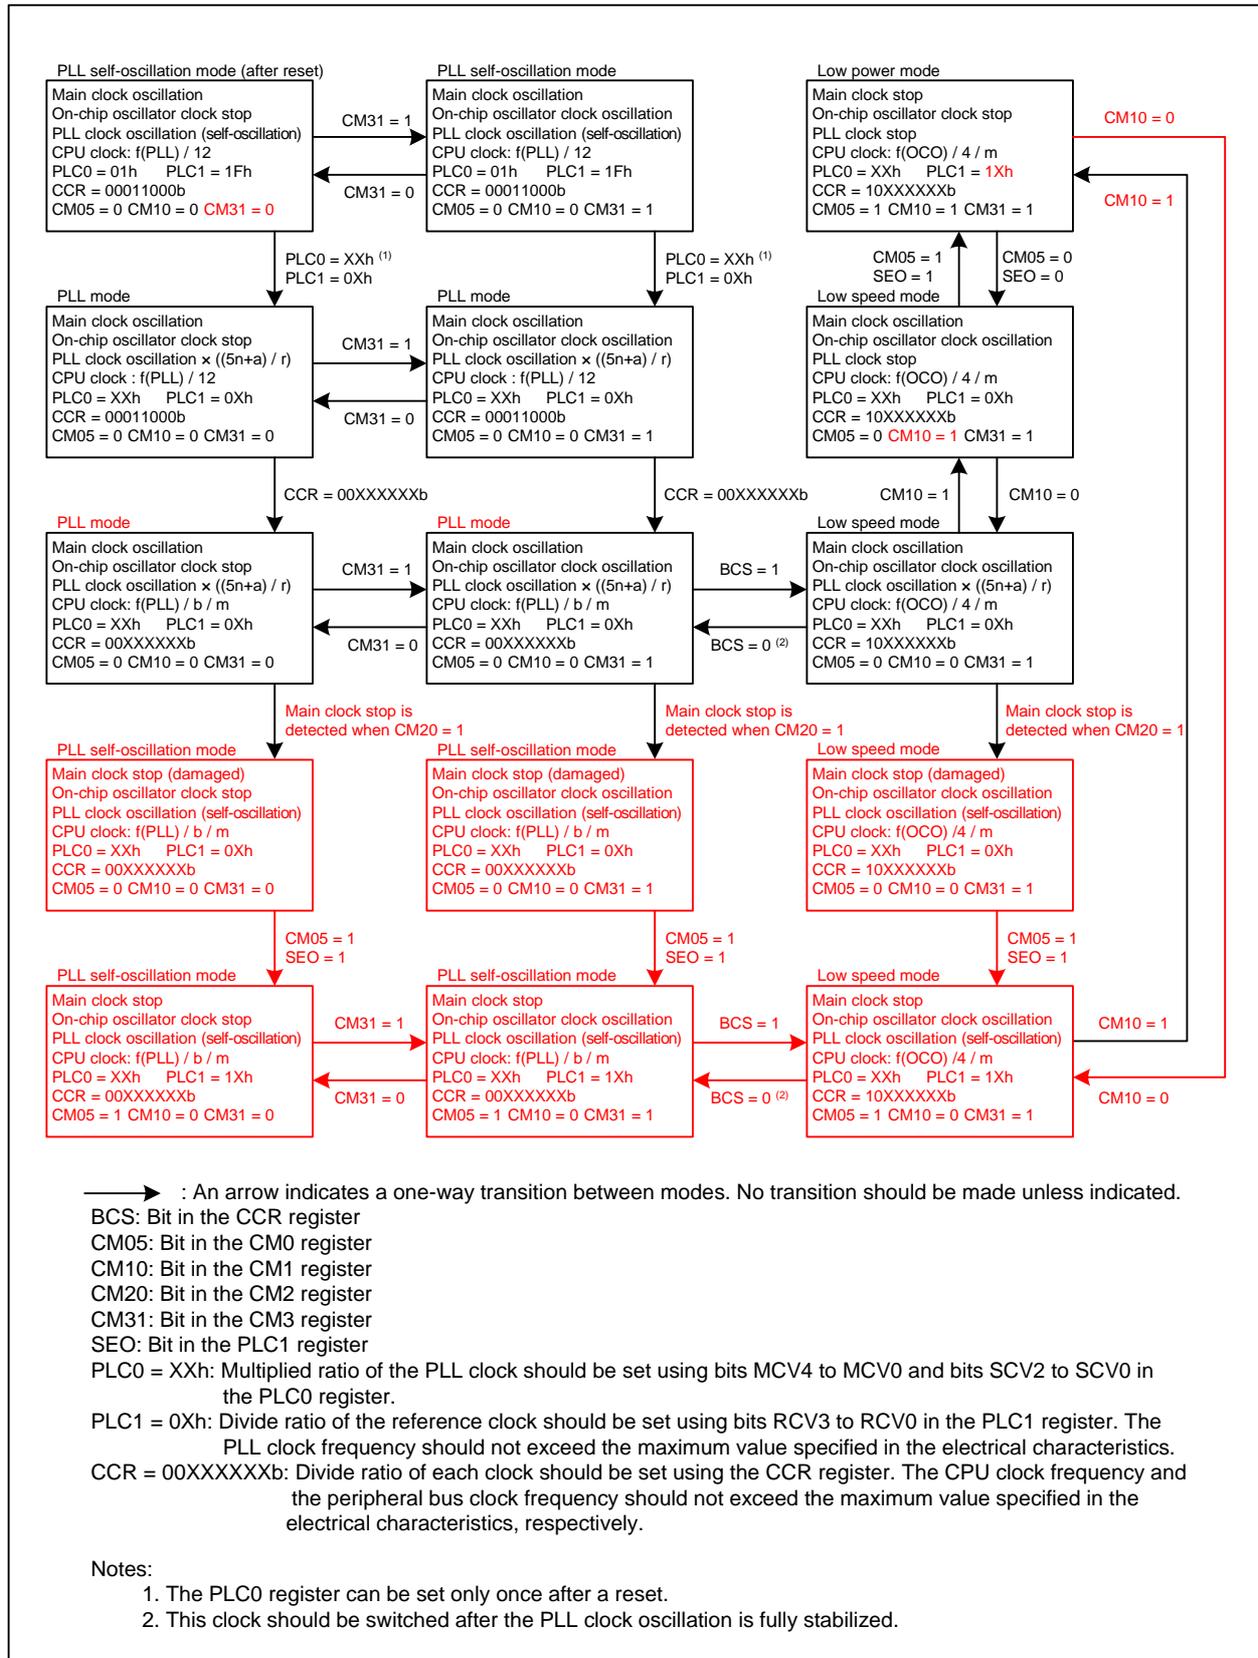
Figure 8.19 State Transition (when the on-chip oscillator clock is used)

•Page 117 of 615, descriptions of “CM31 = 1” in the first row and “CM10 = 0” in the second row in Figure 8.19 are corrected, and the flowchart are clarified as follows:

(Note 3 “The CM05 bit is not set to 1 when an oscillator stop is detected through the oscillation stop detector.” is deleted from Figure 8.19)

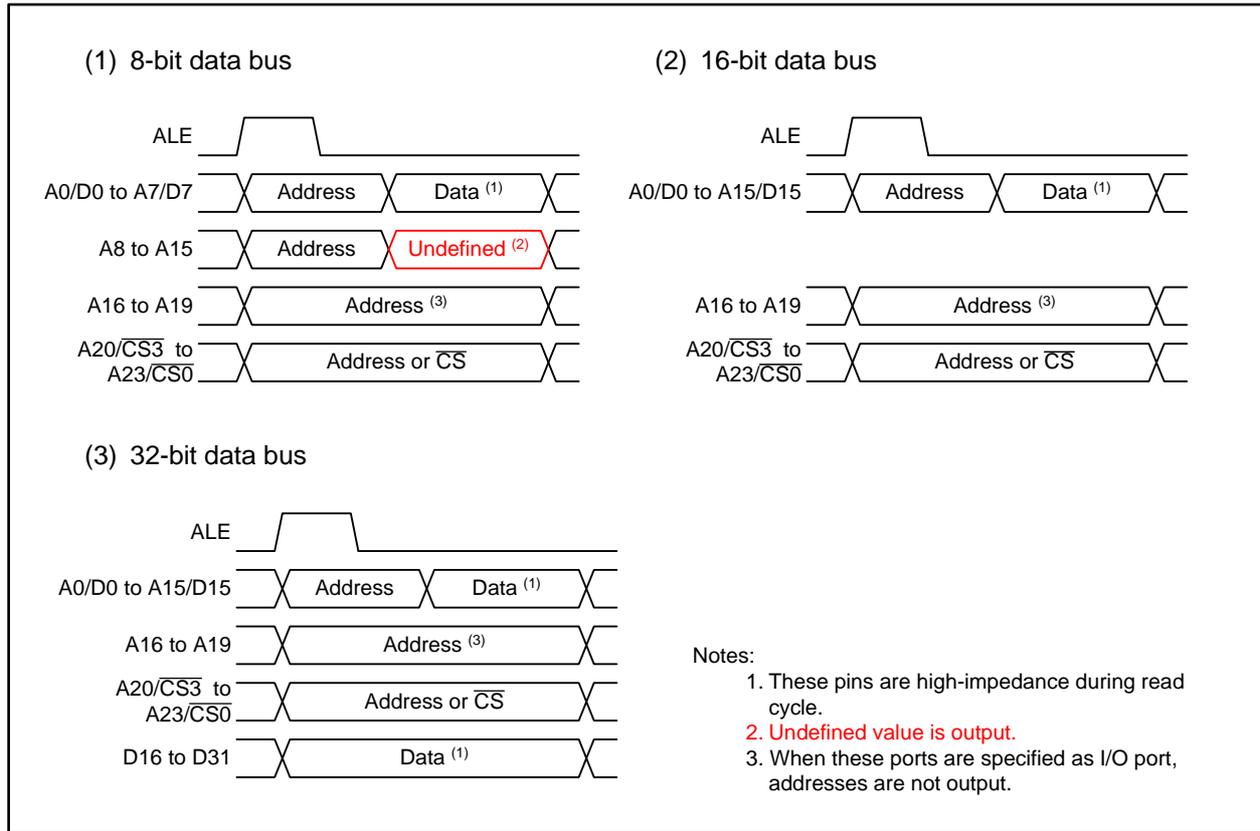
Figure 9.15 ALE Signal and Address Bus/Data Bus

•Page 145 of 615, Figure 9.15 is corrected as follows:

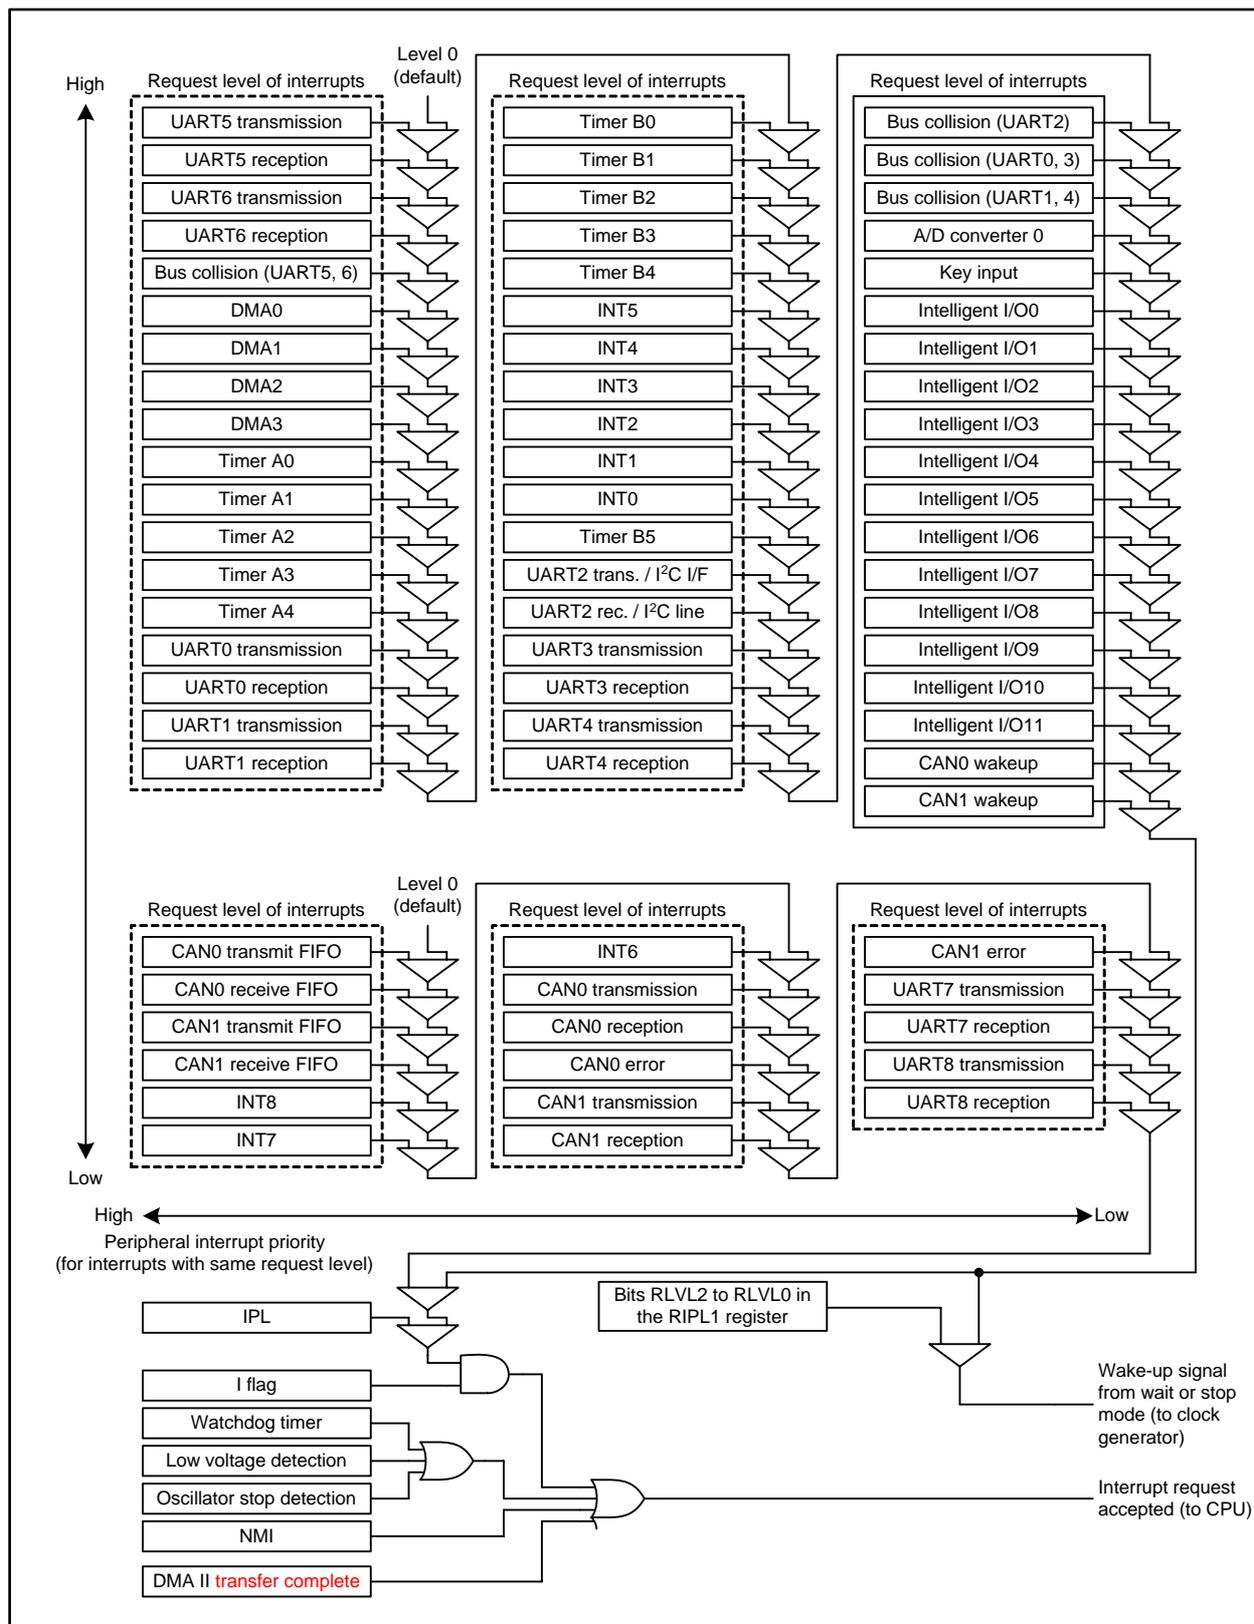
Figure 11.8 Priority Resolver

•Page 172 of 615, Figure 11.8 is corrected as follows:

(Description "Bits RLVL2 to RLVL0 in the RIPL2 register" and associated signal lines are deleted from Figure 11.8)

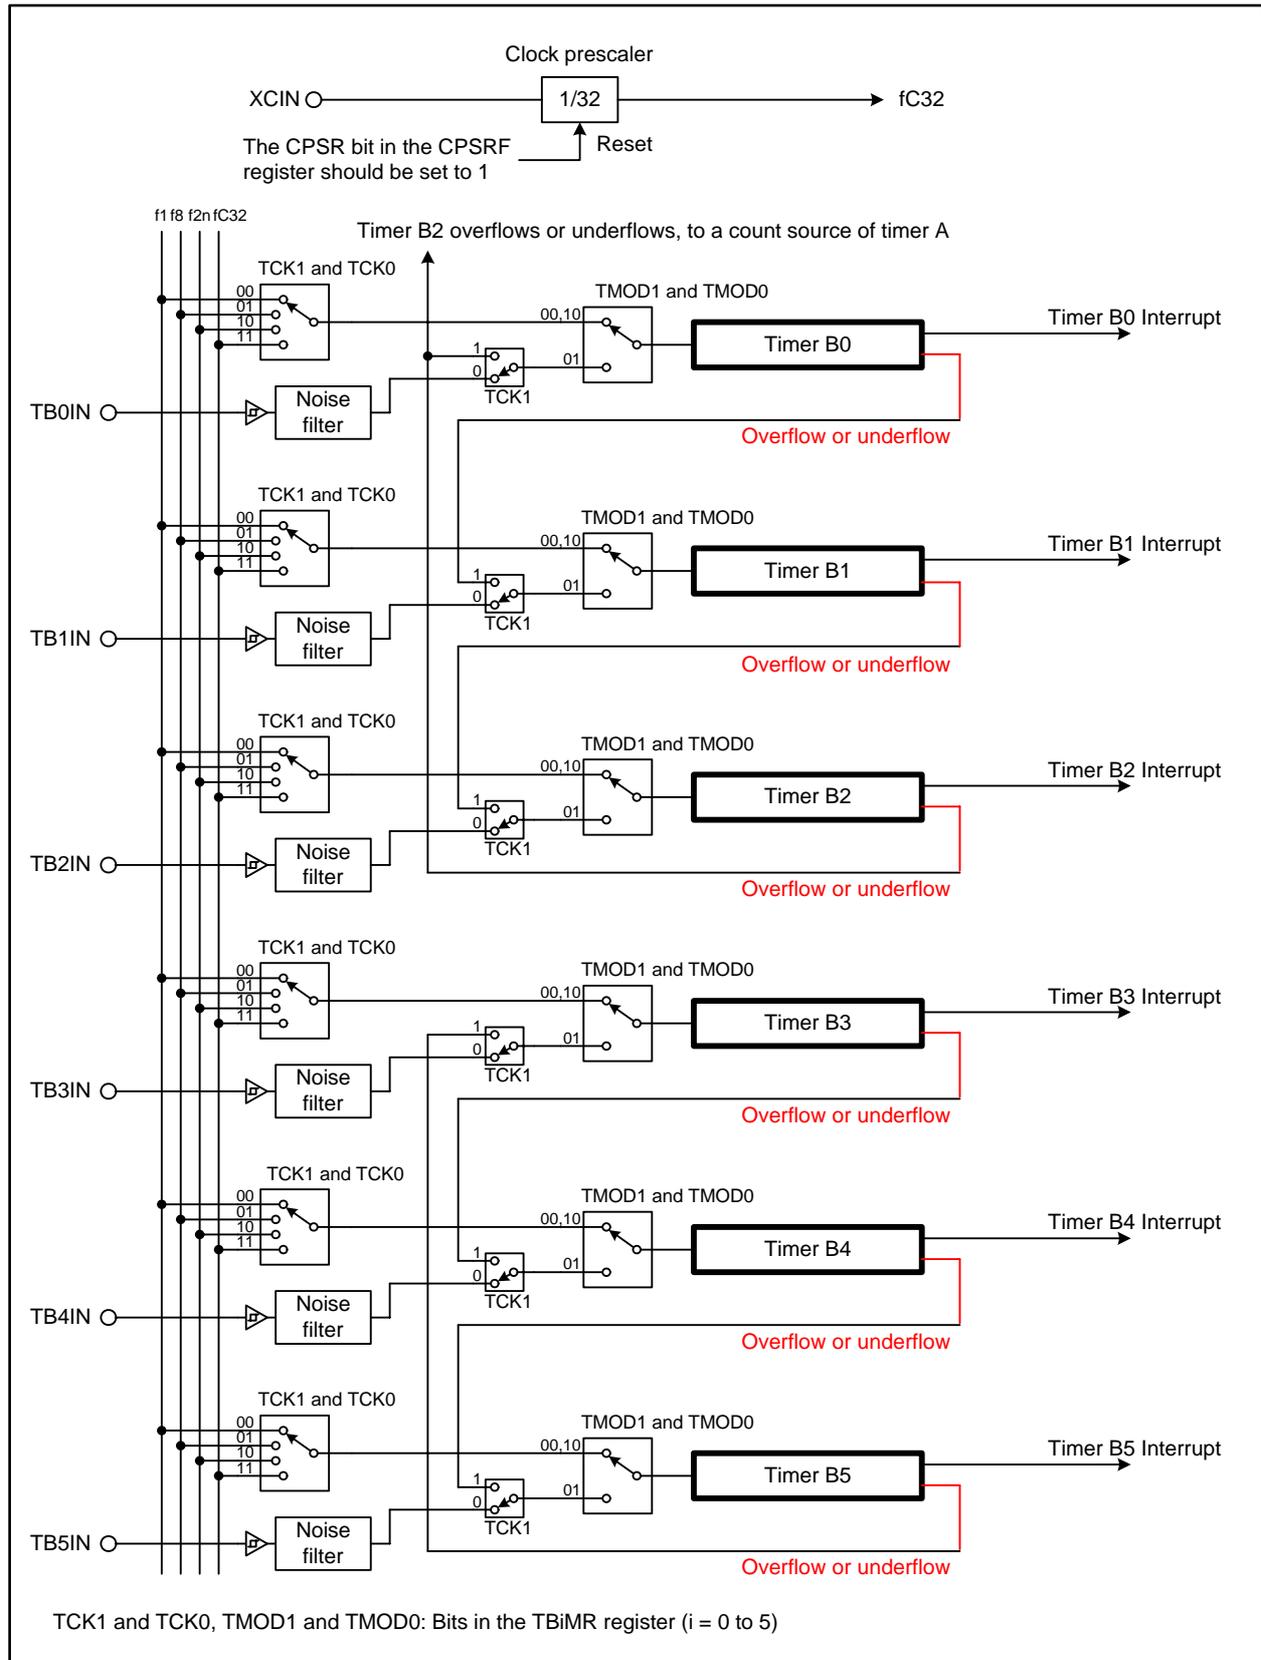
Figure 16.2 Timer B Configuration

•Page 210 of 615, Figure 16.2 is corrected as follows:

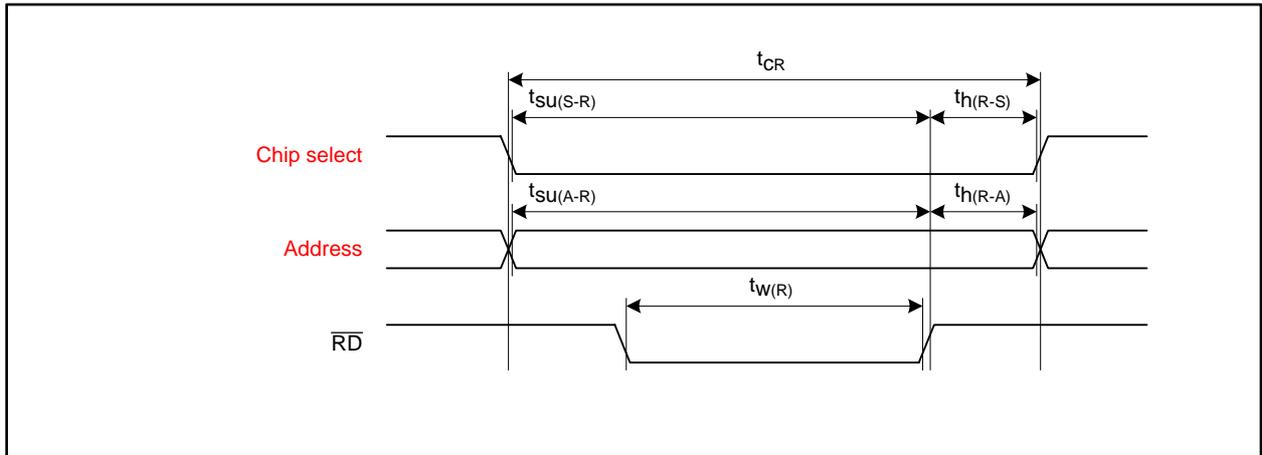
Figure 27.13 Read Timing

•Page 535 and 537 of 615, descriptions in Figures 27.13, 27.14, and 28.5 are corrected as follows:
