RENESAS TECHNICAL UPDATE

Product Category	MPU & MCU	Document No.	TN-16C-A194A/E	Rev.	1.00
Title	Errata to R32C/152 Group Hardware Manual	Information Category	Technical Notification		
Applicable Product	R32C/152 Group	Lot No.	Reference Document	R32C/152 Group Hardware Manual Rev. 1.03 (REJ09B0504-0103)

This document describes corrections to the R32C/152 Group Hardware Manual, Rev. 1.03.
The corrections are indicated in red in the list below.

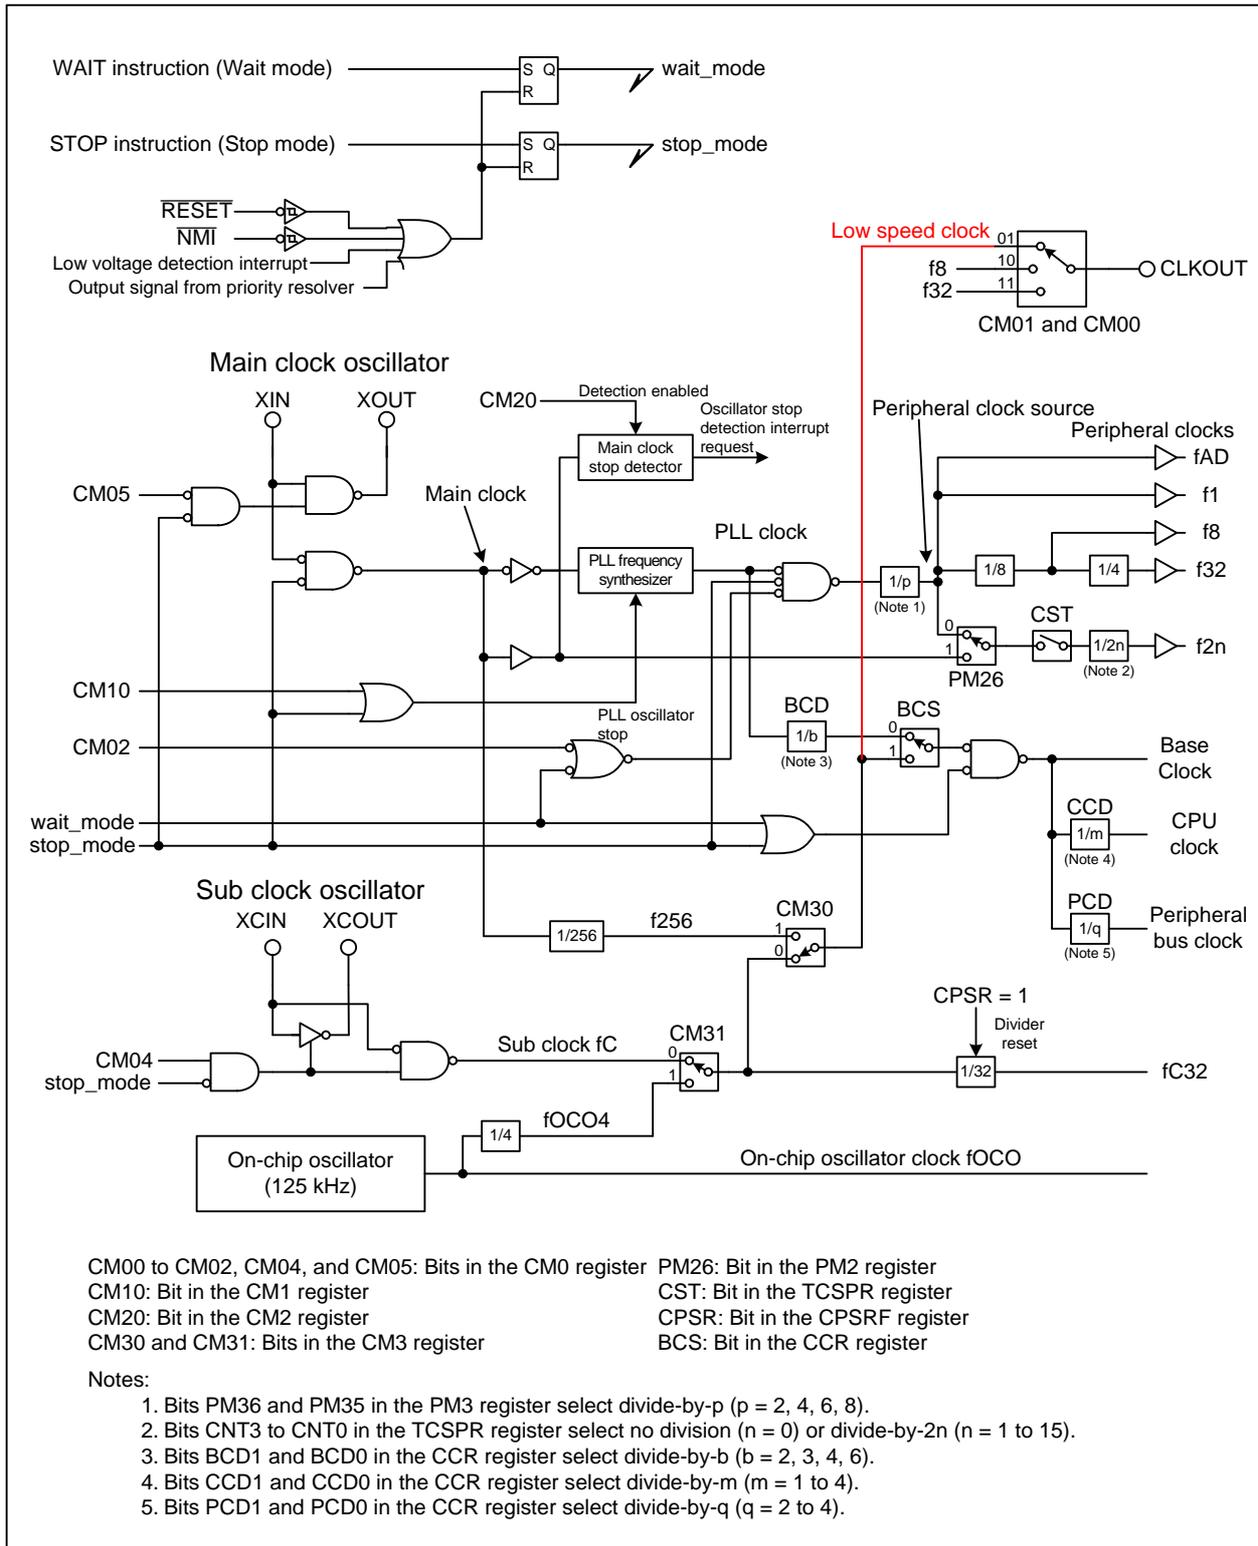
Figure 7.1 Clock Generation Circuitry

•Page 105 of 639, Figure 7.1 is corrected as follows:

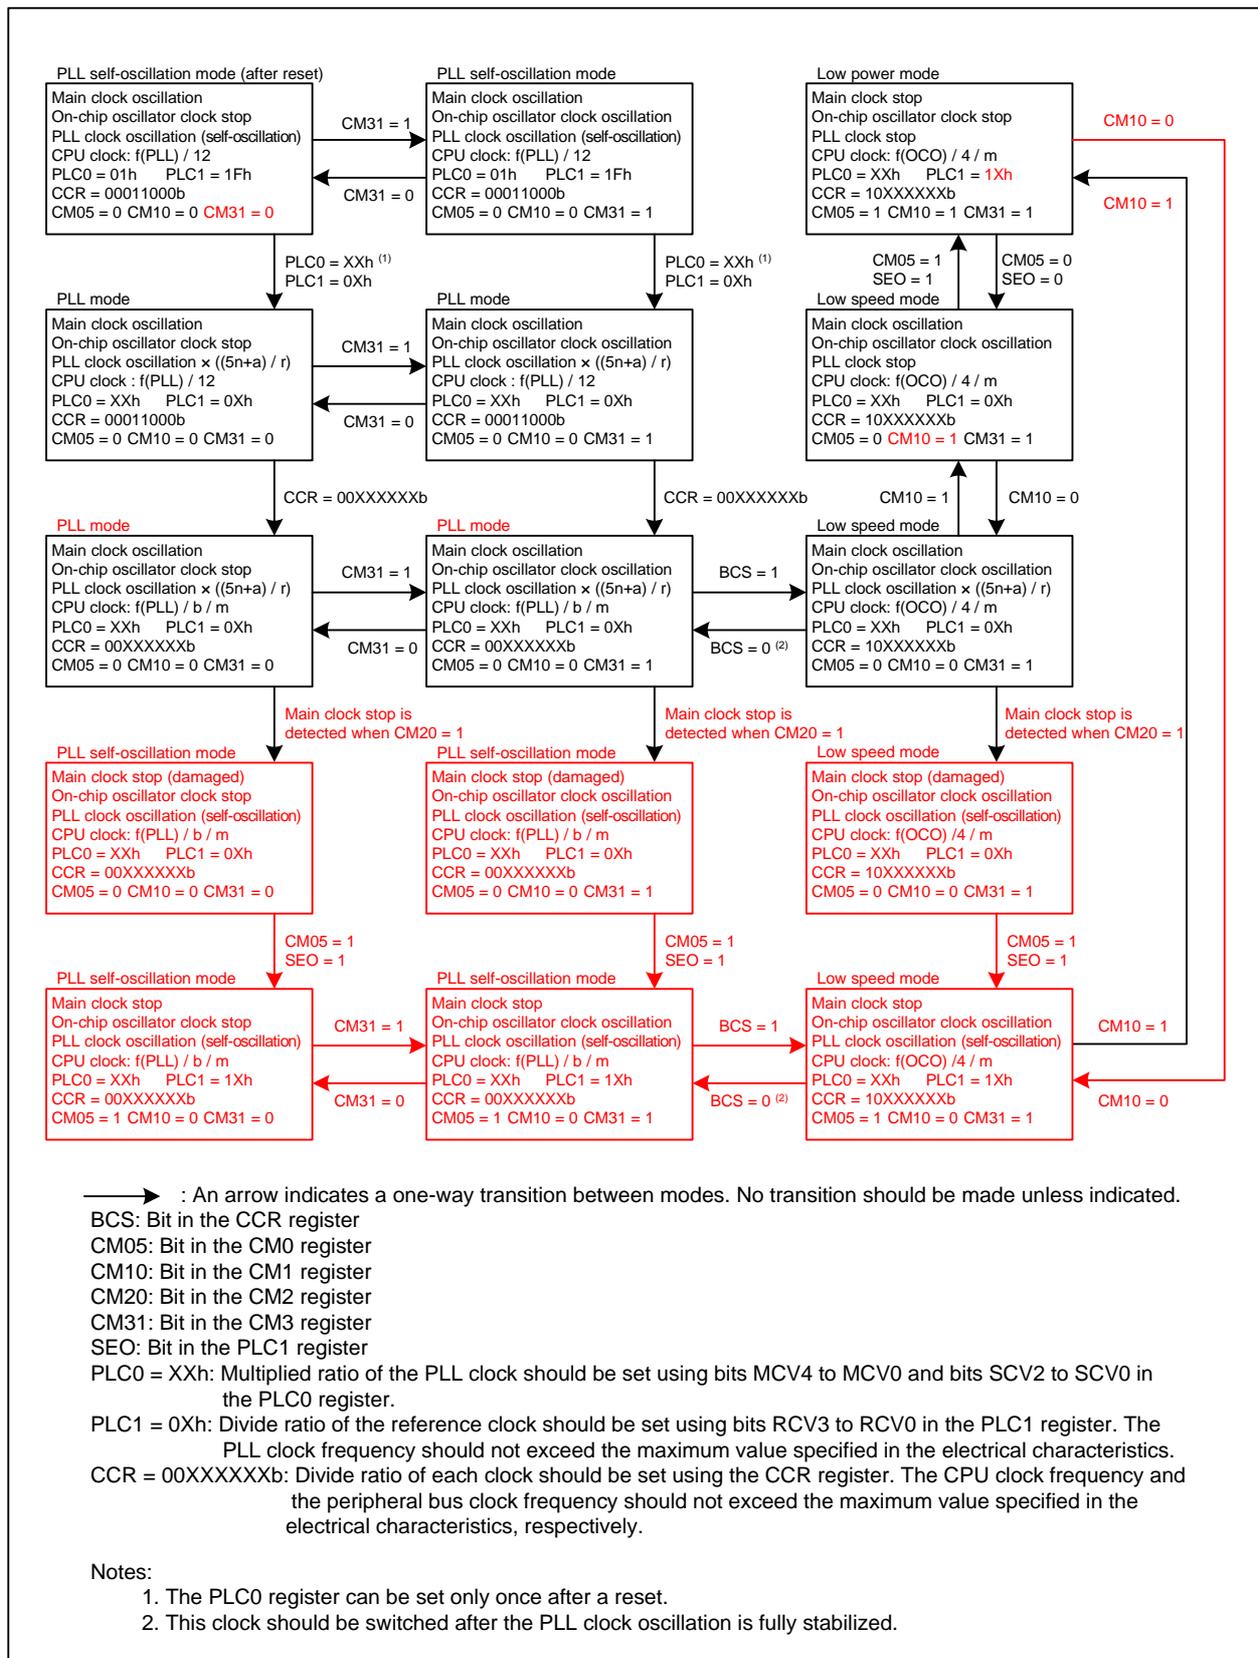
Figure 7.20 State Transition (when the on-chip oscillator clock is used)

•Page 125 of 639, descriptions of “CM31 = 1” in the first row and “CM10 = 0” in the second row in Figure 7.20 are corrected, and the flowchart is clarified as follows:

(Note 3 “The CM05 bit is not set to 1 when an oscillator stop is detected through the oscillation stop detector.” is deleted from Figure 7.20)

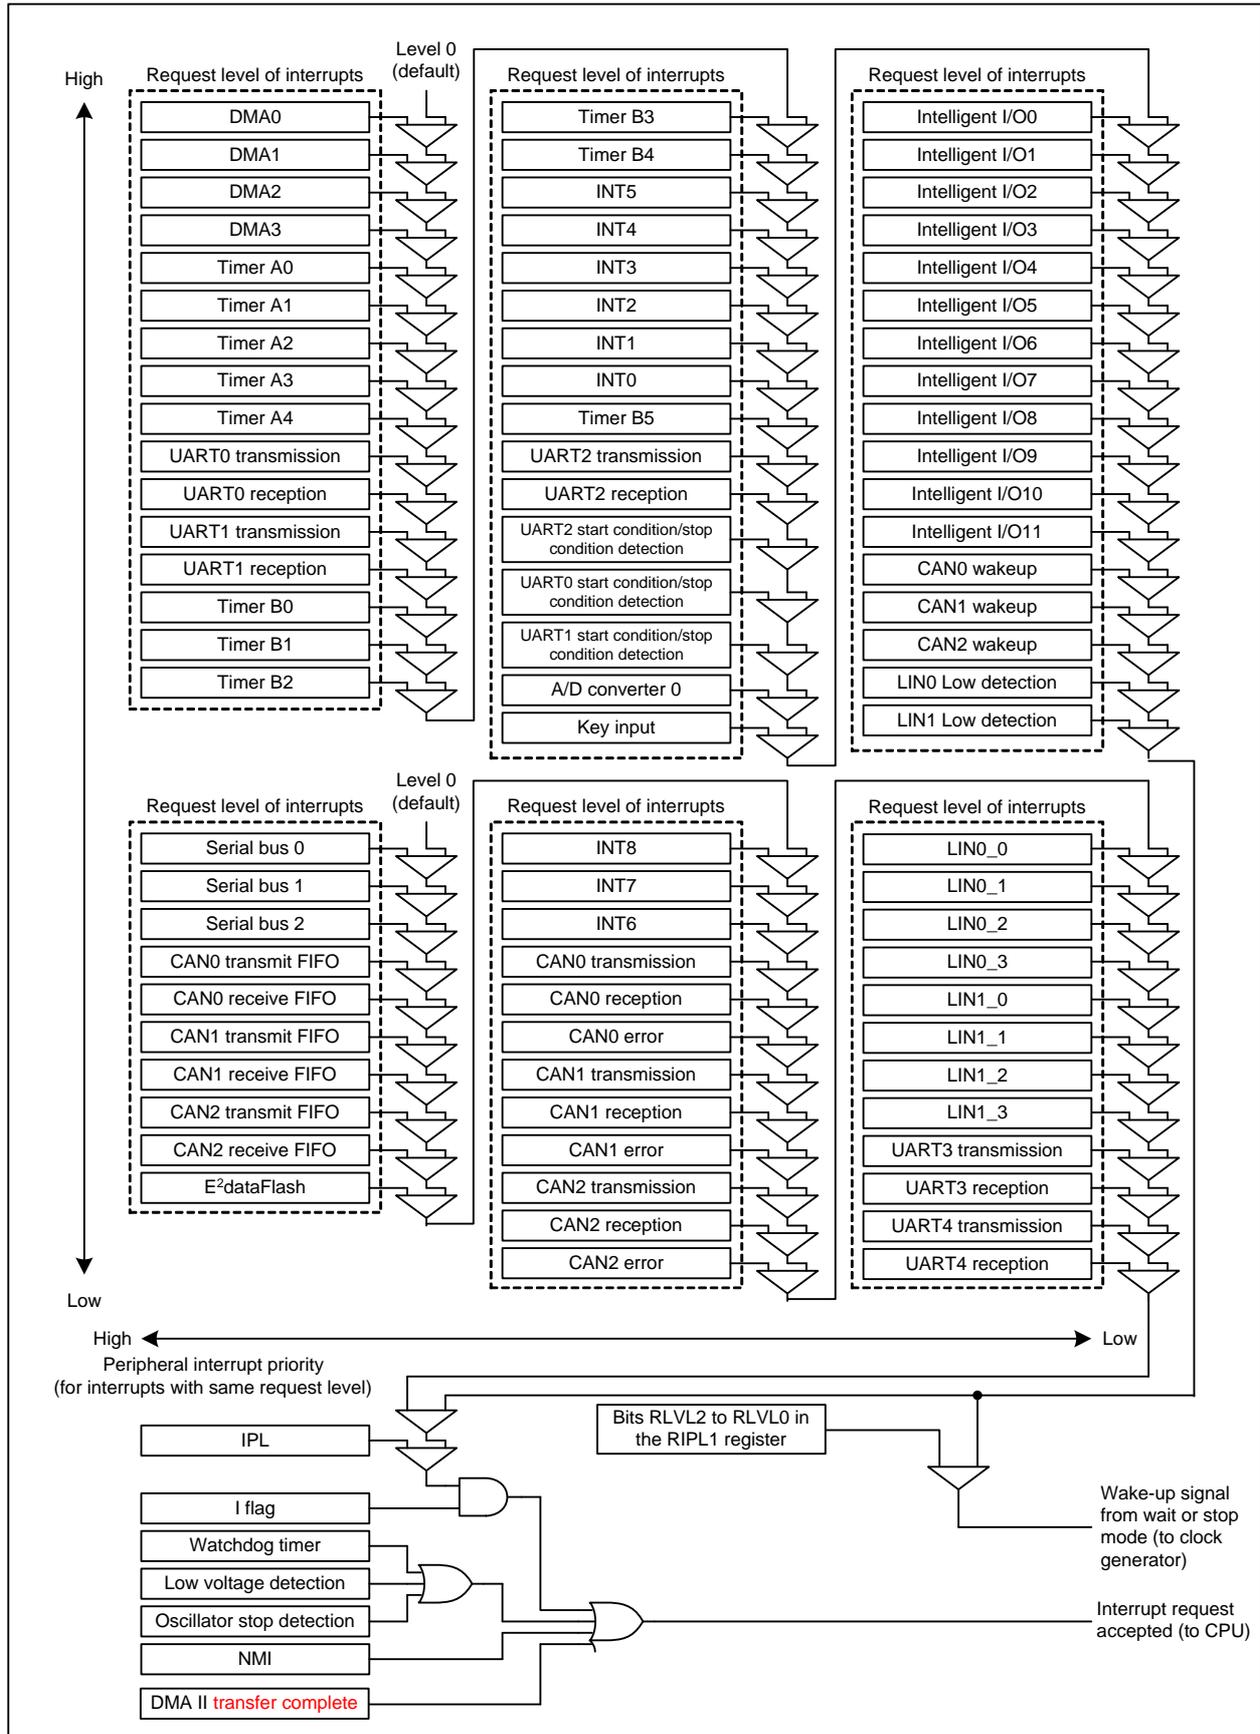
Figure 10.8 Priority Resolver

•Page 157 of 639, Figure 10.8 is corrected as follows:

(Description "Bits RLVL2 to RLVL0 in the RIPL2 register" and associated signal lines are deleted from Figure 10.8)

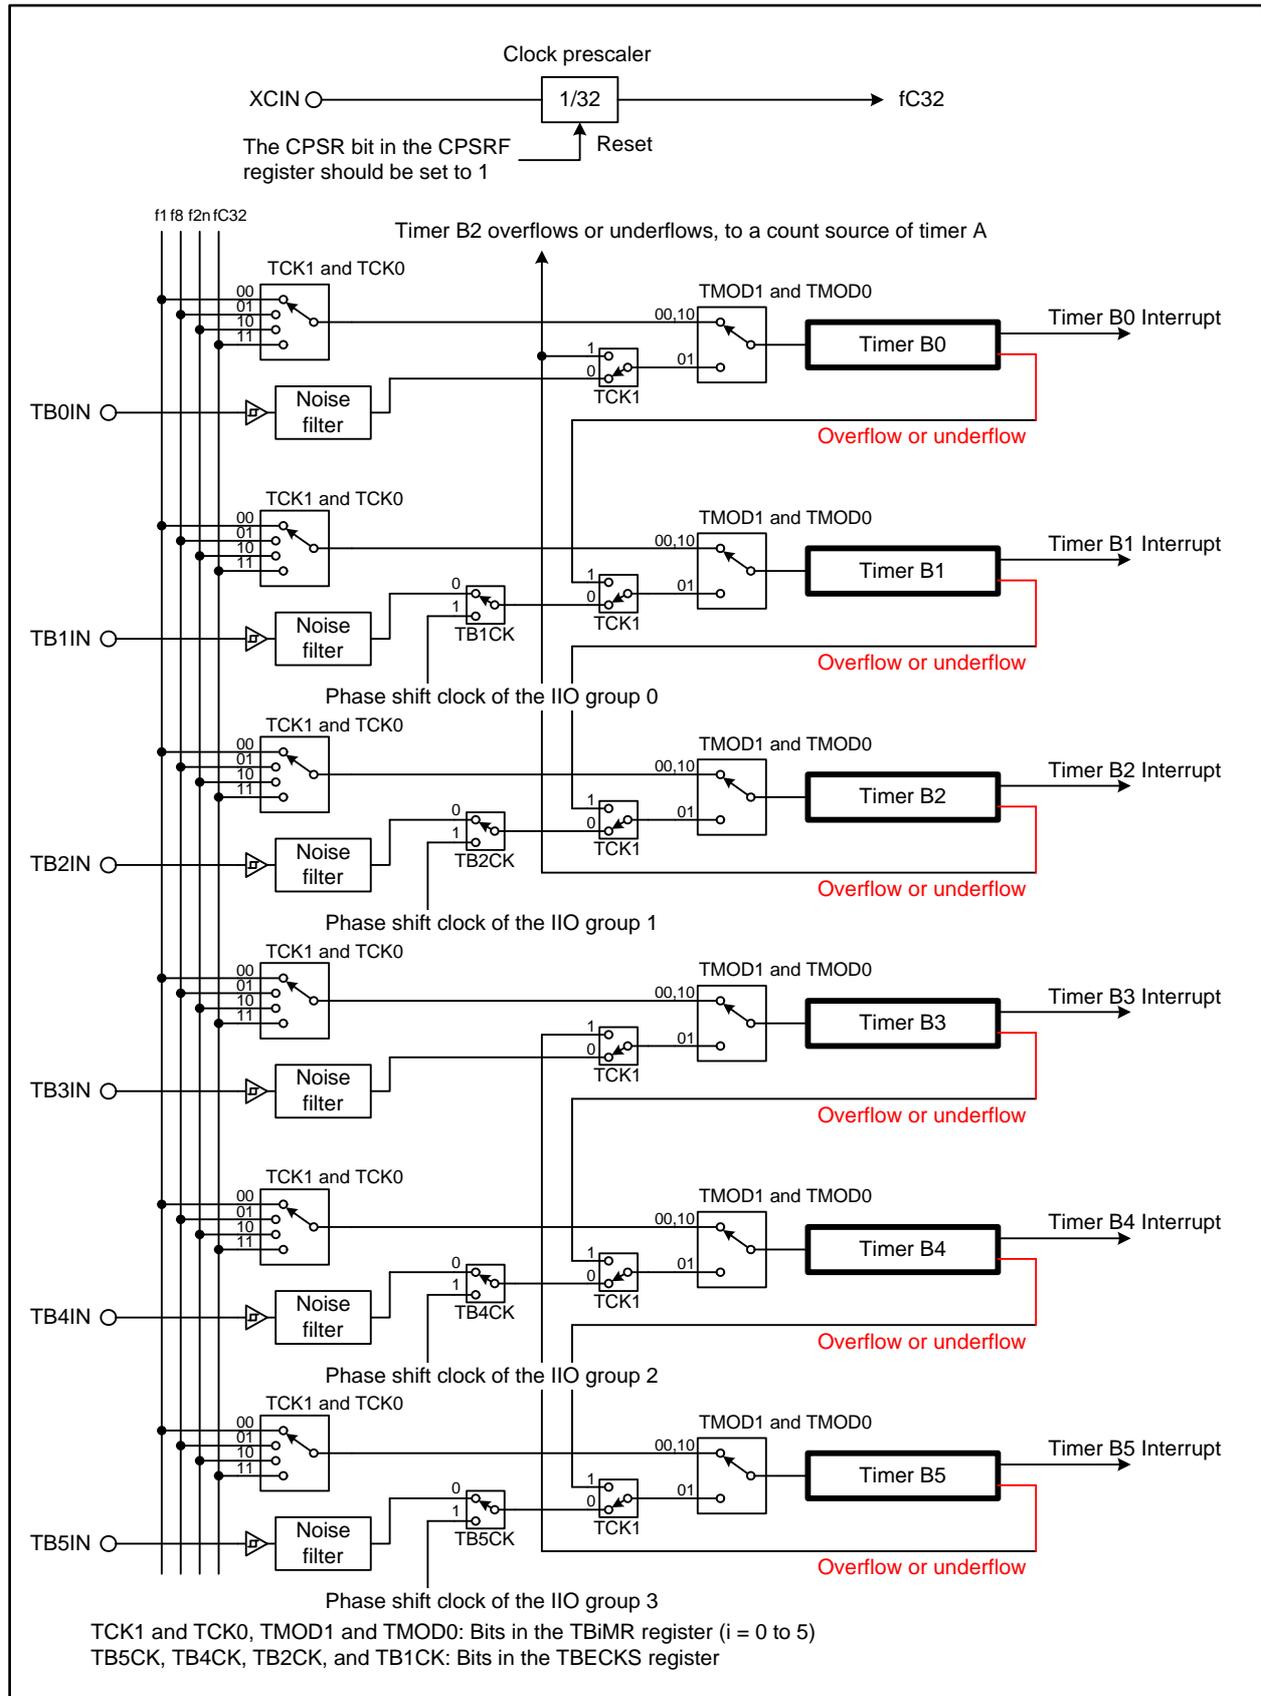
Figure 15.2 Timer B Configuration

•Page 199 of 639, Figure 15.2 is corrected as follows:

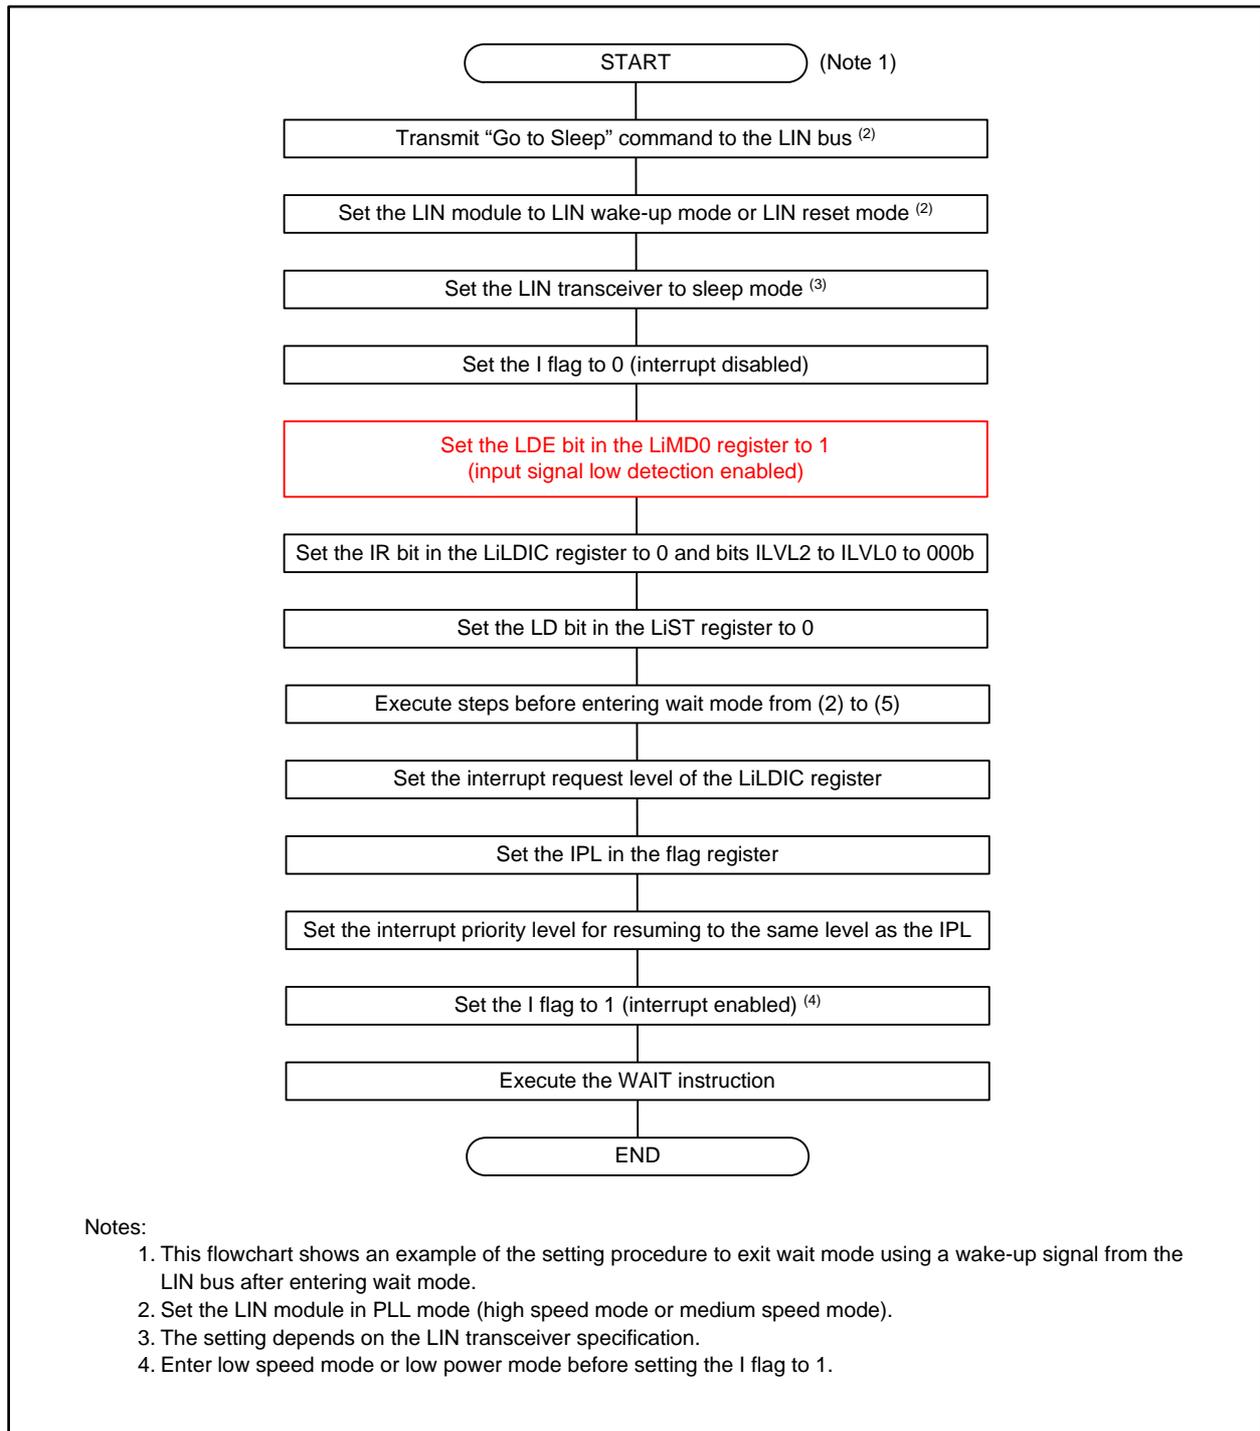
Figure 24.30 Example of Setting Before Transmission to Wait Mode (i = 0, 1)

- Page 423 of 639, descriptions for (4) for “LIN Module Processing” in Table 24.5 are changed as follows:
 “Receive Data 2 due to start bit detection
 Receive Data 3 due to start bit detection
 (Repeat this process for the data length specified in bits RFDL3 to RFDL0 in the LiRFC register. Abort the reception and go to (5) if an error occurs. Checksum judgement is not performed in this case.)”
- Page 426 of 639, description “BPR0” in Note 1 of Table 24.6 is corrected as follows:
 “BRP0”
- Page 433 of 639, Figure 24.30 is corrected as follows:

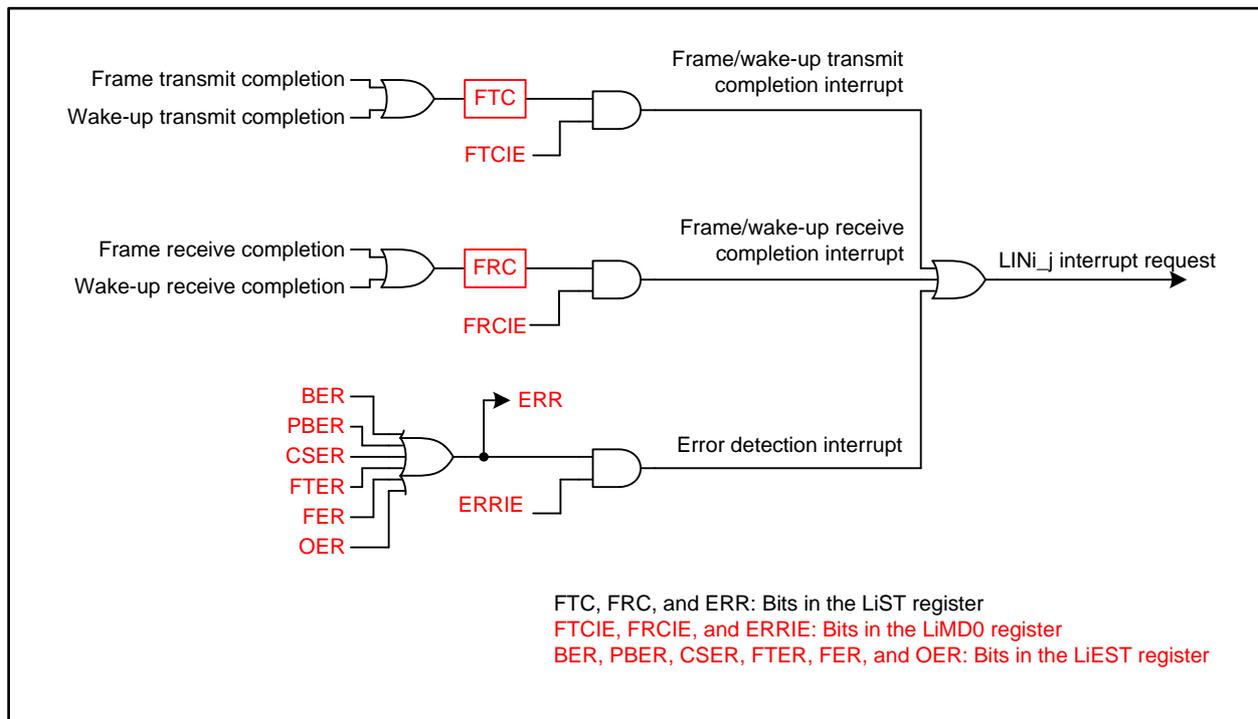
Figure 24.32 LINi_j Interrupt Block Diagram (i = 0, 1; j = 0 to 3)

- Page 434 of 639, description for Detecting Condition for Input signal low detection in Table 24.8 is changed as follows:
 “When the falling edge of input signal at the LINi_jIN pin is detected with the setting of the LDE bit in the LiMD0 register to 1 (Input signal low detection enabled), or when setting the LDE bit to 1 while the LINi_jIN pin is low.”
- Page 435 of 639, value range “; j = 0 to 3” in the title of Table 24.9 is deleted.
- Page 437 of 639, description in lines 9 to 10 of 24.11 is added as follows:
 “The respective interrupt request is output when the corresponding flag in the LiST register becomes 1 while the corresponding bit in the LiMD0 register is set to 1 (interrupt enabled). No new interrupt request is generated by the other sources if any of them is 1 since multiple interrupt sources are aggregated.”
- Page 437 of 639, Figure 24.32 is corrected as follows:

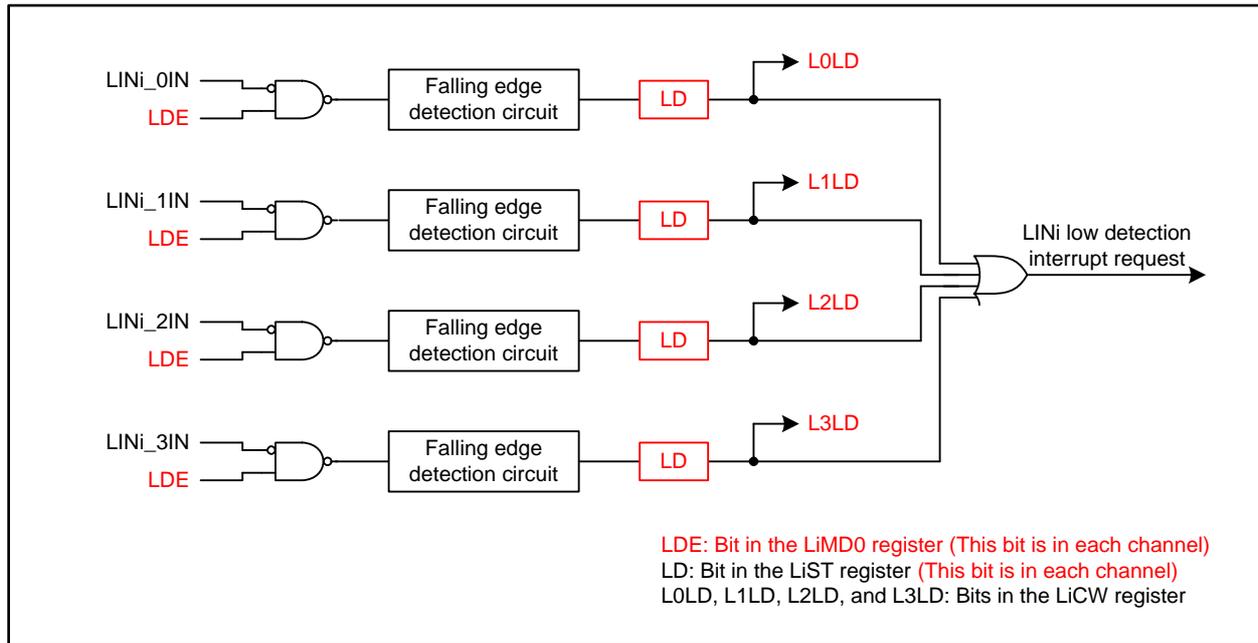
Figure 24.33 LINi Low Detection Interrupt Block Diagram (i = 0, 1)

•Page 438 of 639, Figure 24.33 is corrected as follows:

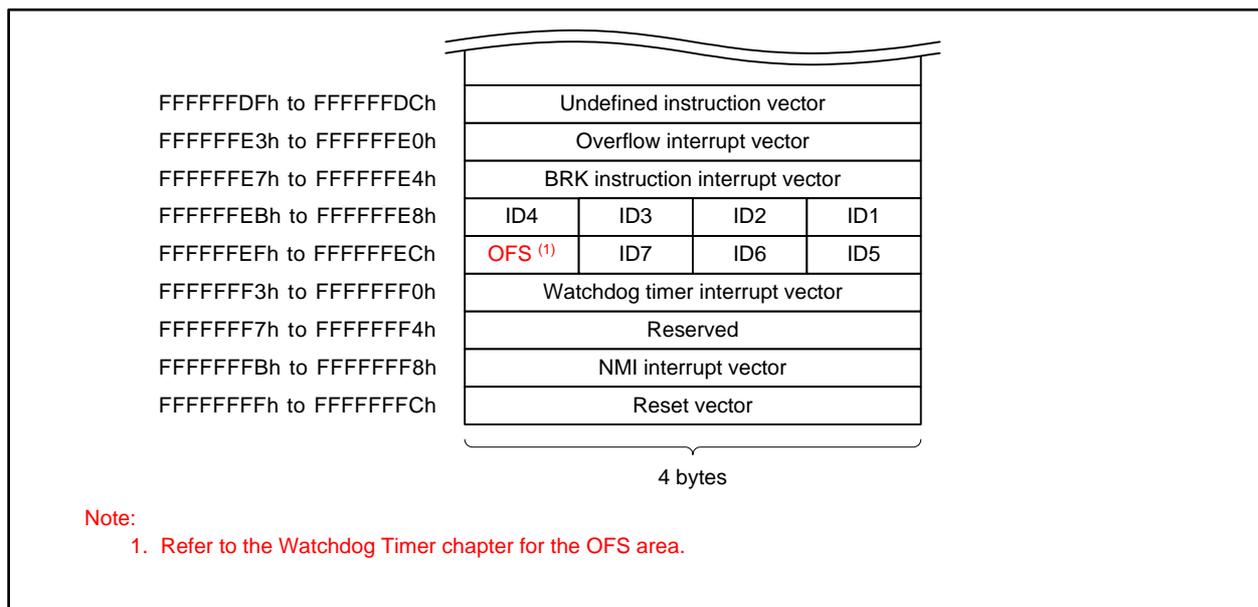
Figure 27.2 Addresses for ID Code Stored

•Page 543 of 639, Figure 27.2 is corrected as follows:

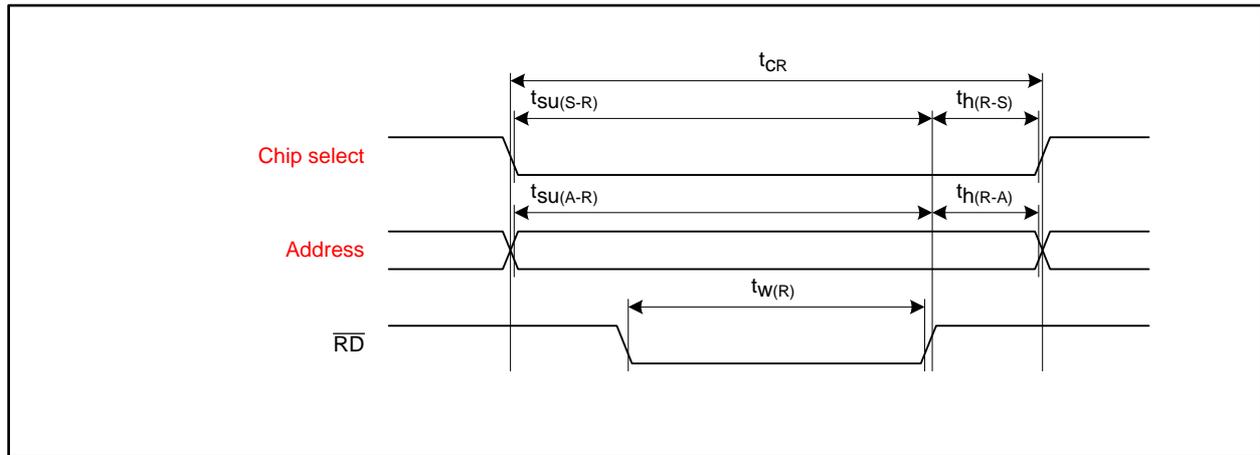
Figure 27.13 Read Timing

- Pages 552 and 554 of 639, descriptions in Figures 27.13 and 27.14 are corrected as follows:

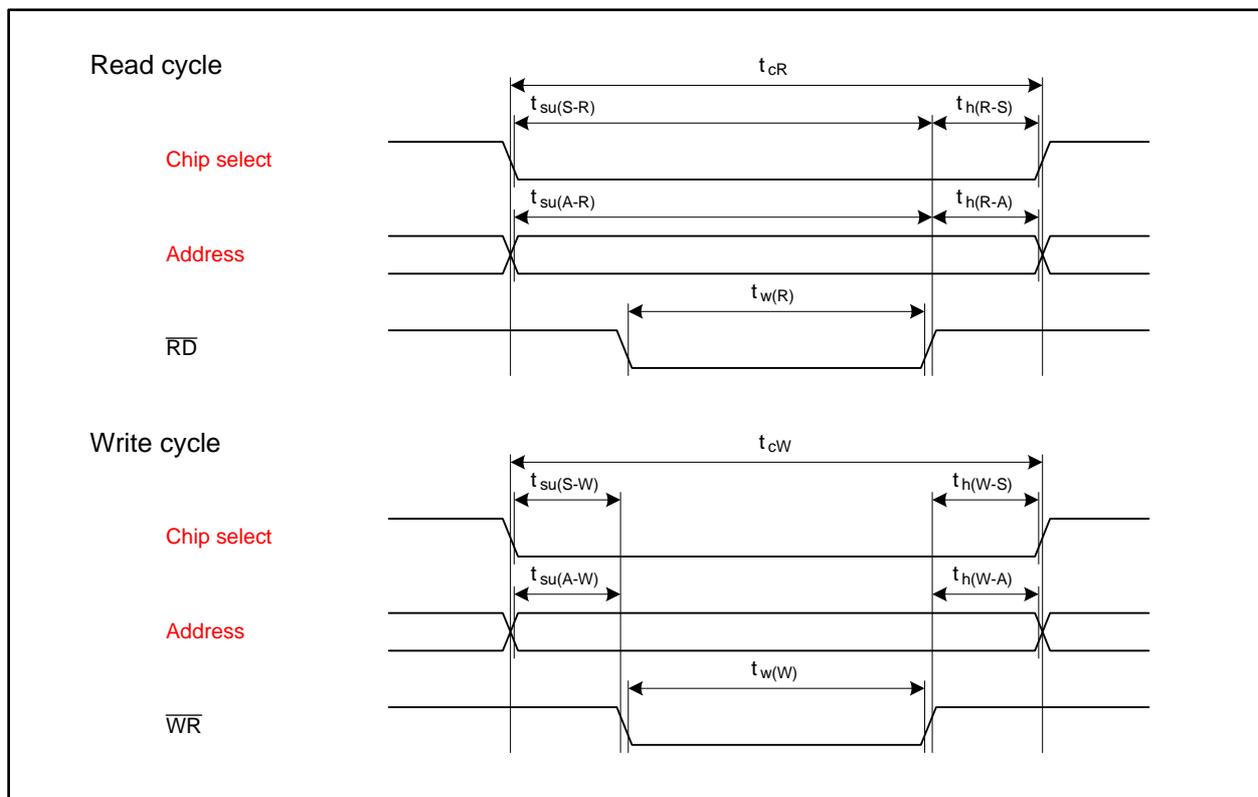
Figure 29.5 Flash Memory CPU Rewrite Mode Timing

•Page 591 of 639, descriptions in Figure 29.5 are corrected as follows:
