RENESAS TECHNICAL UPDATE

Product Category	MPU & MCU	Document No.	TN-16C-A231A/E	Rev.	1.00
Title	Errata to R32C/157 Group User's Manual: Hardware		Information Category	Technical Notification	
Applicable Product	R32C/157 Group	Lot No.	Reference Document	R32C/157 Group User's Manual: Hardware Rev. 1.10 (REJ09B0507-0110)

This document describes corrections to the R32C/157 Group User's Manual: Hardware, Rev. 1.10. The corrections are indicated in red in the list below.

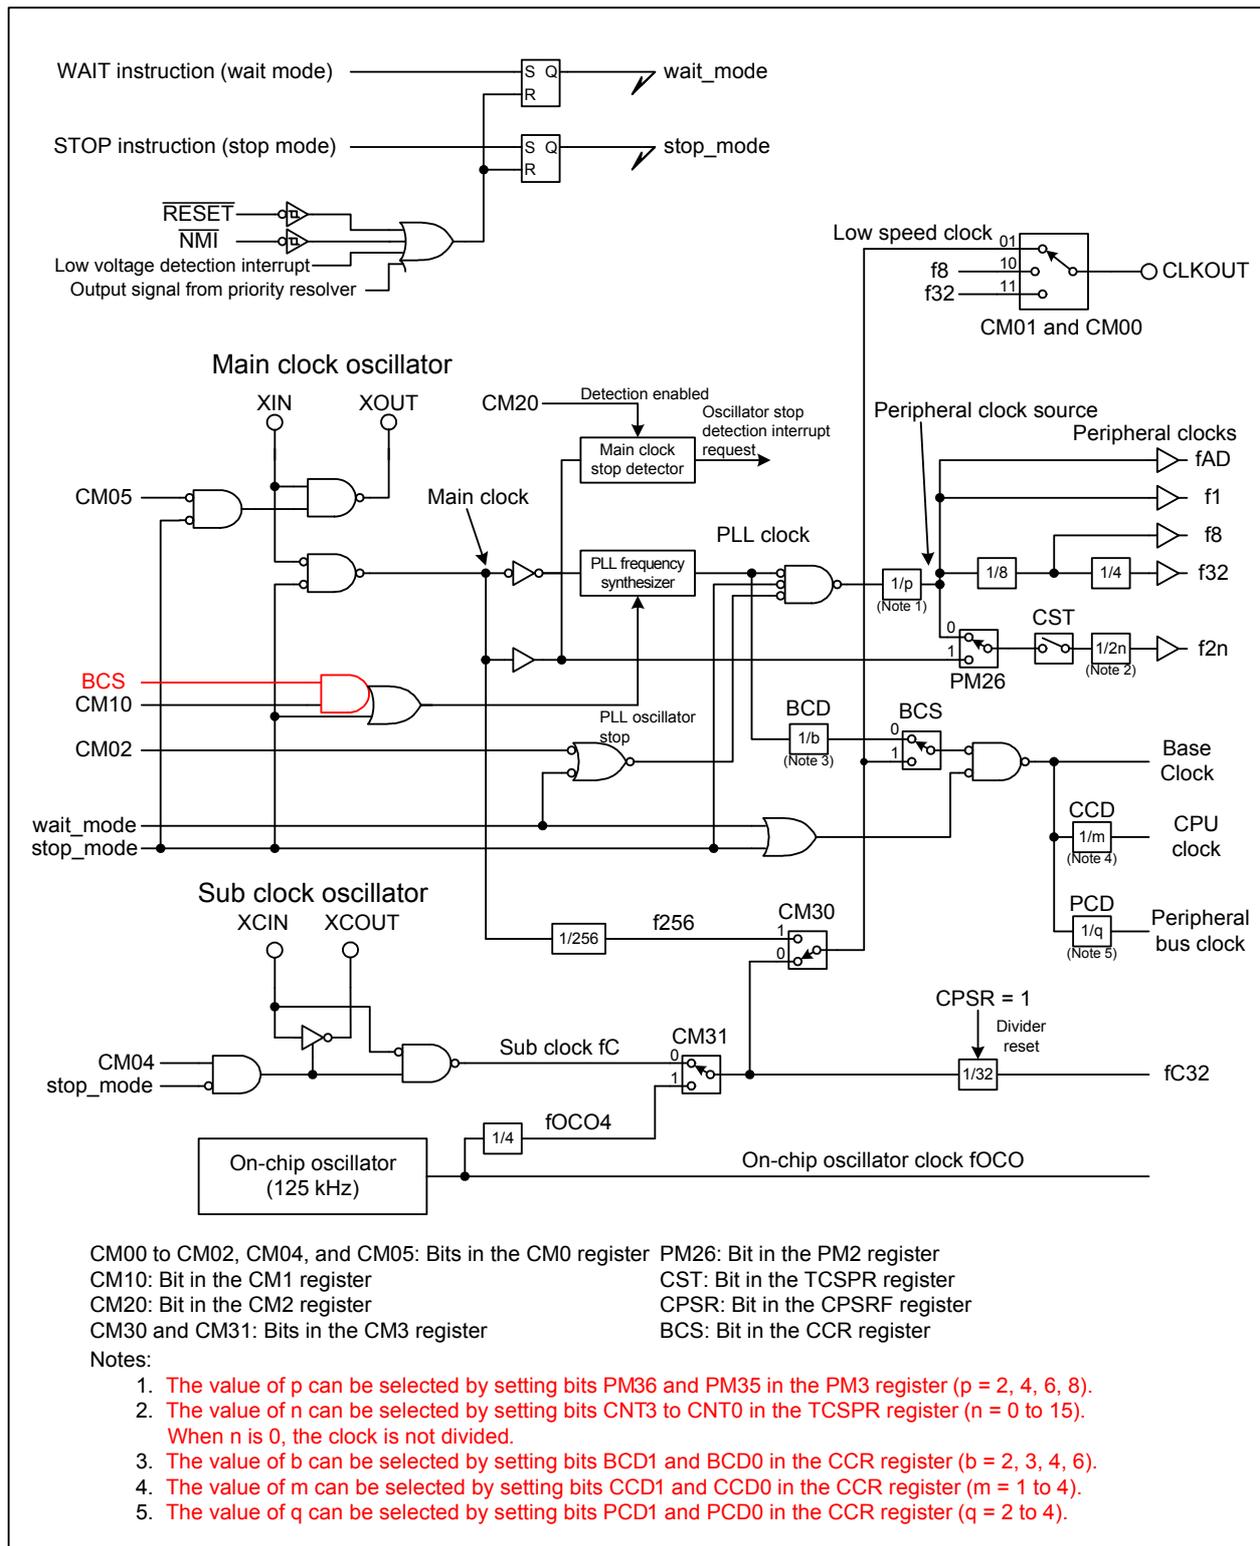
Figure 7.1 Clock Generation Circuitry

•Page 104 of 639, Figure 7.1 is corrected as follows:

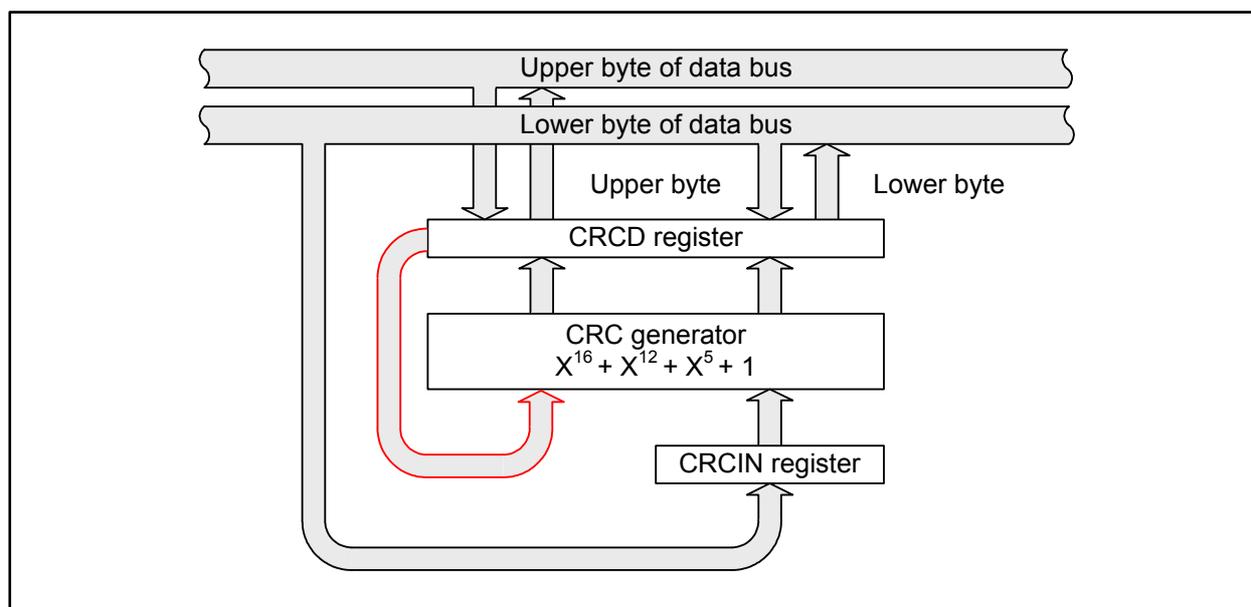
Figure 20.1 CRC Calculator Block Diagram

- Page 326 of 639, Figure 20.1 is corrected as follows:

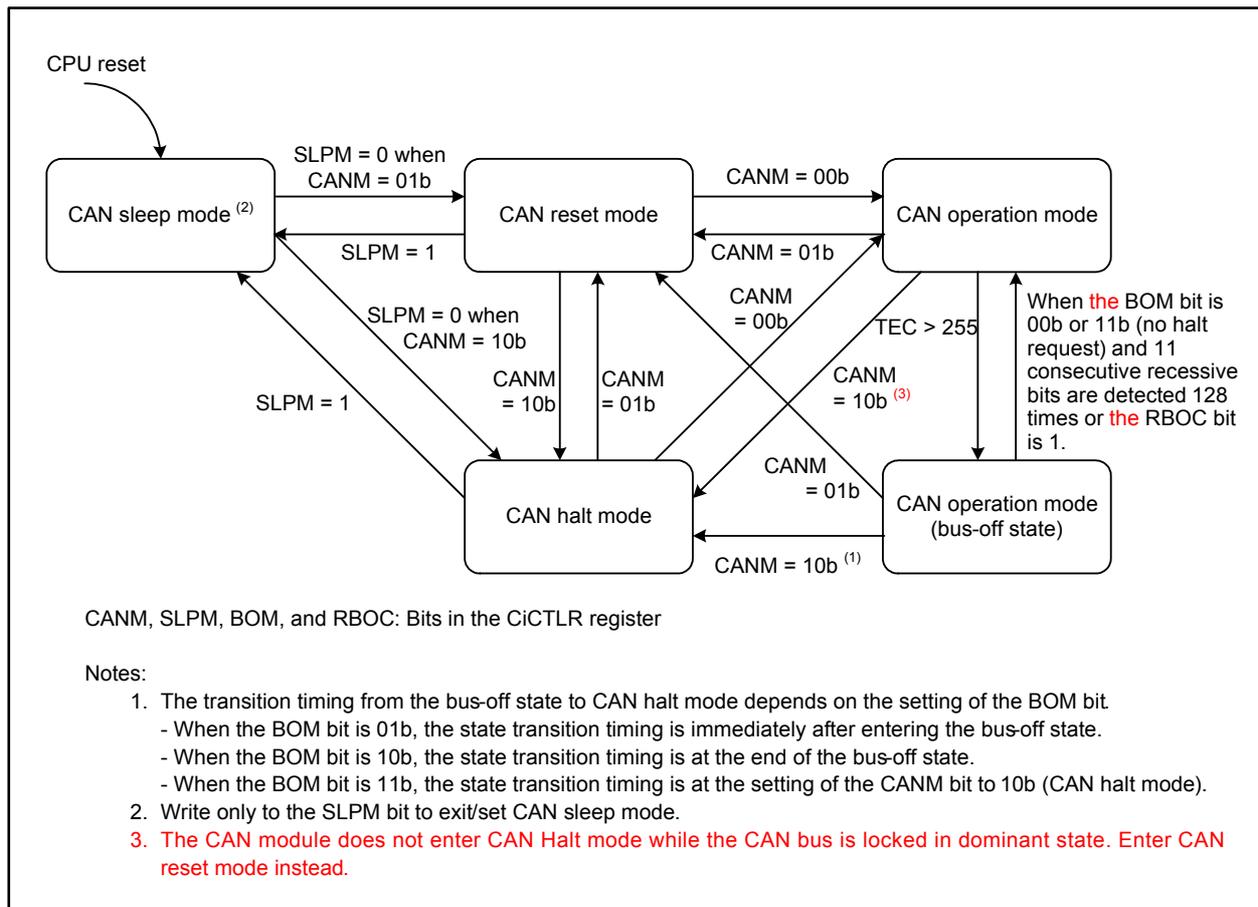
•Page 492 of 639, Note 3 is added to Figure 25.34 as follows (refer to TN-16C-A229A/E):
