# RENESAS TECHNICAL UPDATE

Product Category	MPU & MCU	Document No.	TN-16C-A218A/E	Rev.	1.00
Title	Errata to R32C/160 Group Hardware Manual		Information Category	Technical Notification	
Applicable Product	R32C/160 Group	Lot No.	Reference Document	R32C/160 Group Hardware Manual Rev. 1.02 (REJ09B0516-0102)

This document describes corrections to the R32C/160 Group Hardware Manual, Rev. 1.02.  
The corrections are indicated in red in the list below.

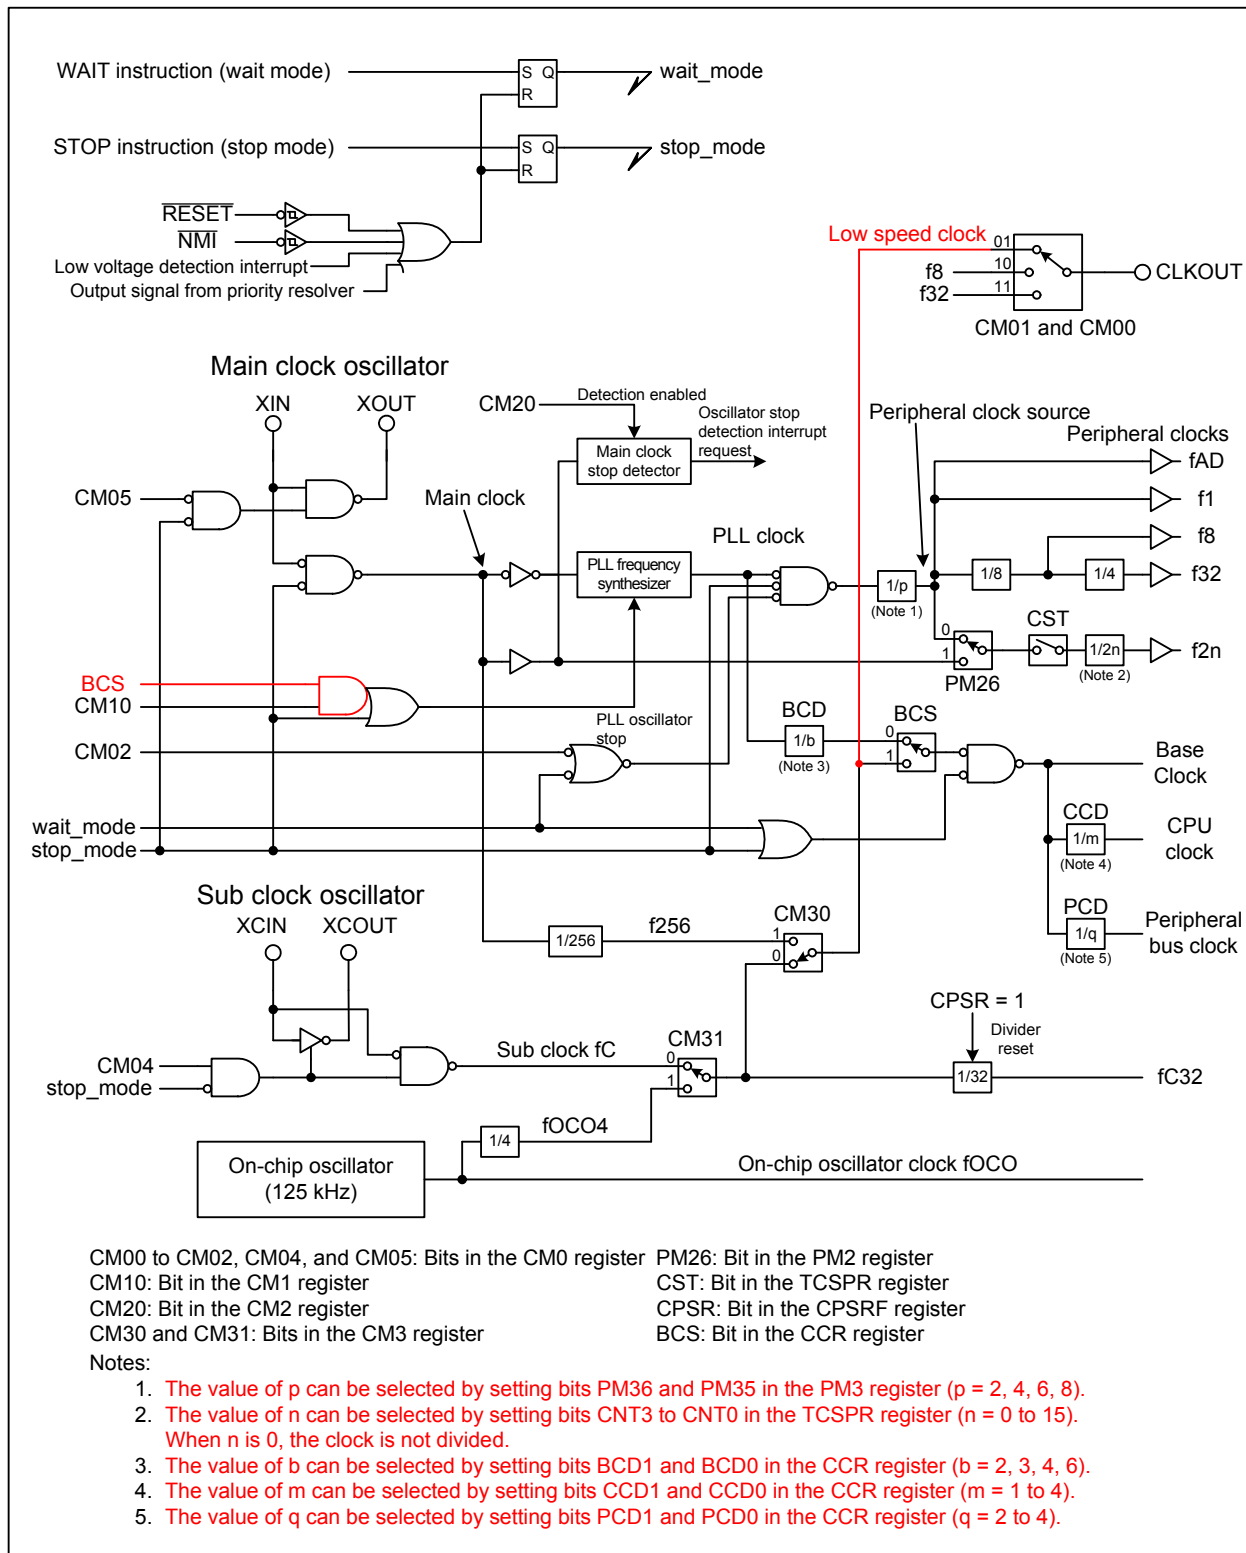
Figure 7.1 Clock Generation Circuitry

•Page 68 of 572, Figure 7.1 is corrected as follows:

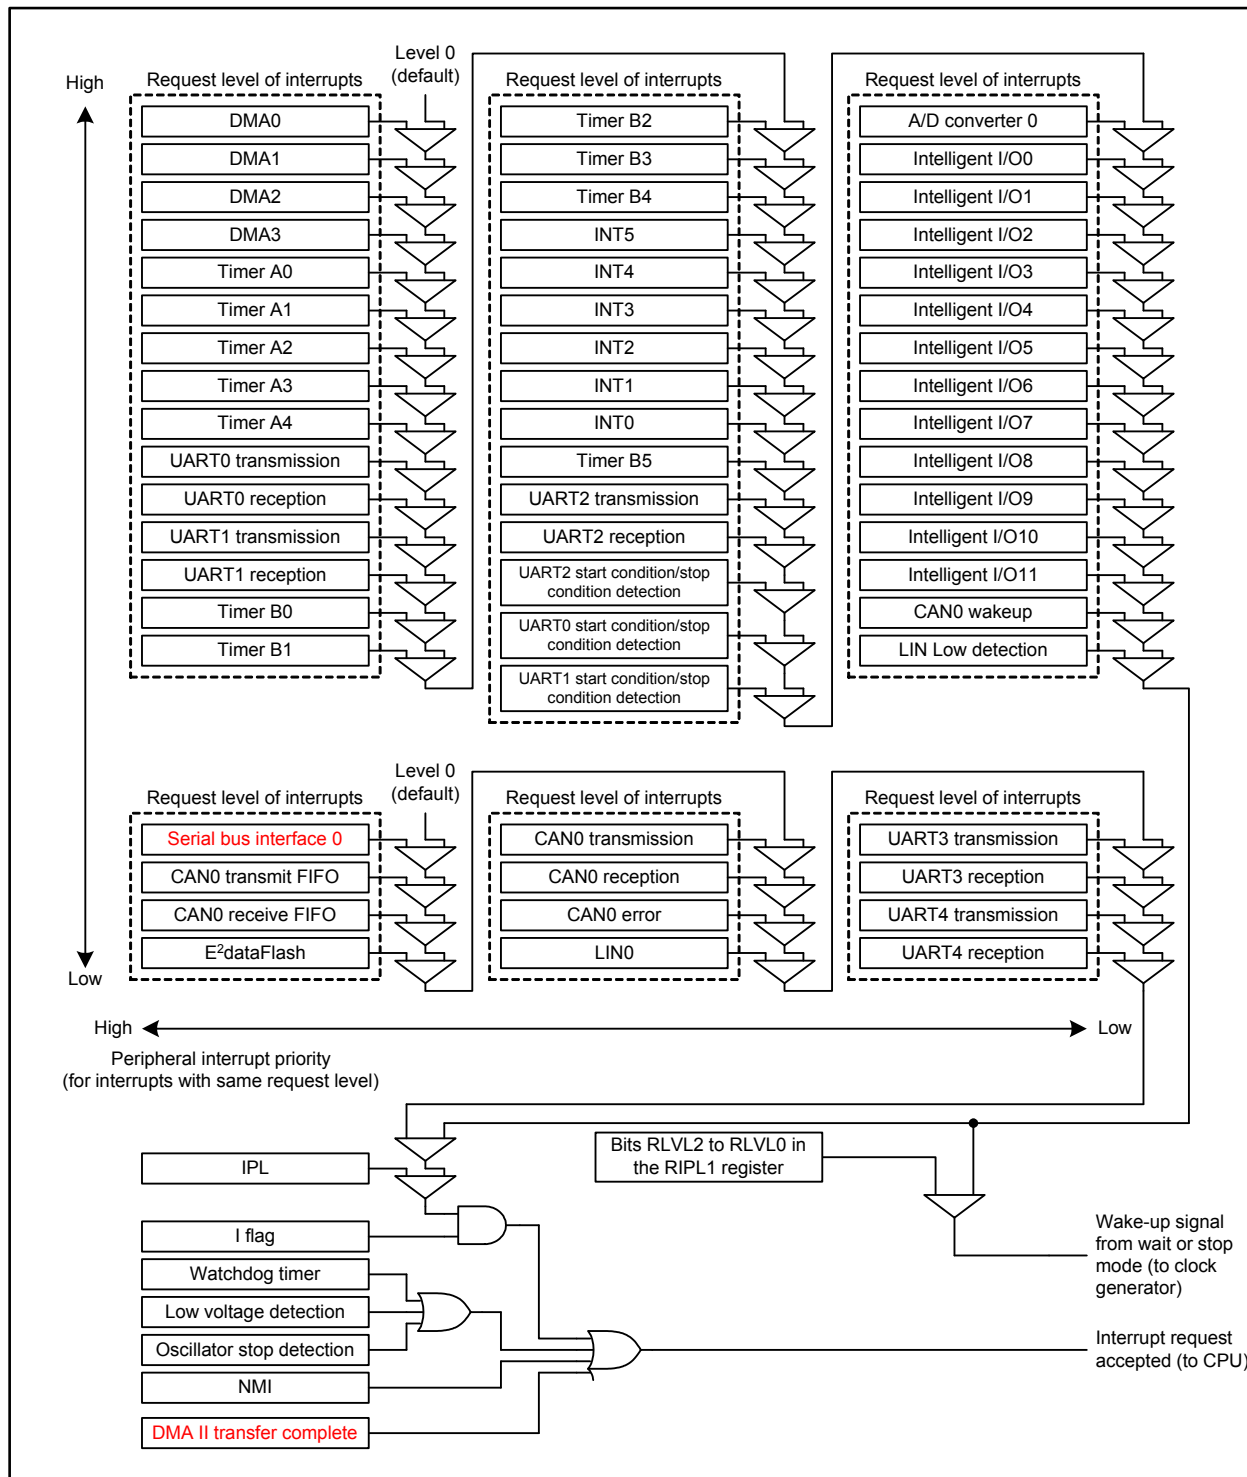
**Figure 10.8 Priority Resolver**

•Page 120 of 572, Figure 10.8 is corrected as follows:

(Description “Bits RLVL2 to RLVL0 in the RIPL2 register” and associated signal lines are deleted from Figure 10.8)

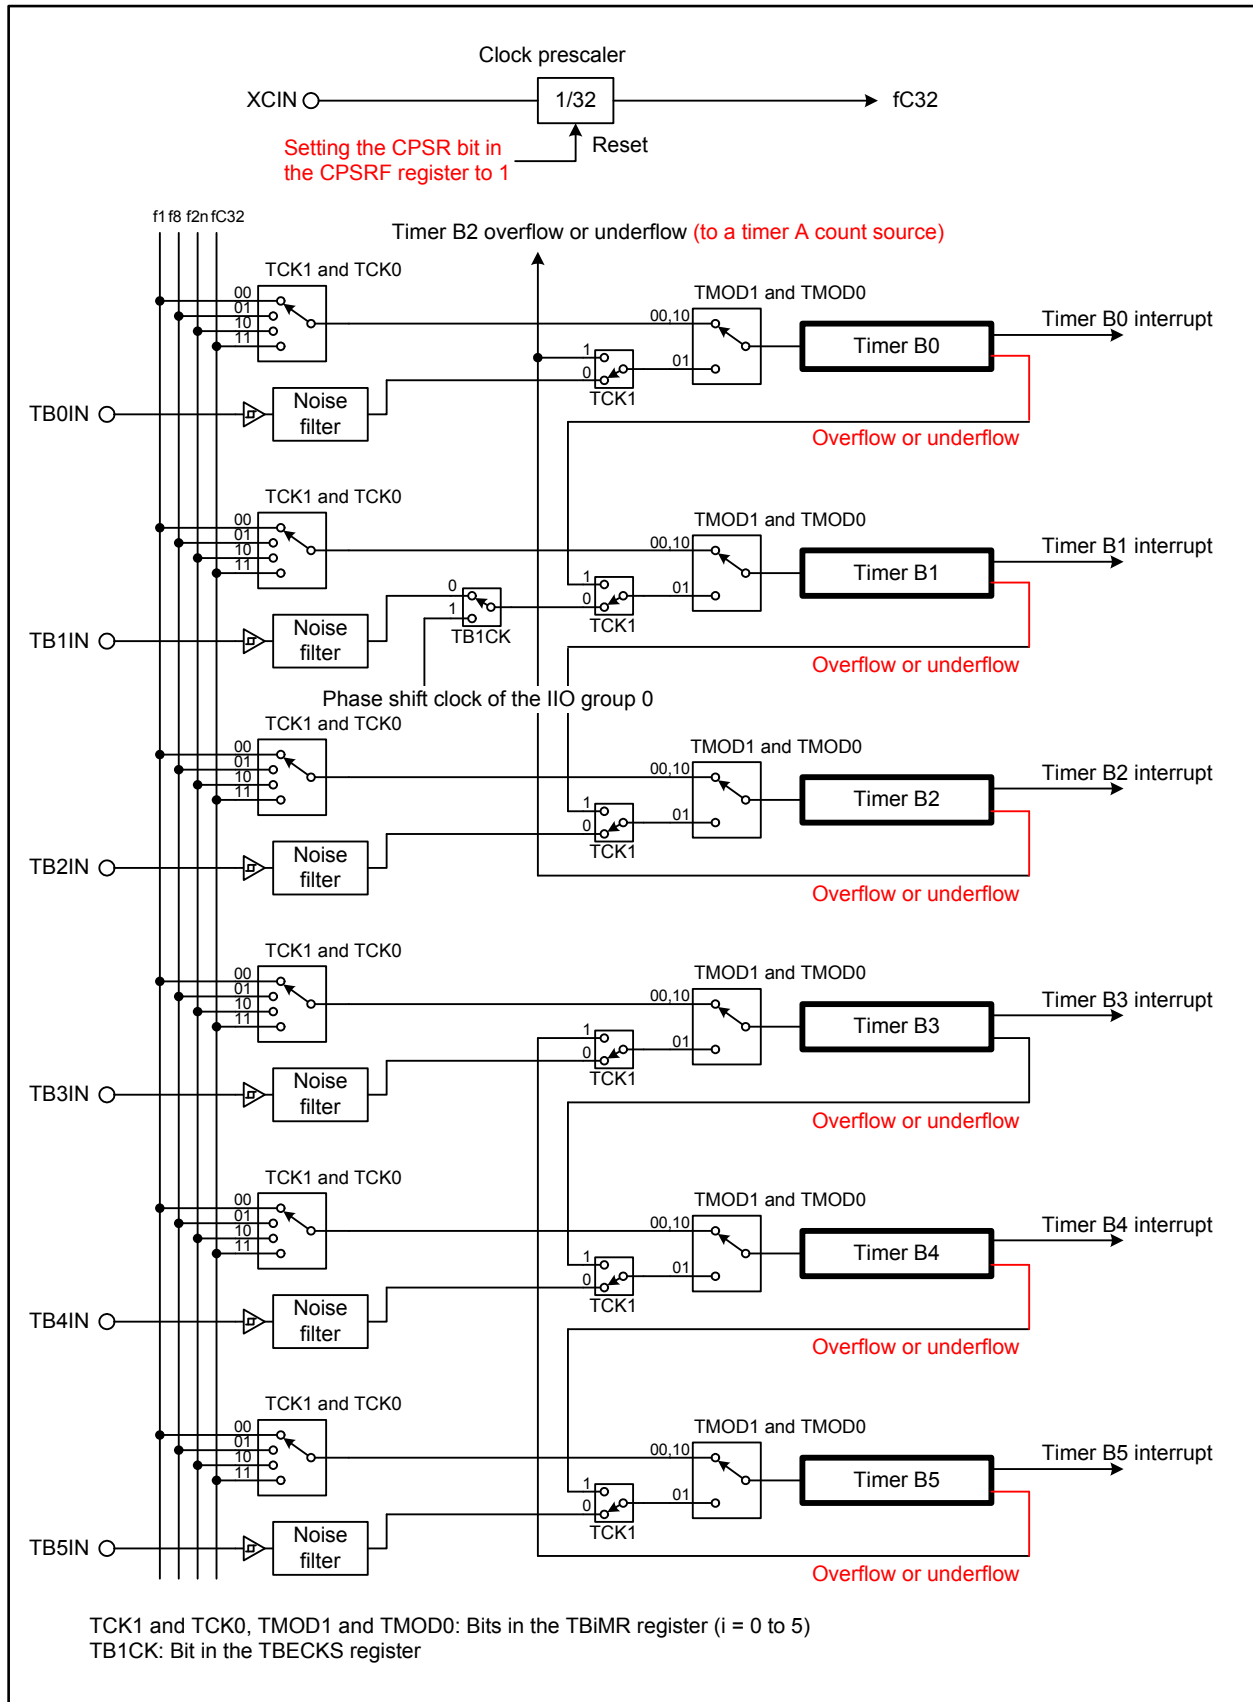
Figure 15.2 Timer B Configuration

•Page 159 of 572, Figure 15.2 is corrected as follows:

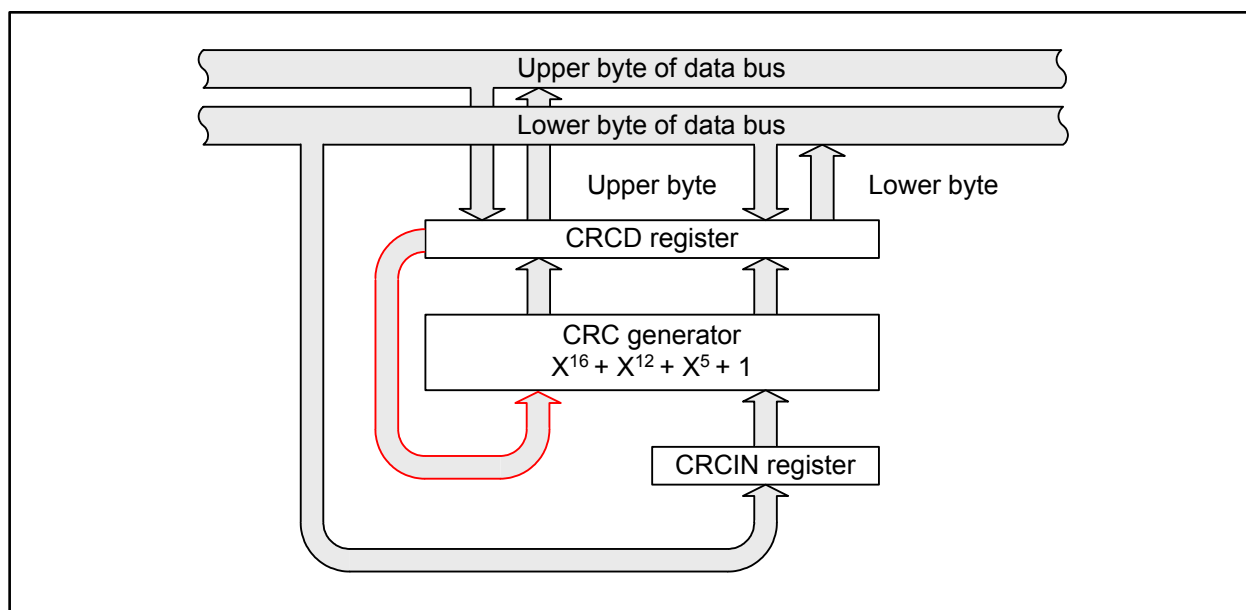
**Figure 19.1 CRC Calculator Block Diagram**

**"CRC-CCITT"**
- Page 278 of 572, Figure 19.1 is corrected as follows:

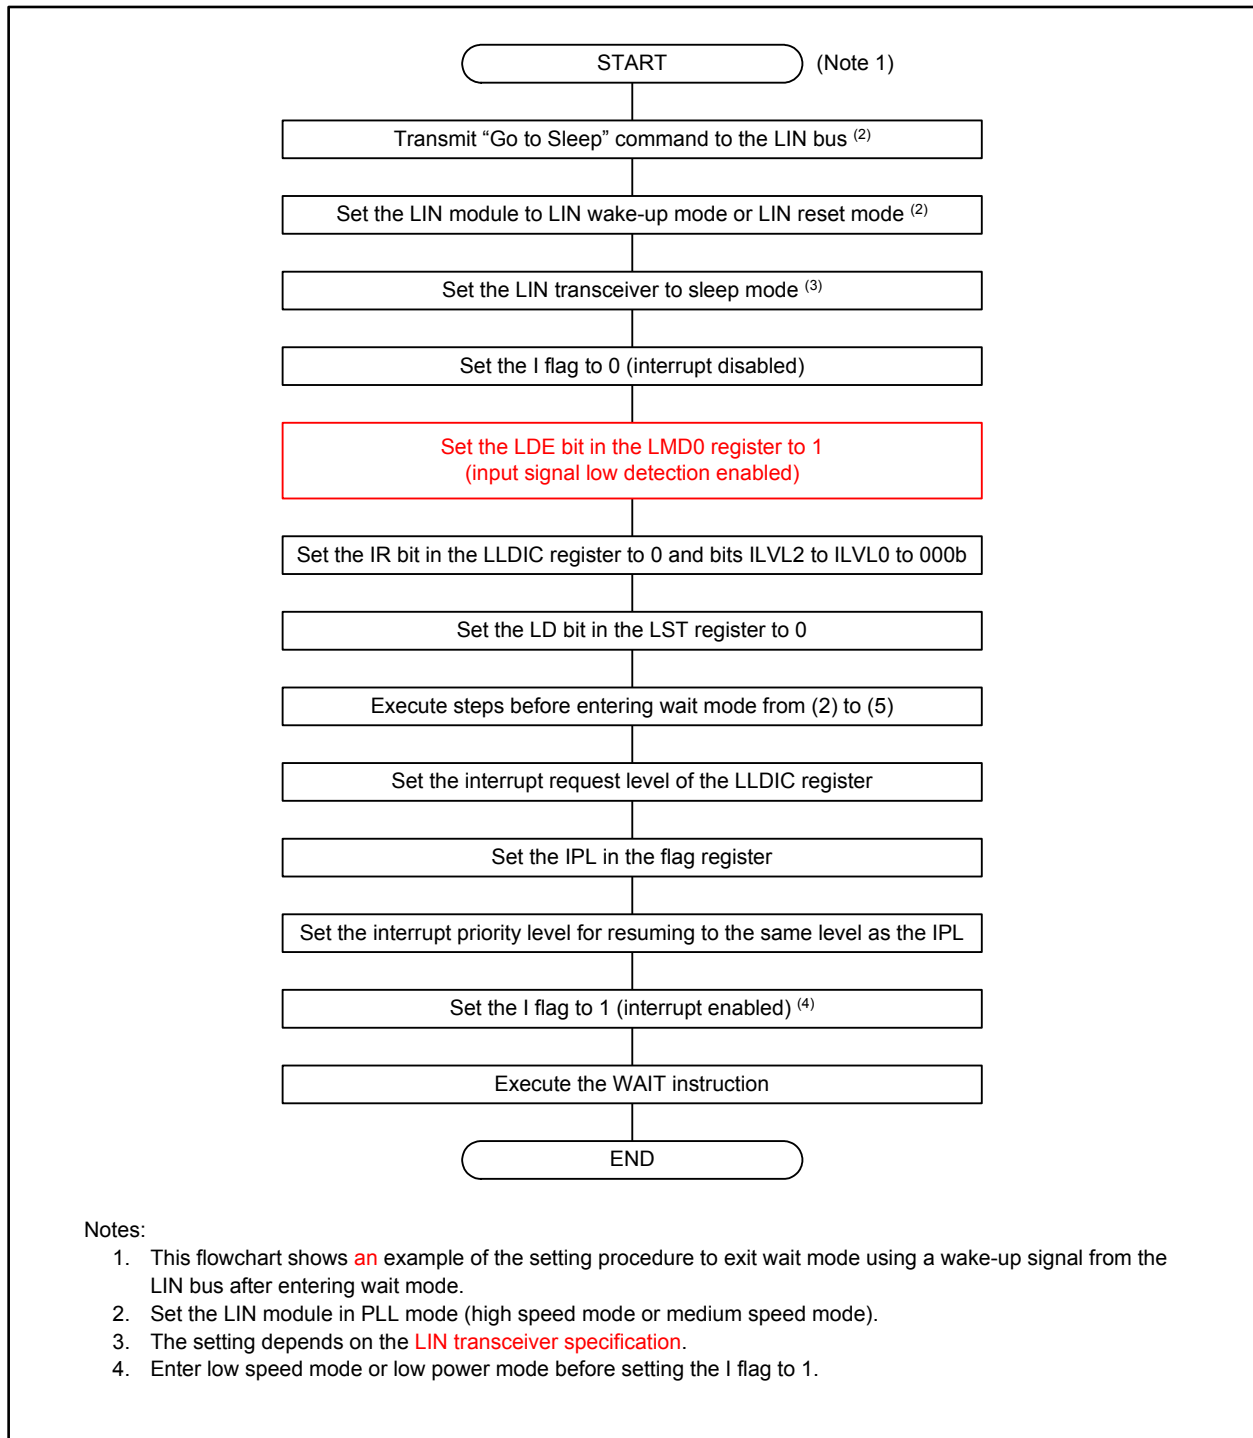
Figure 23.30 Example of Setting Before Transition to Wait Mode

•Page 382 of 572, Figure 23.30 is corrected as follows:

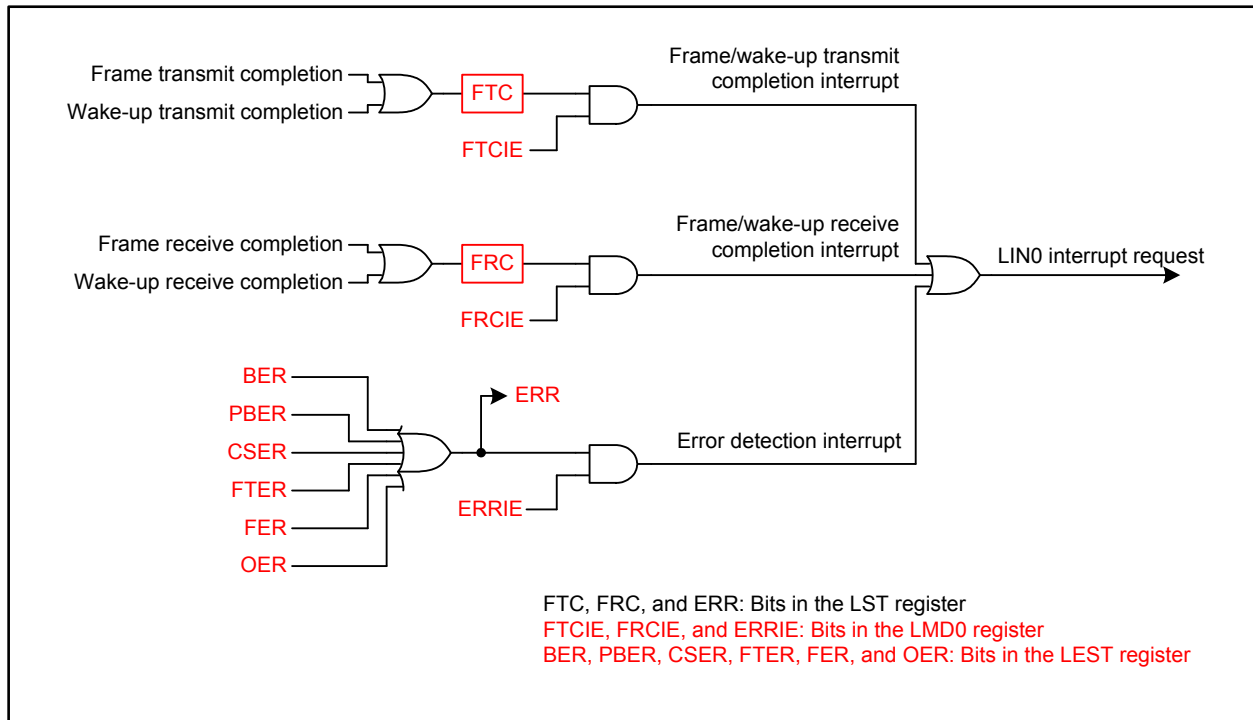
Figure 23.32 LIN0 Interrupt Block Diagram

- Page 386 of 572, the following description is added to line 8 of 23.11:  
 “No new interrupt request is generated by the other sources if any of them is 1 since multiple interrupt sources are aggregated.”
- Page 386 of 572, Figure 23.32 is corrected as follows:

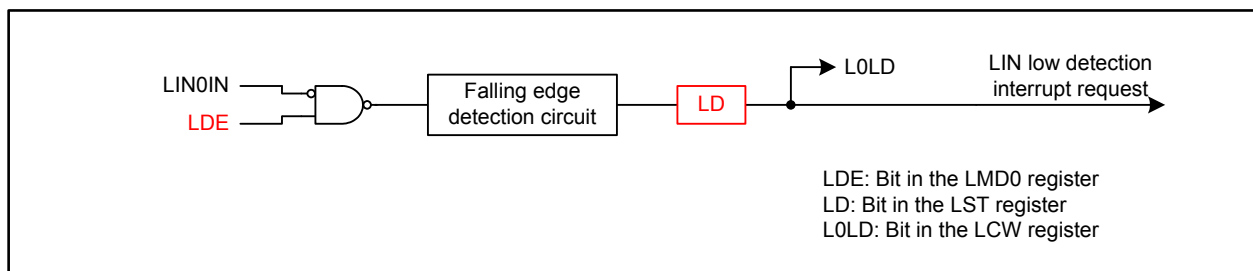
Figure 23.33 LIN Low Detection Interrupt Block Diagram

- Page 386 of 572, Figure 23.33 is corrected as follows:

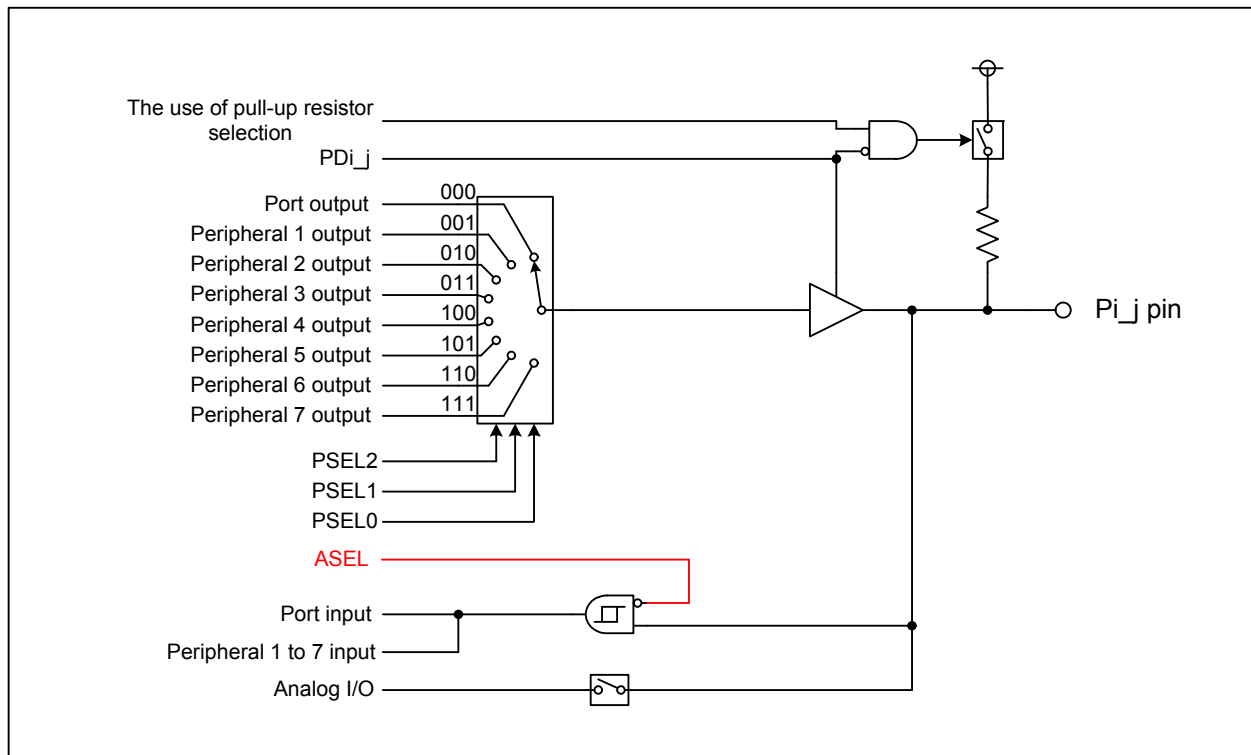
Figure 25.1 Typical I/O Pin Block Diagram (i = 0 to 9; j = 0 to 7)

- Page 456 of 572, Figure 25.1 is corrected as follows (refer to TN-16C-A198A/E):

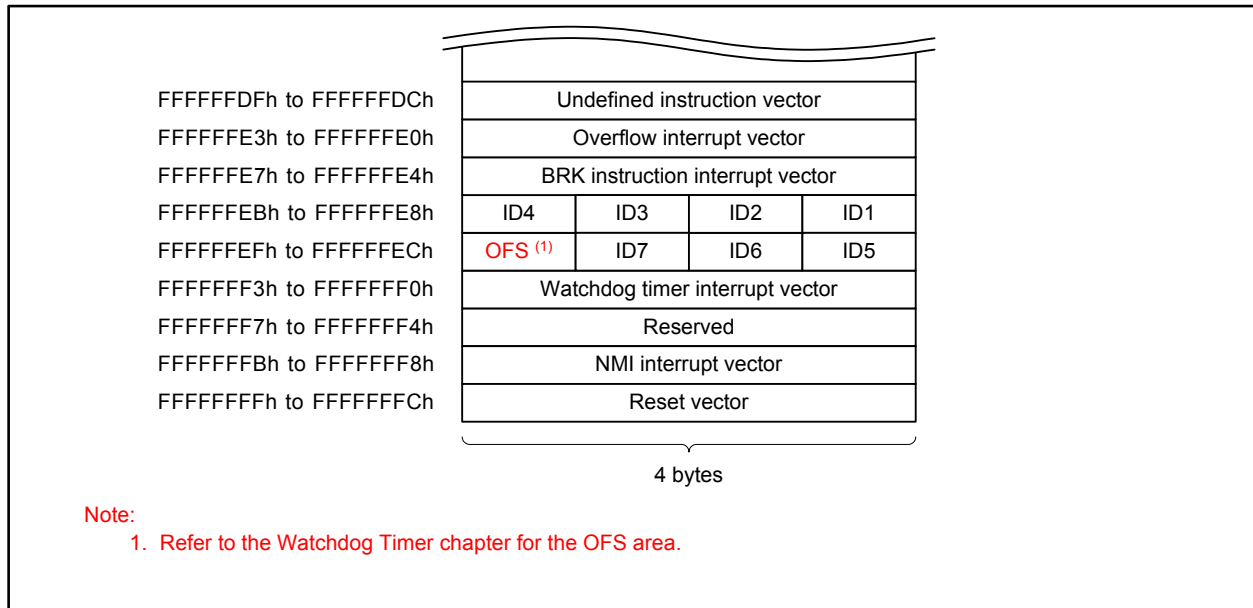
**Figure 26.2 Addresses for ID Code Stored**

•Page 480 of 572, Figure 26.2 is corrected as follows:

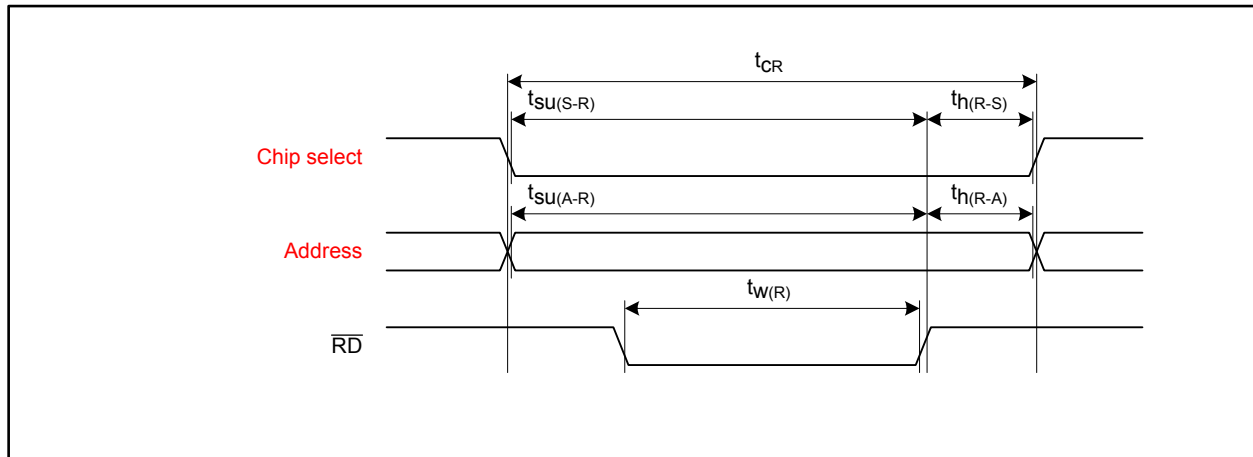
Figure 26.12 Read Timing

- Pages 488 and 490 of 572, descriptions in Figures 26.12 and 26.13 are corrected as follows:

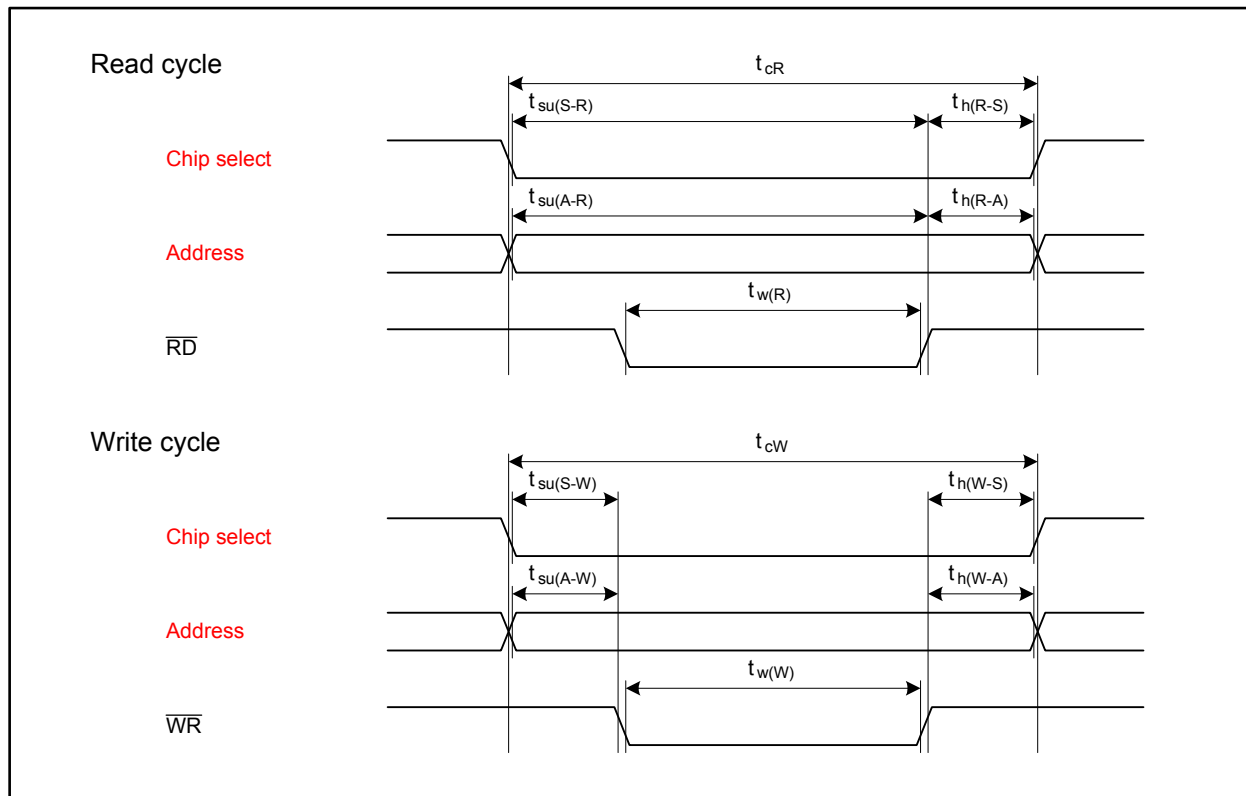
**Figure 28.5 Flash Memory CPU Rewrite Mode Timing**

- Page 527 of 572, descriptions in Figure 28.5 are corrected as follows:
