[Notes]

R20TS0087EJ0100

CS+ Code Generator for RX

Outline

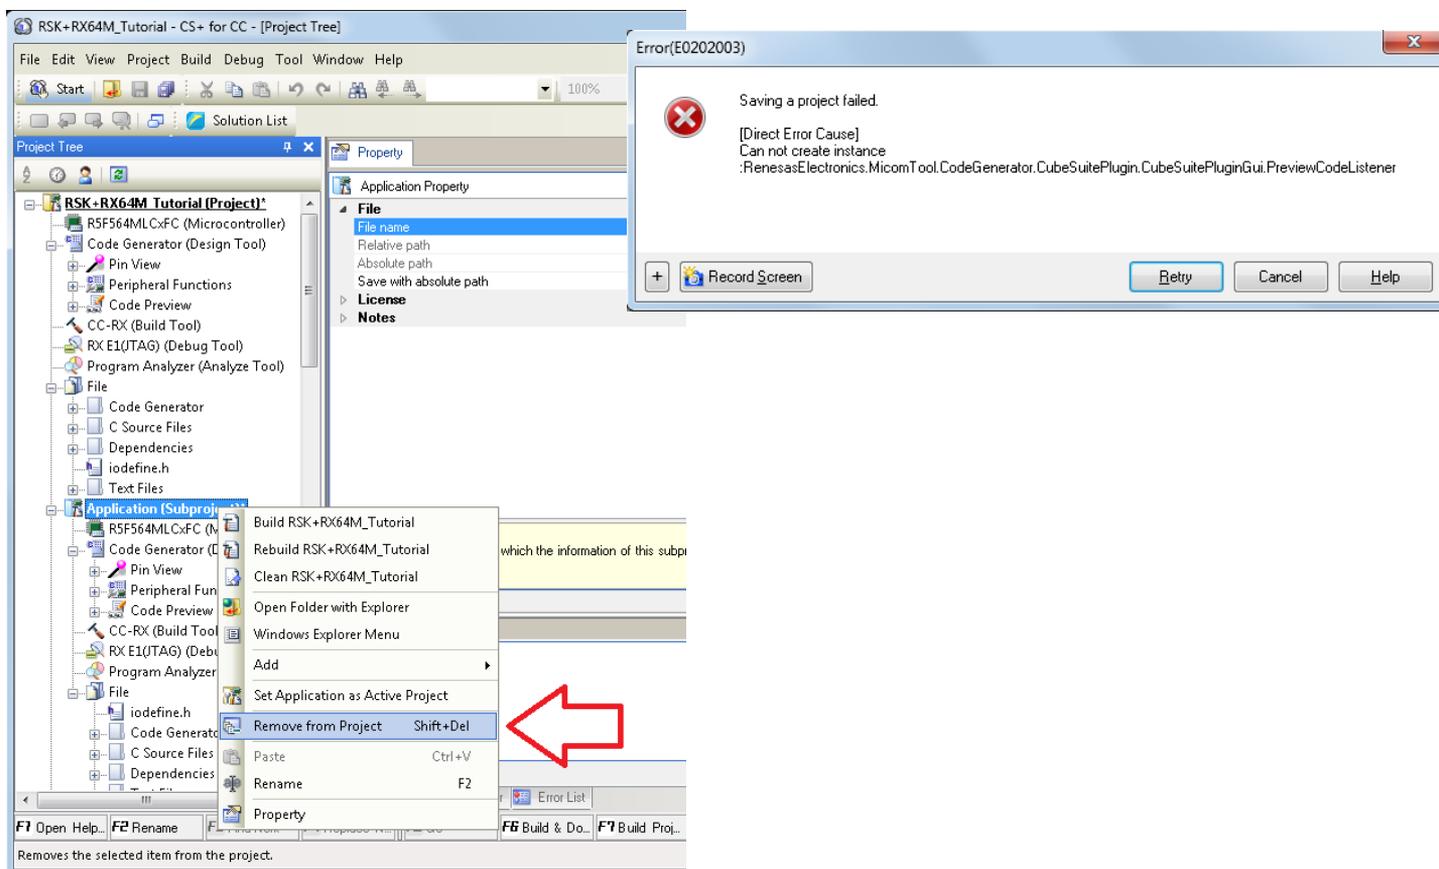
3.3.1 CS+ for CC

When a sub-project has been added to a project, an error occurs if the sub-project is removed from the project and the project is then saved.

Uncheck [Code Generator Plug-in] and [Code Generator/PinView Plug-in] in the Plug-in Manager dialog box before removing a sub-project.

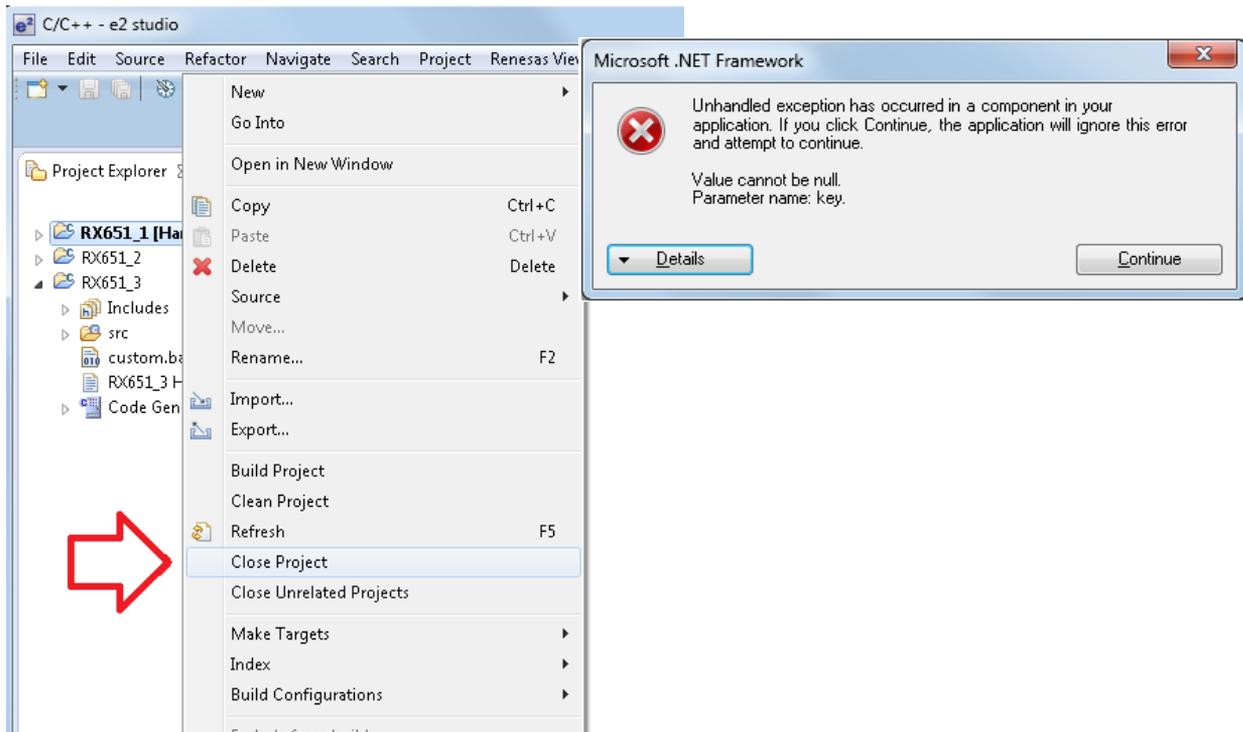
3.3.2 e² studio

An error occurs when any of the following operations proceeds while there are multiple projects in the workspace.

- Operating the code generator for another project after closing a project.
- Operating the code generator for another project after deleting a project.

Reboot the e² studio after selecting [Close Project] or [Delete].
