[Notes] Smart Configurator for RH850

R20TS0744EC0100 Rev.1.00 Sep. 16, 2021

Outline

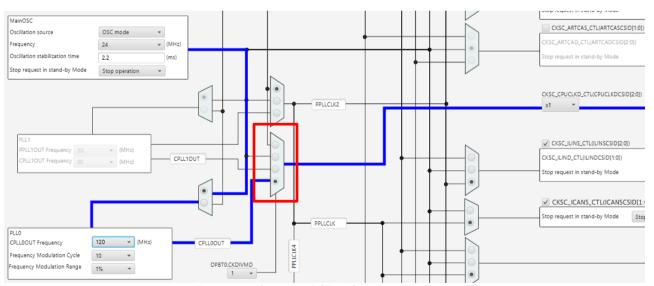
Figure 1-1 Setting of CPU Subsystem clock source

When selecting PLL0 clock CPLL0OUT as source of CPU Subsystem clock (refer to Figure 1-1), the clock initialization enters an infinite loop, and the program cannot continue to run.

User can manually modify the code in the following source file

- Source file: "r_cg_cgc.c".
- Function: "void R_CGC_Create (void)"

This is an example of the required modification. User should manually set protect register and modify CLKCTL.CKSC_CPUCLKD_CTL register setting statement. In the following example, the code in red color is wrong code before modification, while the code in blue color is correct code after modification.

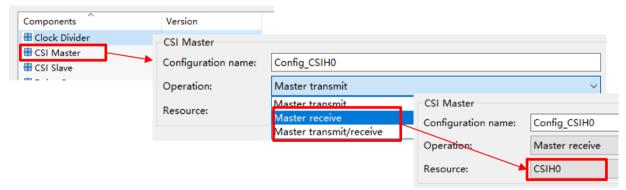
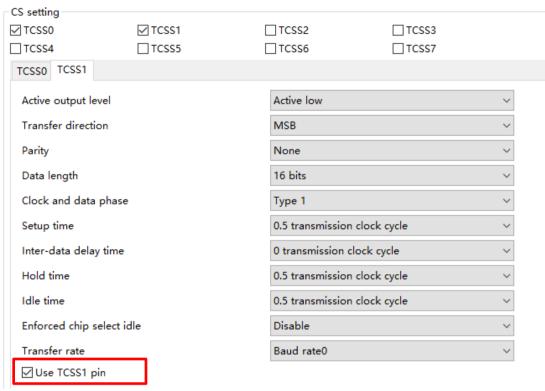
Figure 2-1 Setting of CSI Master operation mode (using CSIH0 as an example)

When using CSI Master component with operation mode of "Master receive" and "Master transmit/receive" (refer to figure 2-1), selecting the master supplies chip select (CS) signal to the slaves (refer to figure 2-2), master can only receive the first data correctly. From the second data, master fails to receive.

User can manually modify the register setting code in the following source file

- · Source file: "<Configuration-name>_user.c".
- Function: "void r_<Configuration-name>_ interrupt_receive (void)"

The following is an example of the required modification when *Configuration-name>* is Config_CSIH0 in the RH850/F1KM group. The code in red color is wrong code before modification, while the code in blue color is correct code after modification.

```
void r_Config_CSIH0_interrupt_receive(void)
{
    uint8_t err_type;
    uint16_t temp;
    .....
    else
    {
        temp = g_csih0_rx_total_num;
        if (temp > g_csih0_rx_num)
        {
            *gp_csih0_rx_address = CSIH0.RXOW;
            gp_csih0_rx_address++;
            g_csih0_rx_num++;
            CSIH0.TXOW |= 0xffffUL;
        }
        .....
}
```
