R20TS0895EC0100

e<sup>2</sup> studio Smart Configurator for RL78 Plug-in,  
Smart Configurator for RL78

1. Notes when changing version of Board Support Program (BSP) or RL78 Software Integration System (SIS) modules

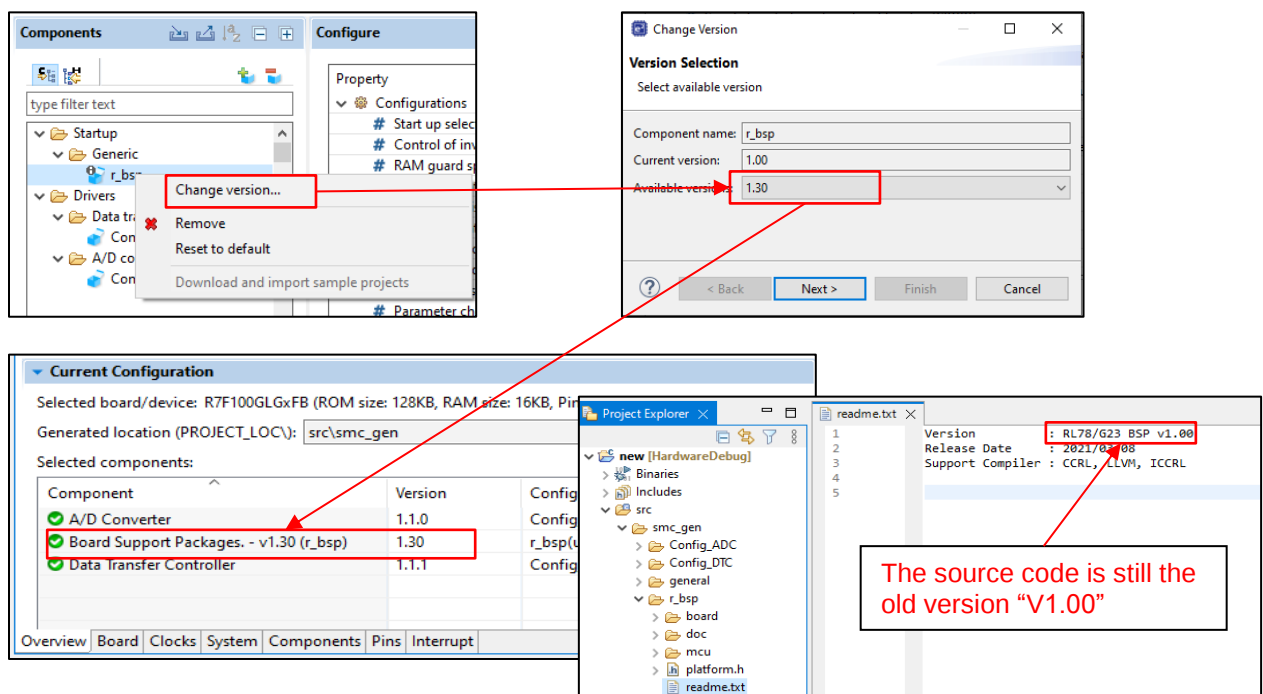
Figure 1-1 BSP/RL78 SIS module [Change version...] operation

After performing [Change version...] for BSP or RL78 SIS modules, version seems be changed successfully in the "Overview" summary. But actually some of the source code files are still the old version. (Refer to Figure1-1). As result, user can't aware the version unchanged and it may cause build error in some cases.

<1> Delete the specified configuration file under “r\_config” folder which want to perform [Change version...].

<2> Change preferences [Smart Configurator] > [Component] > [Generating code] to select “Overwrite existing component”. (Refer to [Figure1-2](#))

<3> Click [Change version...] menu.

After <1>, <2>, <3>, the BSP or RL78 SIS modules files can be generated correctly as expected version.

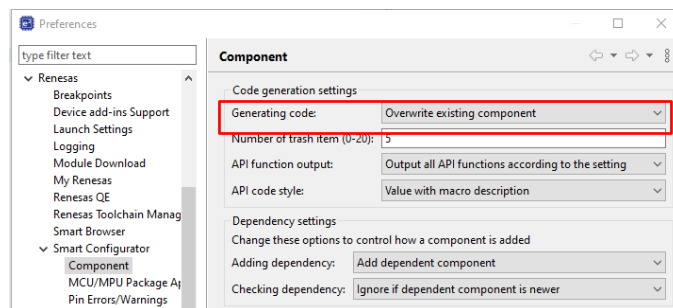
Figure 1-2 “Overwrite existing component” setting

1. When using Smart Configurator for RL78 V1.4.0 and preferences setting [Smart Configurator] > [Component] > [Generating code] selects “Overwrite existing component”

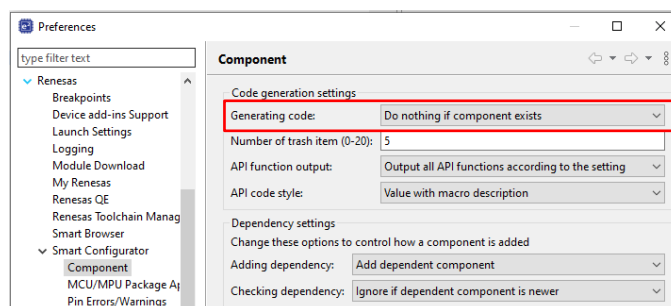
Figure 1-3 “Do nothing if component exists” setting

2. When using Smart Configurator (V1.0.1 or later) and preferences setting [Smart Configurator] > [Component] > [Generating code] selects “Do nothing if component exists”
