RENESAS TECHNICAL UPDATE

Product Category	MPU & MCU	Document No.	TN-16C-A191A/E	Rev.	1.00
Title	Errata to R32C/117 Group Hardware Manual		Information Category	Technical Notification	
Applicable Product	R32C/117 Group	Lot No.	Reference Document	R32C/117 Group Hardware Manual Rev. 1.00 (REJ09B0533-0100)

This document describes corrections to the R32C/117 Group Hardware Manual, Rev. 1.00.
The corrections are indicated in red in the list below.

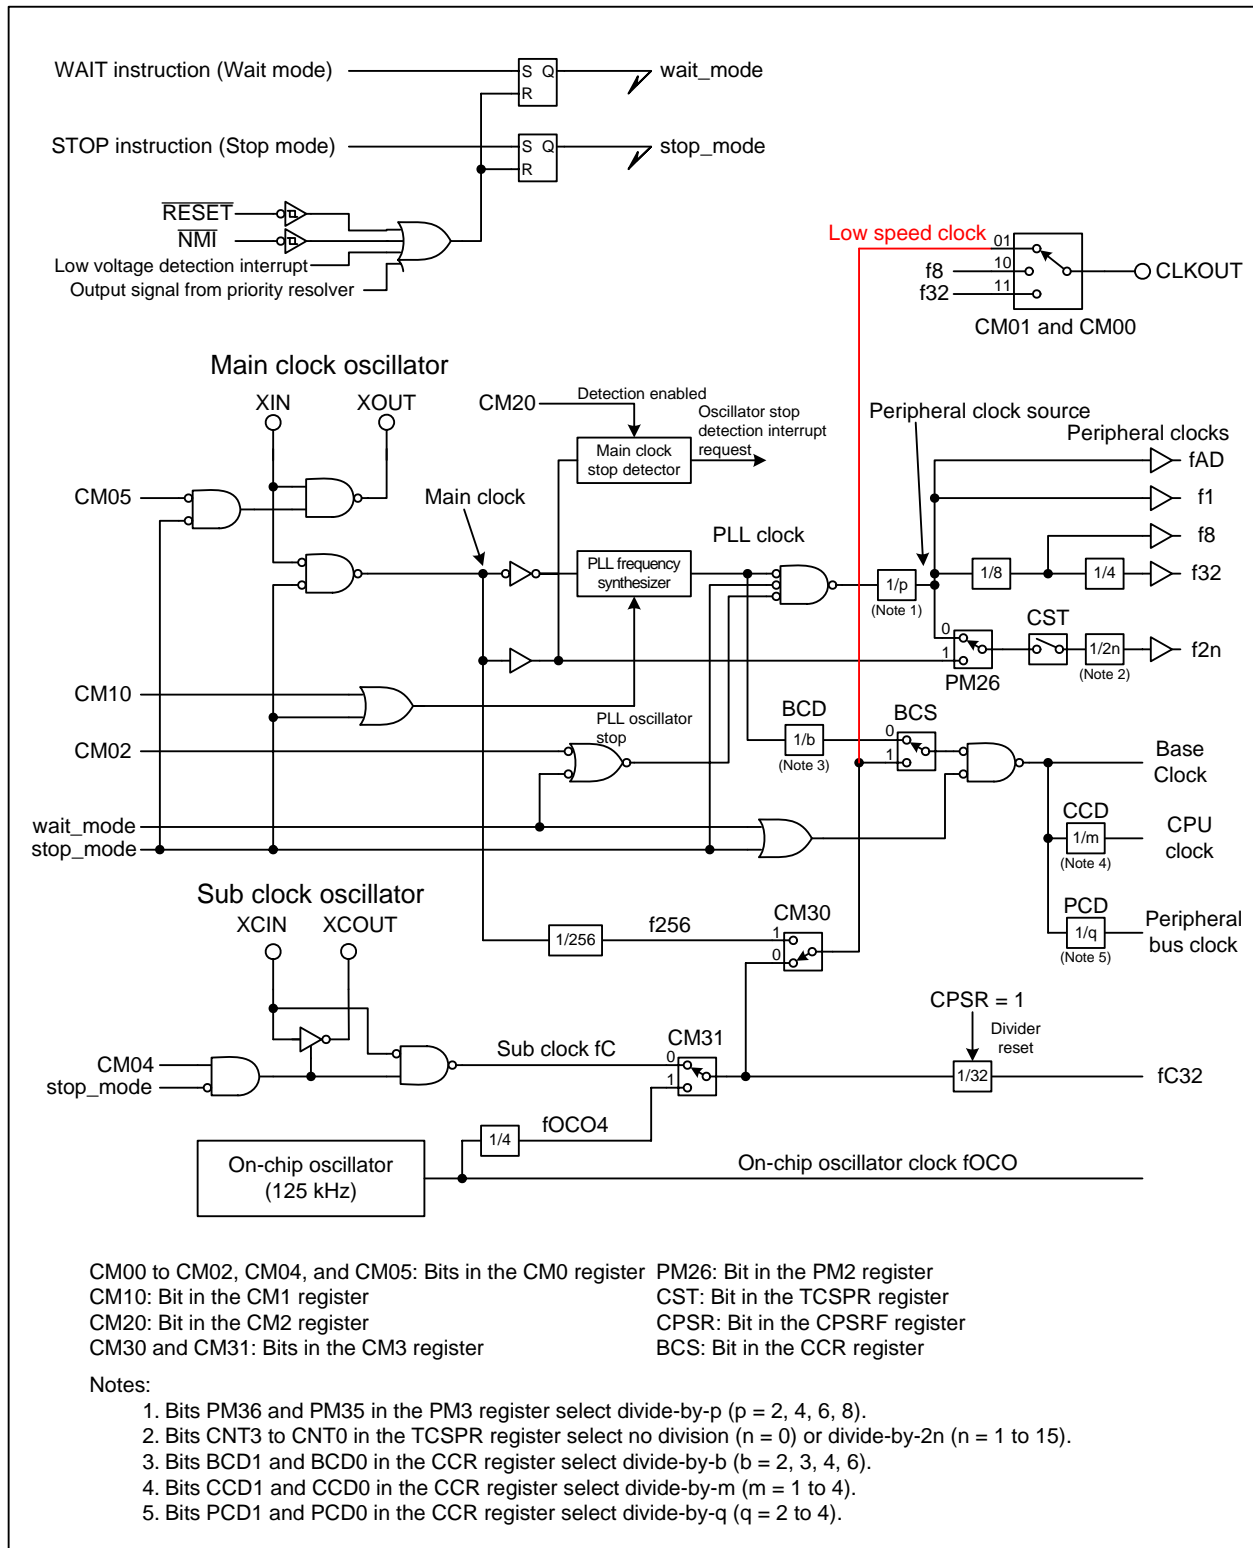
Figure 8.1 Clock Generation Circuitry

•Page 83 of 601, Figure 8.1 is corrected as follows:

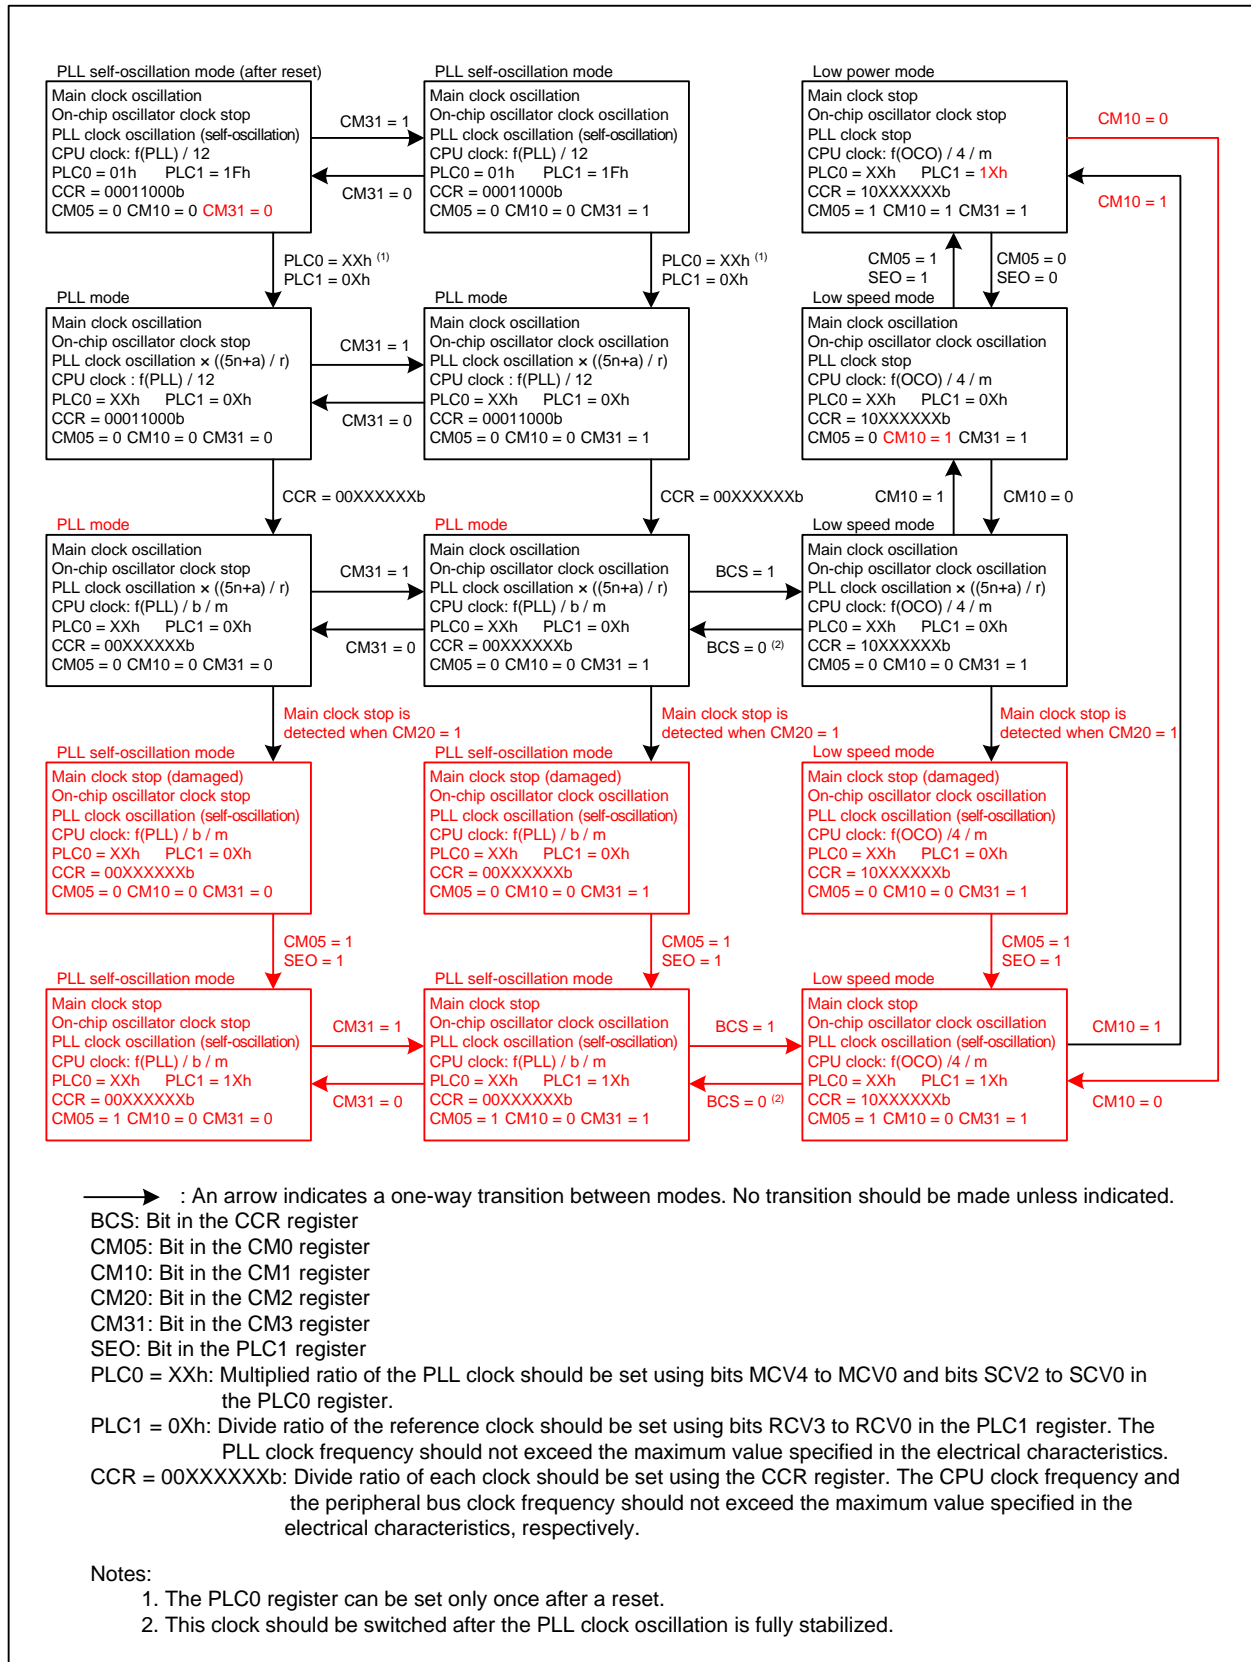
Figure 8.19 State Transition (when the on-chip oscillator clock is used)

•Page 103 of 601, descriptions of “CM31 = 1” in the first row and “CM10 = 0” in the second row in Figure 8.19 are corrected, and the flowchart are clarified as follows:

(Note 3 “The CM05 bit is not set to 1 when an oscillator stop is detected through the oscillation stop detector.” is deleted from Figure 8.19)

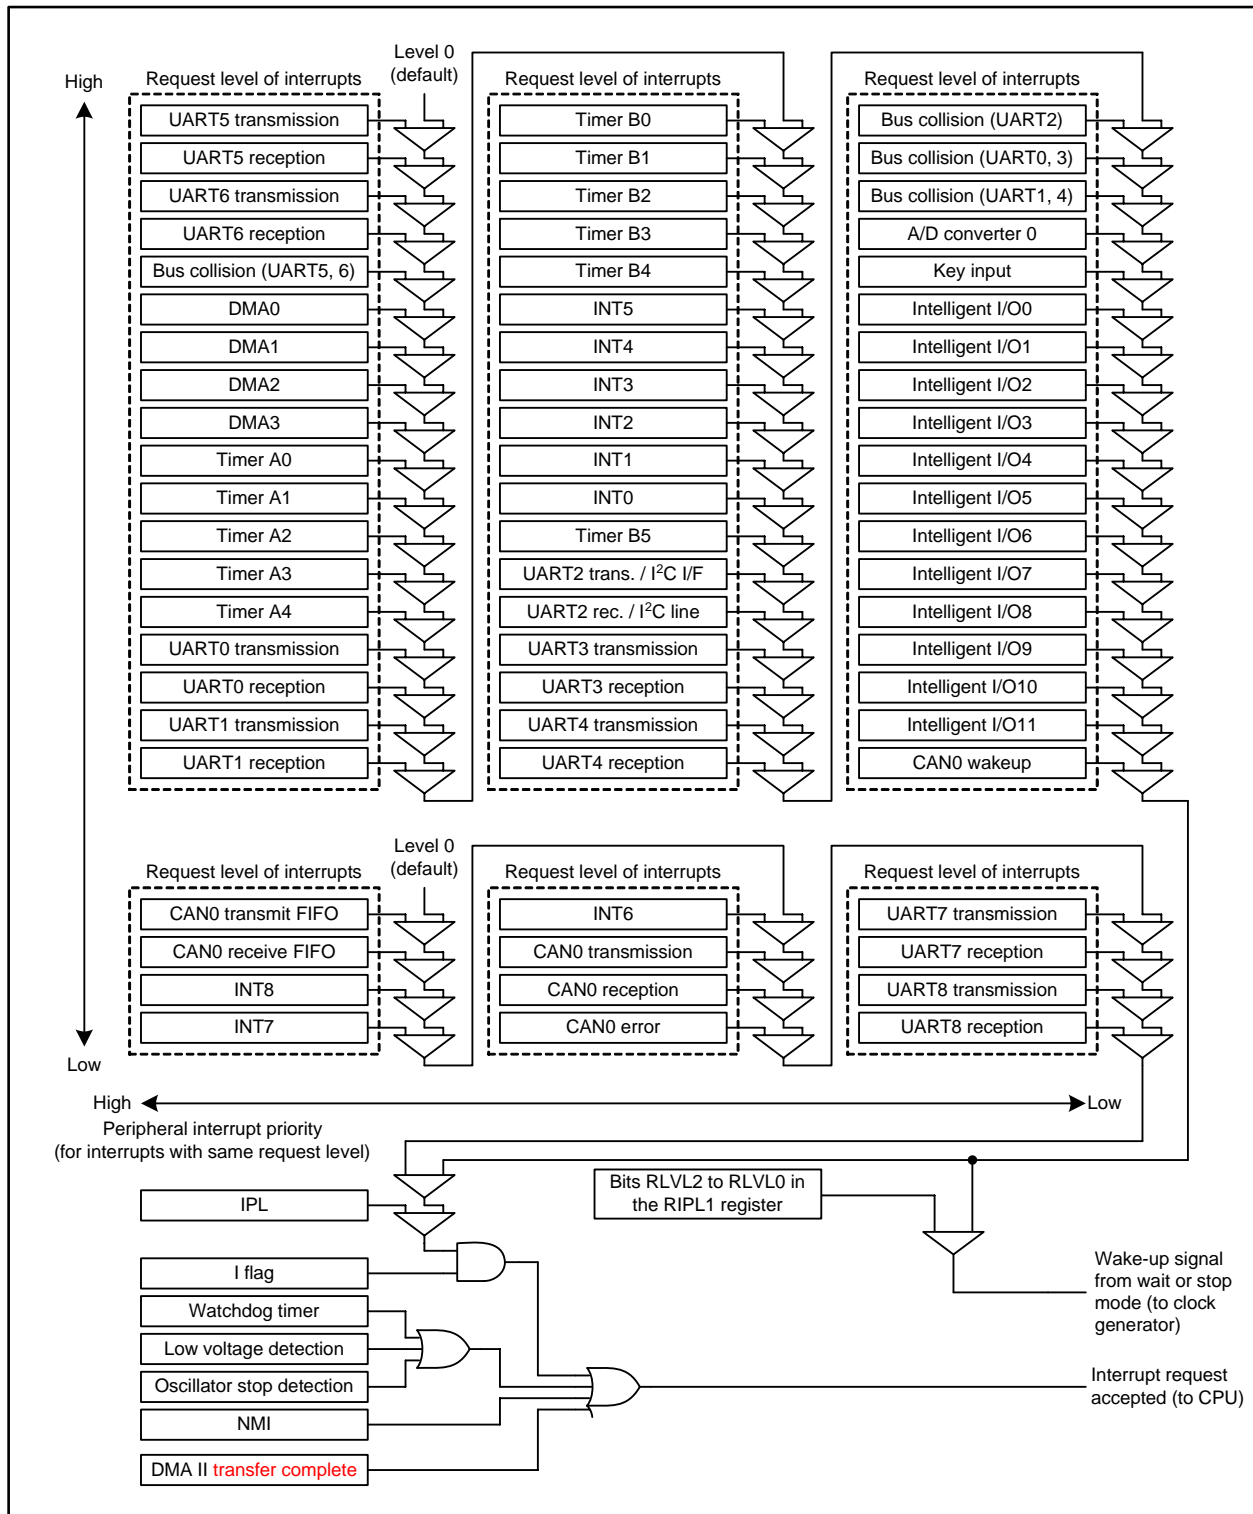
Figure 11.8 Priority Resolver

•Page 158 of 601, Figure 11.8 is corrected as follows:

(Description “Bits RLV2 to RLV0 in the RIPL2 register” and associated signal lines are deleted from Figure 11.8)

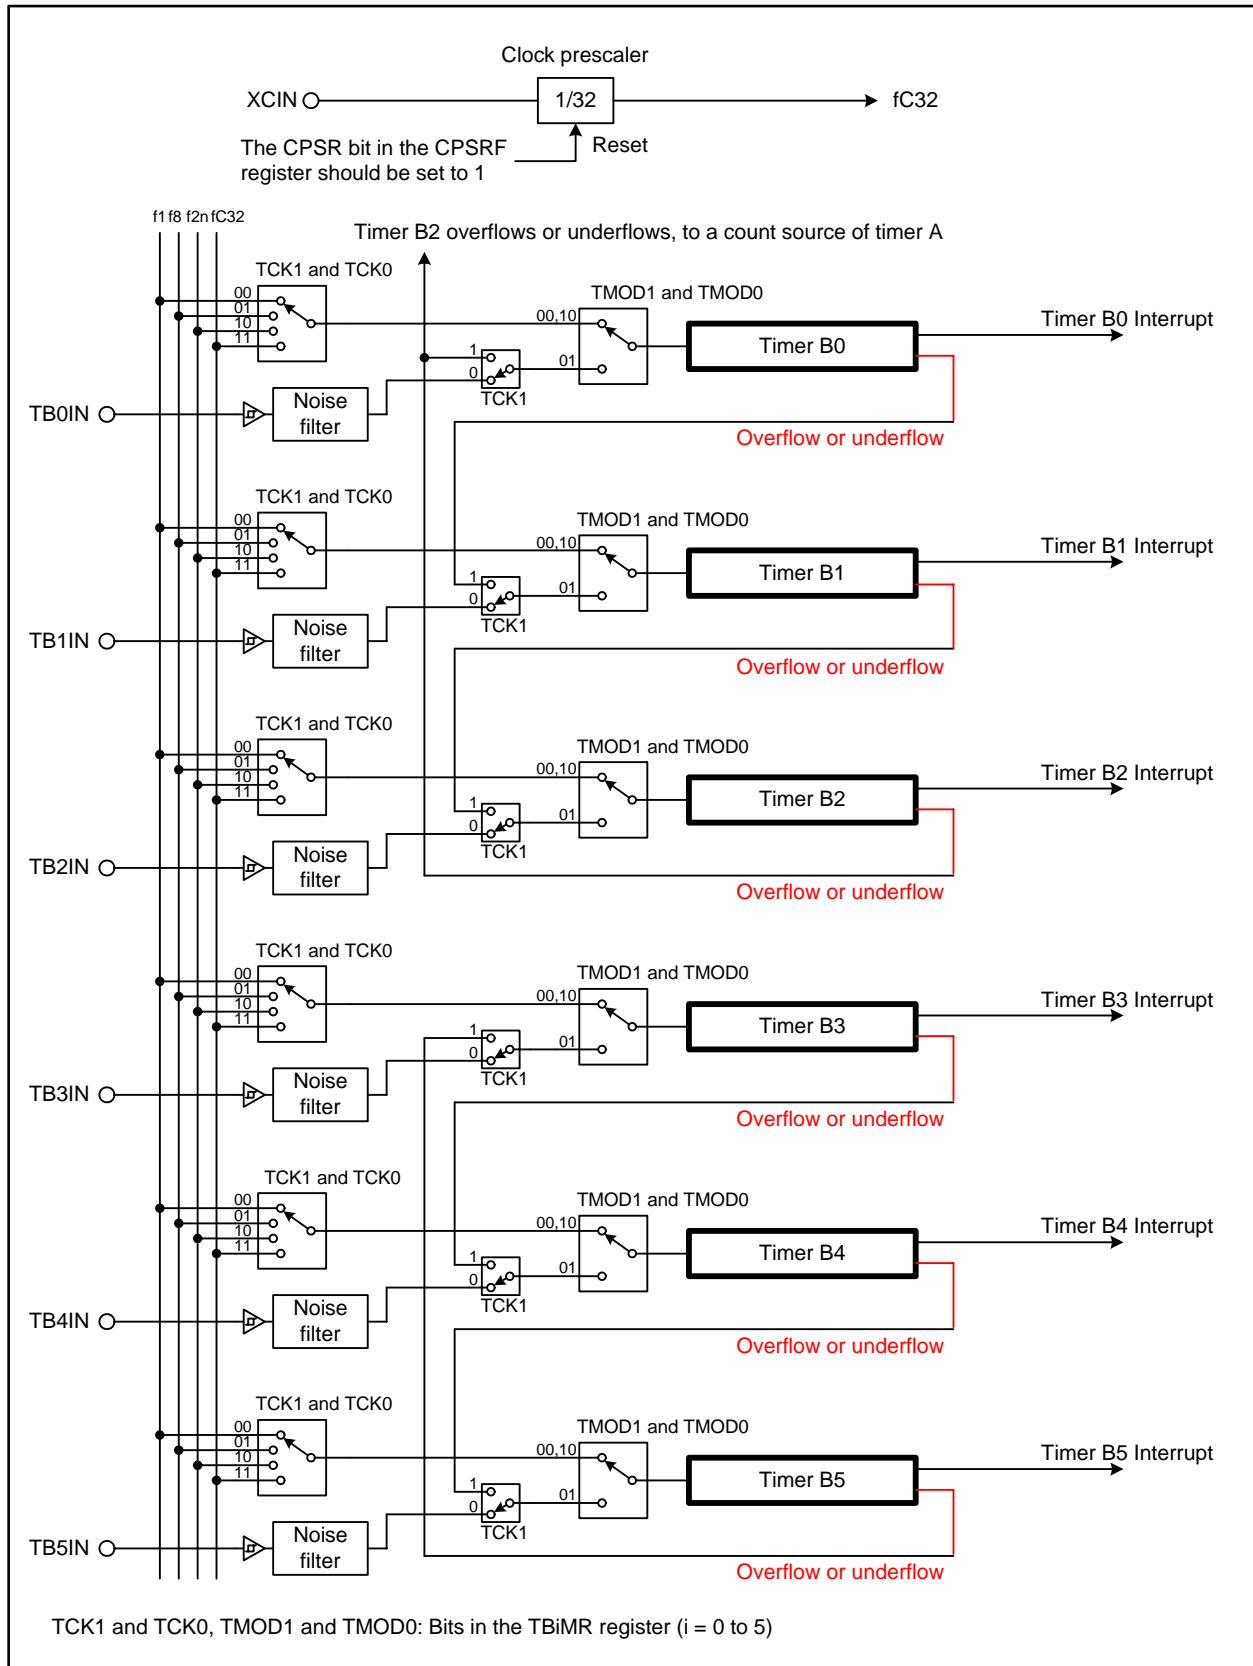
Figure 16.2 Timer B Configuration

•Page 196 of 601, Figure 16.2 is corrected as follows:

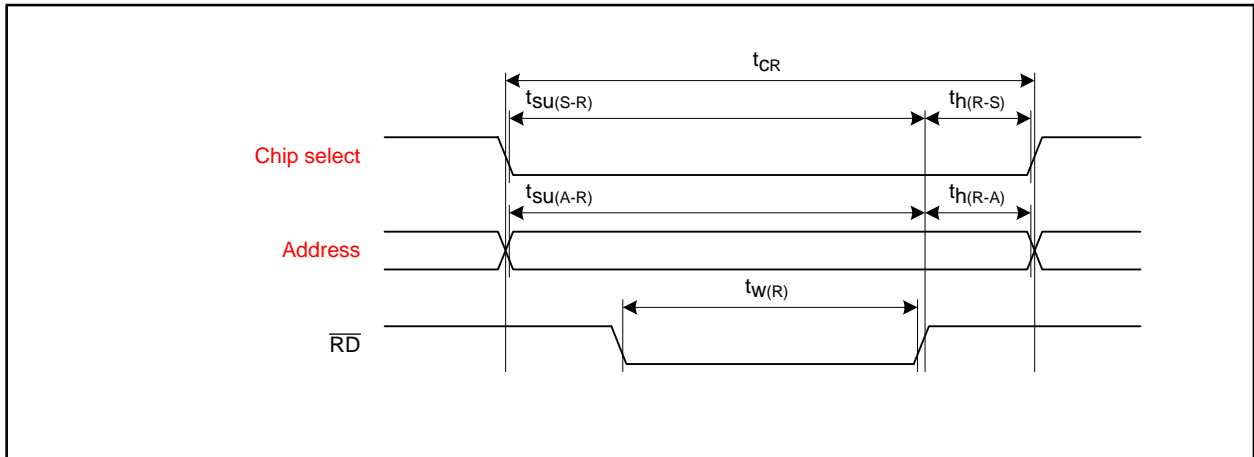
Figure 27.13 Read Timing

•Page 521 and 523 of 601, descriptions in Figures 27.13, 27.14, and 28.5 are corrected as follows:
