## **RENESAS TECHNICAL UPDATE**

Product Category	MPU 8	k MCU		Document No.	TN-16C-A225A/E	Rev.	1.00
Title	Errata Hardw	to R32C/118 Group User's Ma are	anual:	Information Category	Technical Notification		
Applicable Product	R32C/	118 Group	Lot No.	Reference Document	R32C/118 Group User's Hardware Rev. 1.10 (REJ09B0534-0110)	s Manu	al:
		scribes corrections to the R32 e indicated in red in the list be		user's Manu	ial: Hardware, Rev. 1.10		
•Page 25 " <mark>R3R1</mark>		register symbol "R3R0" in line	e 3 of 2.1.1 i	s corrected as	follows:		
follows: "Increr •Pages 6 Tables 4	ment/De 4 to 65 : .36 to 4	register name "Increment/Dec ecrement Select Register" and 78 to 79 of 618, register n .37 and 4.50 to 4.51 is correct k Register 0/1/2/3/4/5/6/7"	ame "CAN1	/0 Acceptance

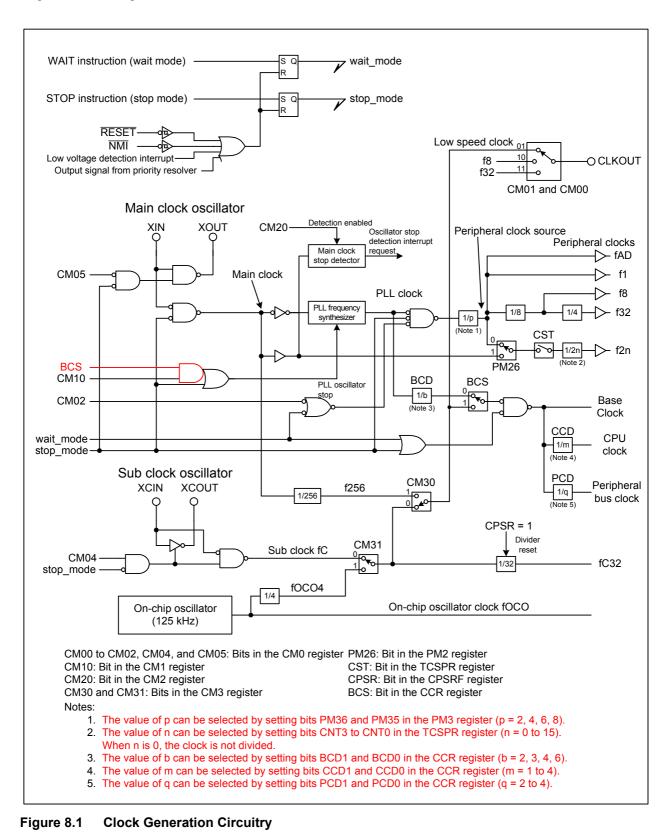
•Page 97 of 618, Figure 8.1 is corrected as follows:

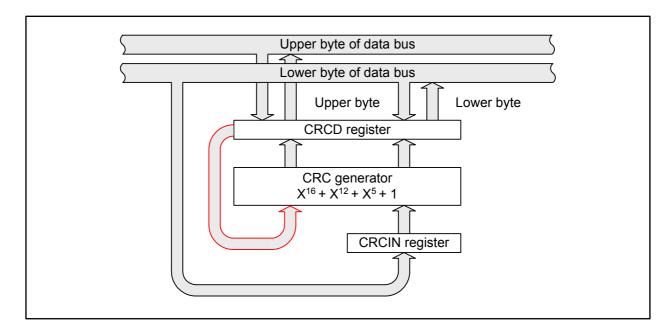
## Figure 21.1 CRC Calculator Block Diagram

•Page 336 of 618, Figure 21.1 is corrected as follows:

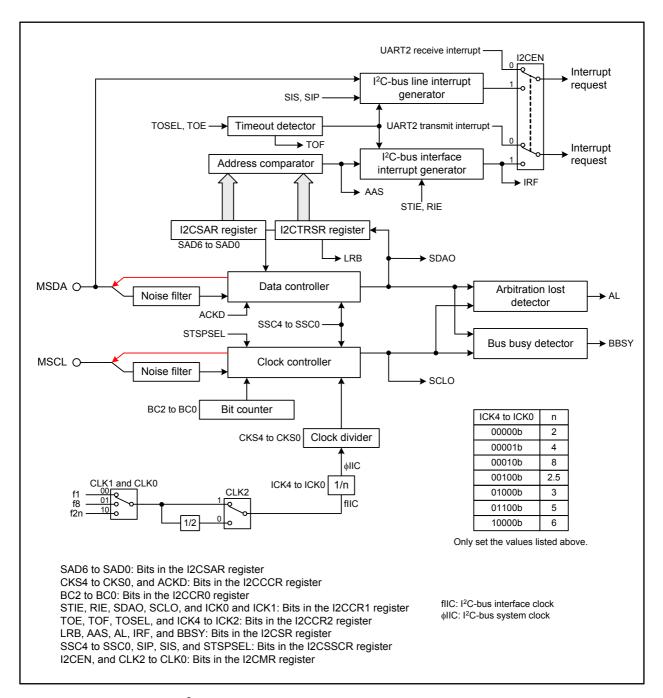
## Figure 24.1 Multi-master I<sup>2</sup>C-bus Interface Block Diagram

•Page 391 of 618, Figure 24.1 is corrected as follows:
