RENESAS TECHNICAL UPDATE

Product Category	MPU & MCU		Document No.	TN-RX*-A114A/E	Rev.	1.00
Title	Corrections to User's Manual regarding the FASR.EXS bit for the Flash Memory in the RX110 Group		Information Category	Technical Notification		
		Lot No.		RX110 Group User's Manual:		
Applicable Product	RX110 Group	All	Reference Document	(R01UH0421EJ0100) Specification Changes RX110 Group (TN-R) Corrections to Descrip	Specification Changes to the RX110 Group (TN-RX*-A112A/ Corrections to Descriptions for the Flash Memory in the RX110 Group User's Manual

This document describes corrections to the description for the FASR.EXS bit in section 31. Flash Memory of RX110 Group User's Manual: Hardware Rev.1.00.

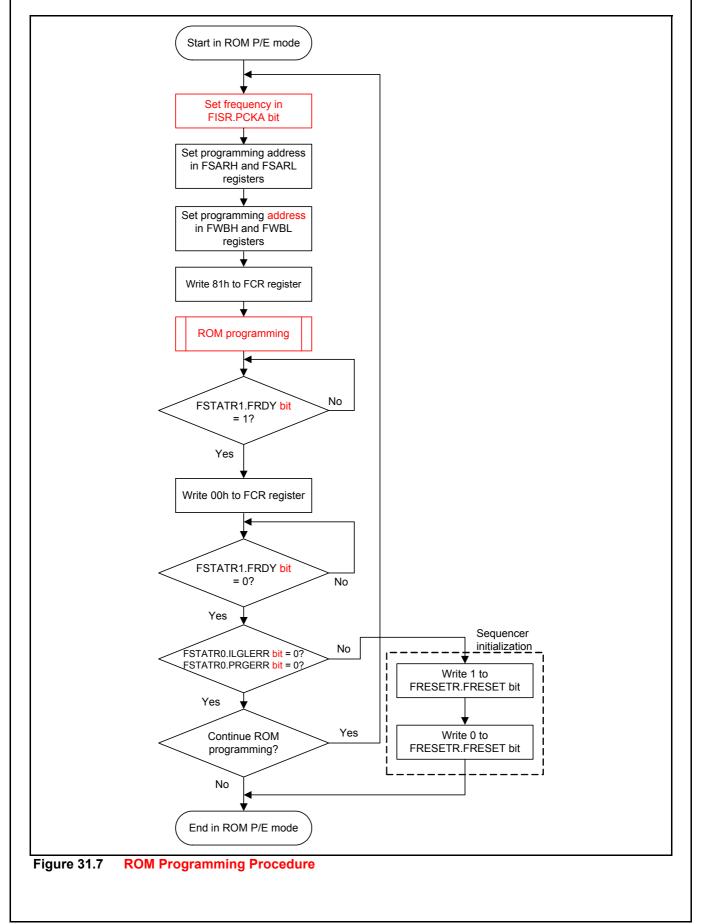
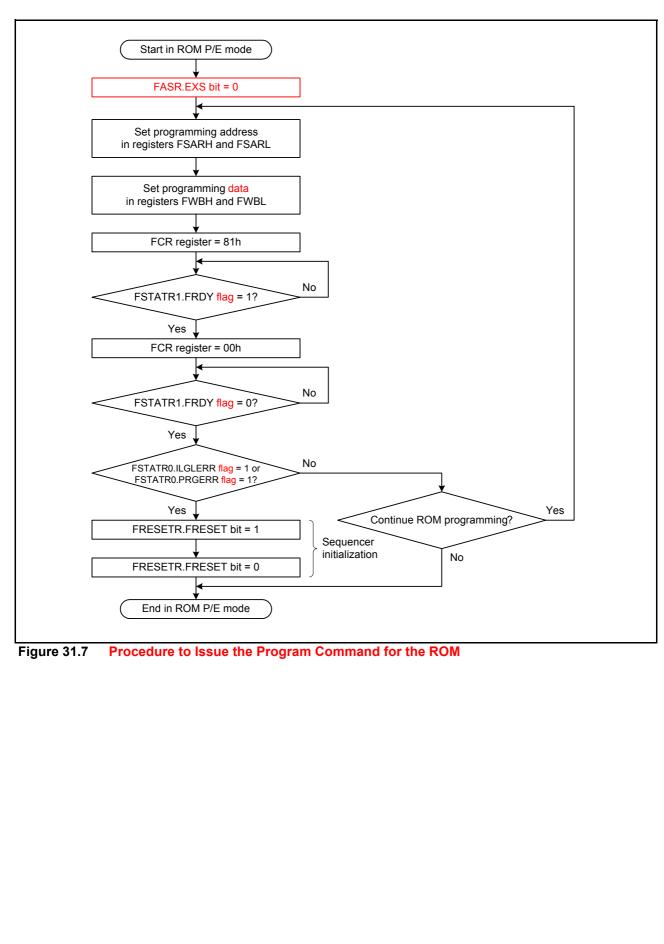
• Page 866 of 966

Figure 31.7 in (3) Programming and Erasure Procedures of 31.6.3 Software Command Usage is corrected as follows:

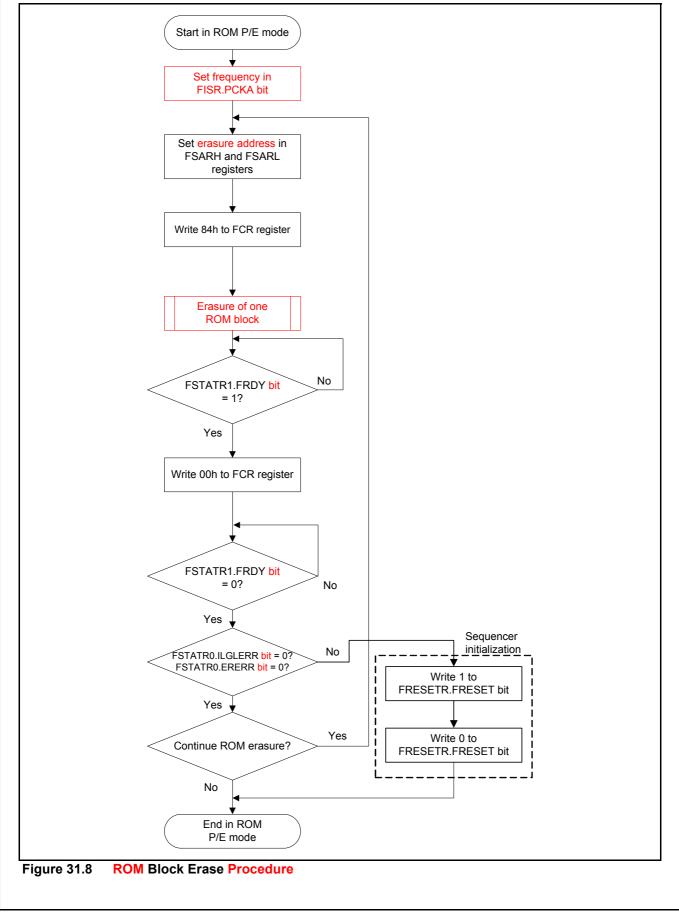
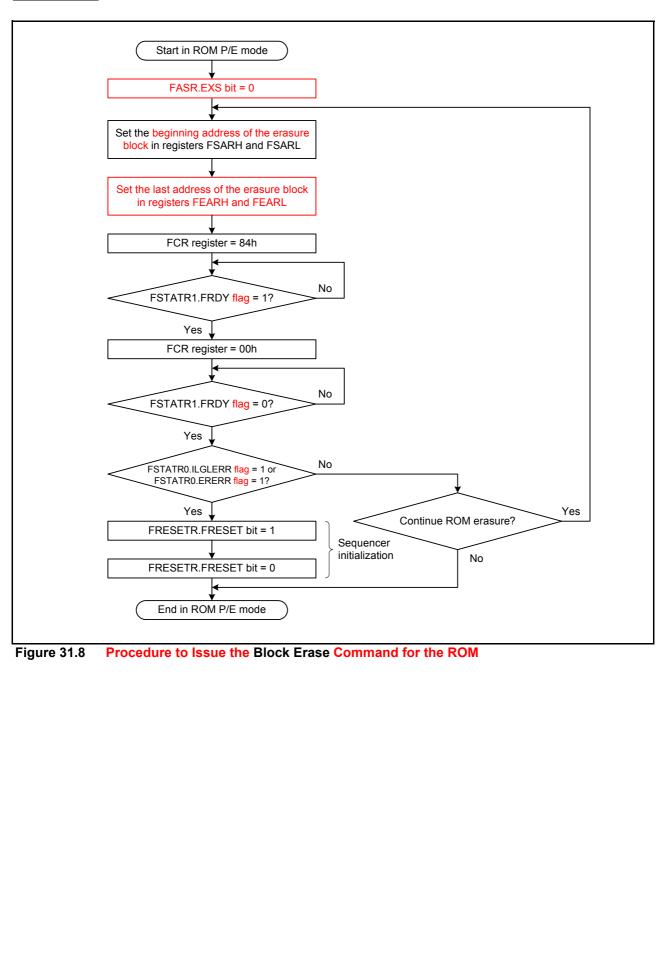
• Page 867 of 966

Figure 31.8 in (3) Programming and Erasure Procedures of 31.6.3 Software Command Usage is corrected as follows:

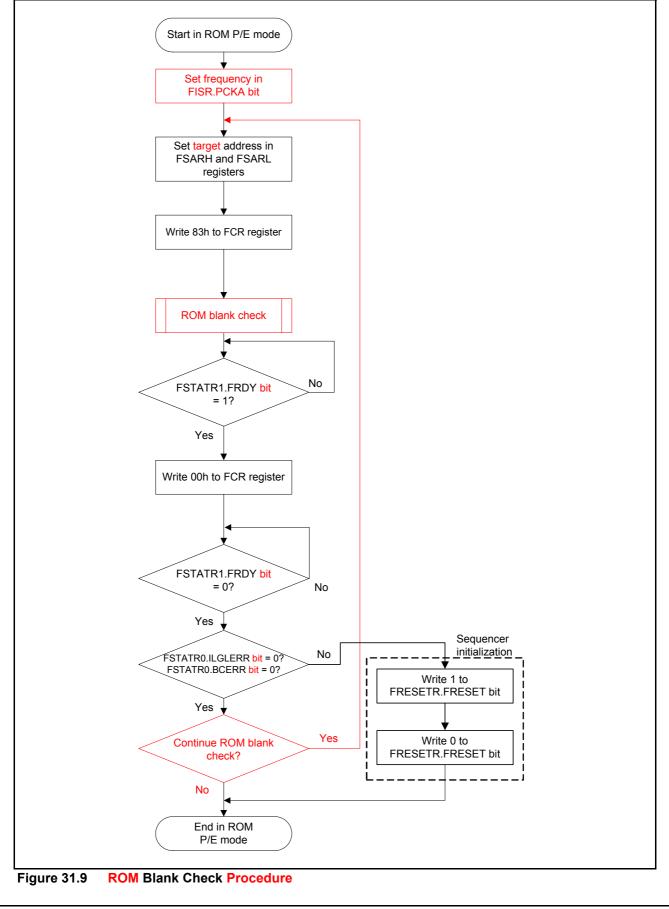
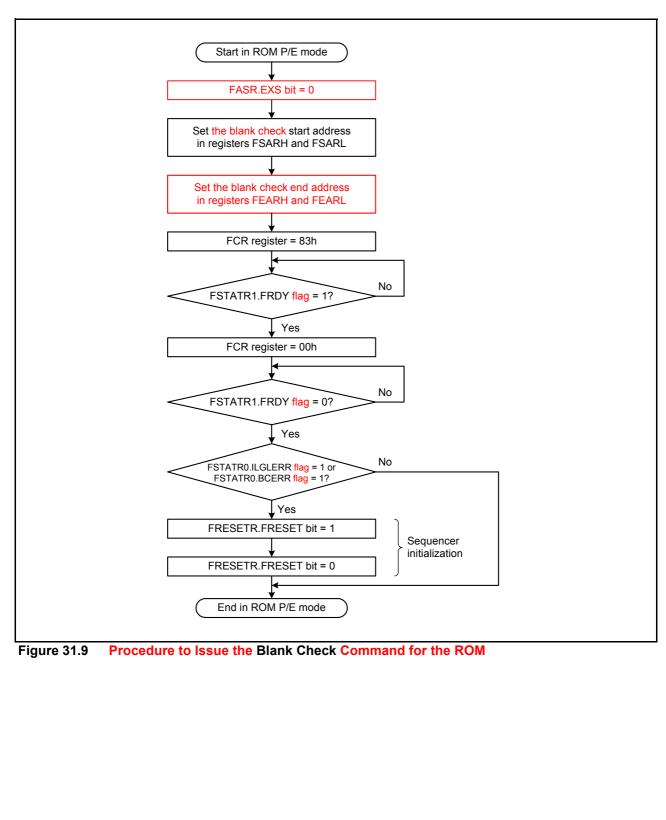
• Page 868 of 966

Figure 31.9 in (3) Programming and Erasure Procedures of 31.6.3 Software Command Usage is corrected as follows:

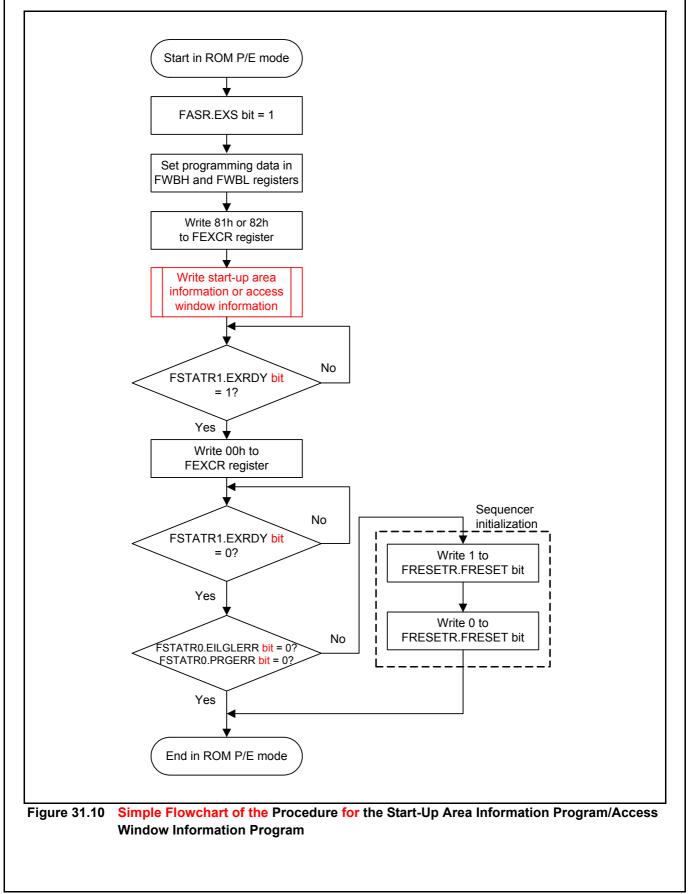
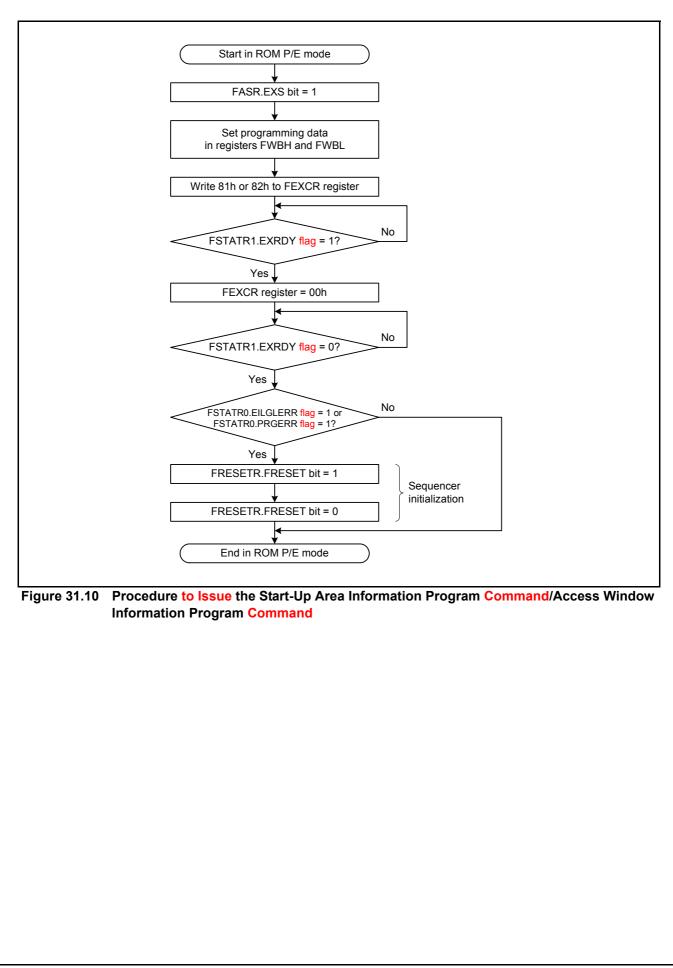
• Page 869 of 966

Figure 31.10 in (4) Start-Up Area Information Program/Access Window Information Program of 31.6.3 Software Command Usage is corrected as follows:
