[Notes]
e² studio Smart Configurator Plug-in,
Smart Configurator for RX

R20TS0638ES0100 Rev.1.00 Dec. 01, 2020

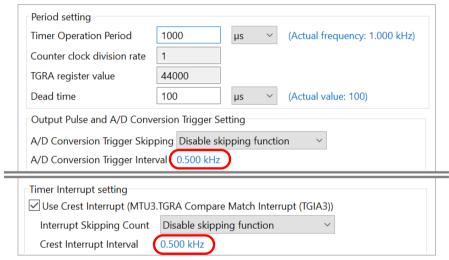
Figure.1.2 Example of incorrect A/D Conversion Trigger Interval and Crest Interrupt Interval

These may also display incorrect values, however they do not affect generated code.

Incorrect A/D Conversion Trigger Interval and Crest Interrupt Interval Input clock frequency: 80MHz

Correct interval: 1kHz

To obtain correct TGRA register value, please do either of the following:

- Delete and re-input the dead time value
 - 1) Delete dead time value

- Change the unit of dead time once and restore to original settings
- 1) Change the unit of dead time

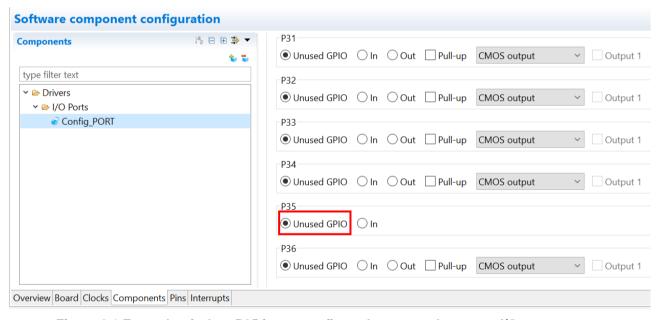
Figure 2.1 Example of when P35 is not configured as general purpose I/O port

When loading a project that meets the following (a) and (b), if you click the "Generate Code" button without opening the port component configuration GUI, redundant codes with DSCR/DSCR2 registers' settings will be generated in the initialization API. This then will cause a build error.

- (a) A project is created in Smart Configurator for RX V2.5.0 or earlier
- (b) P35 is not configured as general purpose I/O port in the port configuration

When loading a project with port configuration created in V2.5.0 or version before into V2.6.0 version onwards, please assure to open the port configuration GUI first before clicking the "Generate Code" button.
