Thank you for purchasing the PG-FP5 flash memory programmer.

This document describes specifications that have been added or changed, restrictions, and cautions on using the PG-FP5. Also see the user's manual of the PG-FP5 for terminology and points for caution on using the PG-FP5.

Chapter 1 Product Version

Chapter 2 Additions and Changes to Specifications

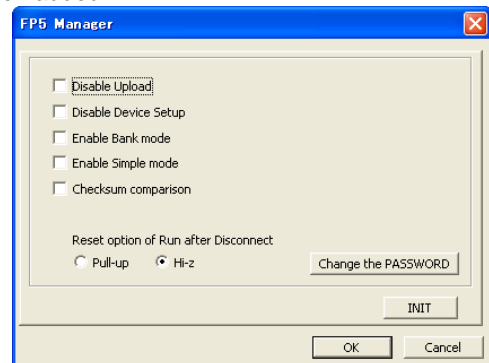
No. 2 Addition of FP5 Manager functions

Description: The following FP5 Manager functions have been added.

- Password function
- Upload disable function
- Device setup disable function
- Bank mode enable function
- Simple mode enable function
- Checksum compare function
- Reset pin characteristics switch function

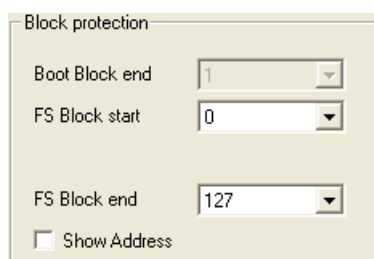
Before change

No. 16 Change of layout in **Block protection** area

Description: The layout in the **Block protection** area has been changed.

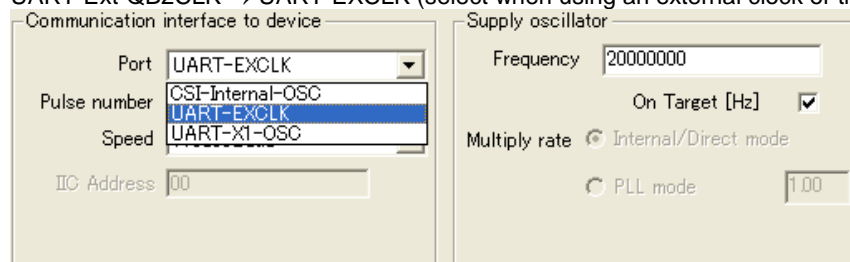
[No. 26 Writing to 78K0 microcontrollers by using an external UART clock](#)

Description: When writing to 78K0 microcontrollers by using UART communication, the PG-FP5 can now perform writing to a target system in which an external clock is input to the microcontroller's EXCLK pin. To enable this feature, select **UART-EXCLK** in the **Port** list box, select the **On Target** check box, and input the relevant frequency to the **Frequency** box.

Along with the addition of this feature, the options in the **Port** list box have been changed as follows:

UART-Ext-OSC → UART-X1-OSC (select when using an external resonator clock)

UART-Ext-QB2CLK → UART-EXCLK (select when using an external clock or the FP5 clock)
