RENESAS TECHNICAL UPDATE

Product Category	MPU & MCU	Document No.	TN-16C-A190A/E	Rev.	1.00
Title	Errata to R32C/116 Group Hardware Manual		Information Category	Technical Notification	
Applicable Product	R32C/116 Group	Lot No.	Reference Document	R32C/116 Group Hardware Manual Rev. 1.00 (REJ09B0532-0100)

This document describes corrections to the R32C/116 Group Hardware Manual, Rev. 1.00.
The corrections are indicated in red in the list below.

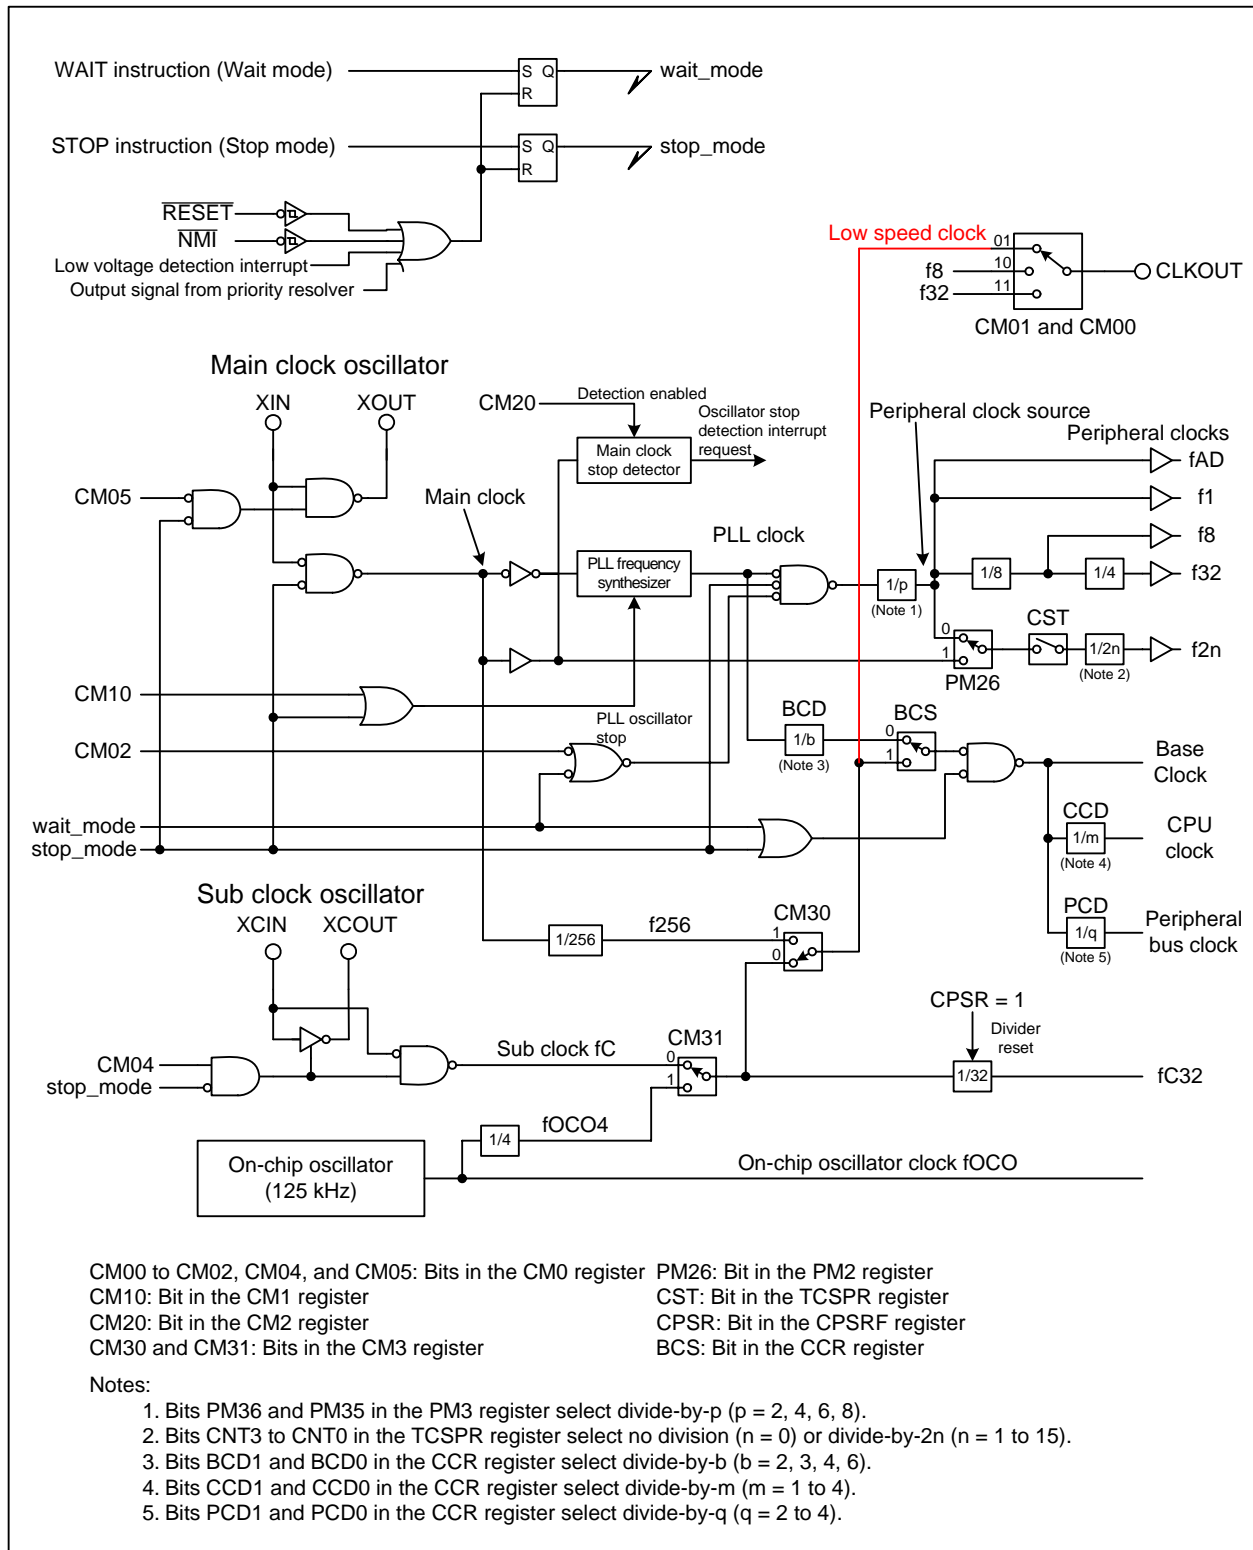
Figure 8.1 Clock Generation Circuitry

•Page 69 of 516, Figure 8.1 is corrected as follows:

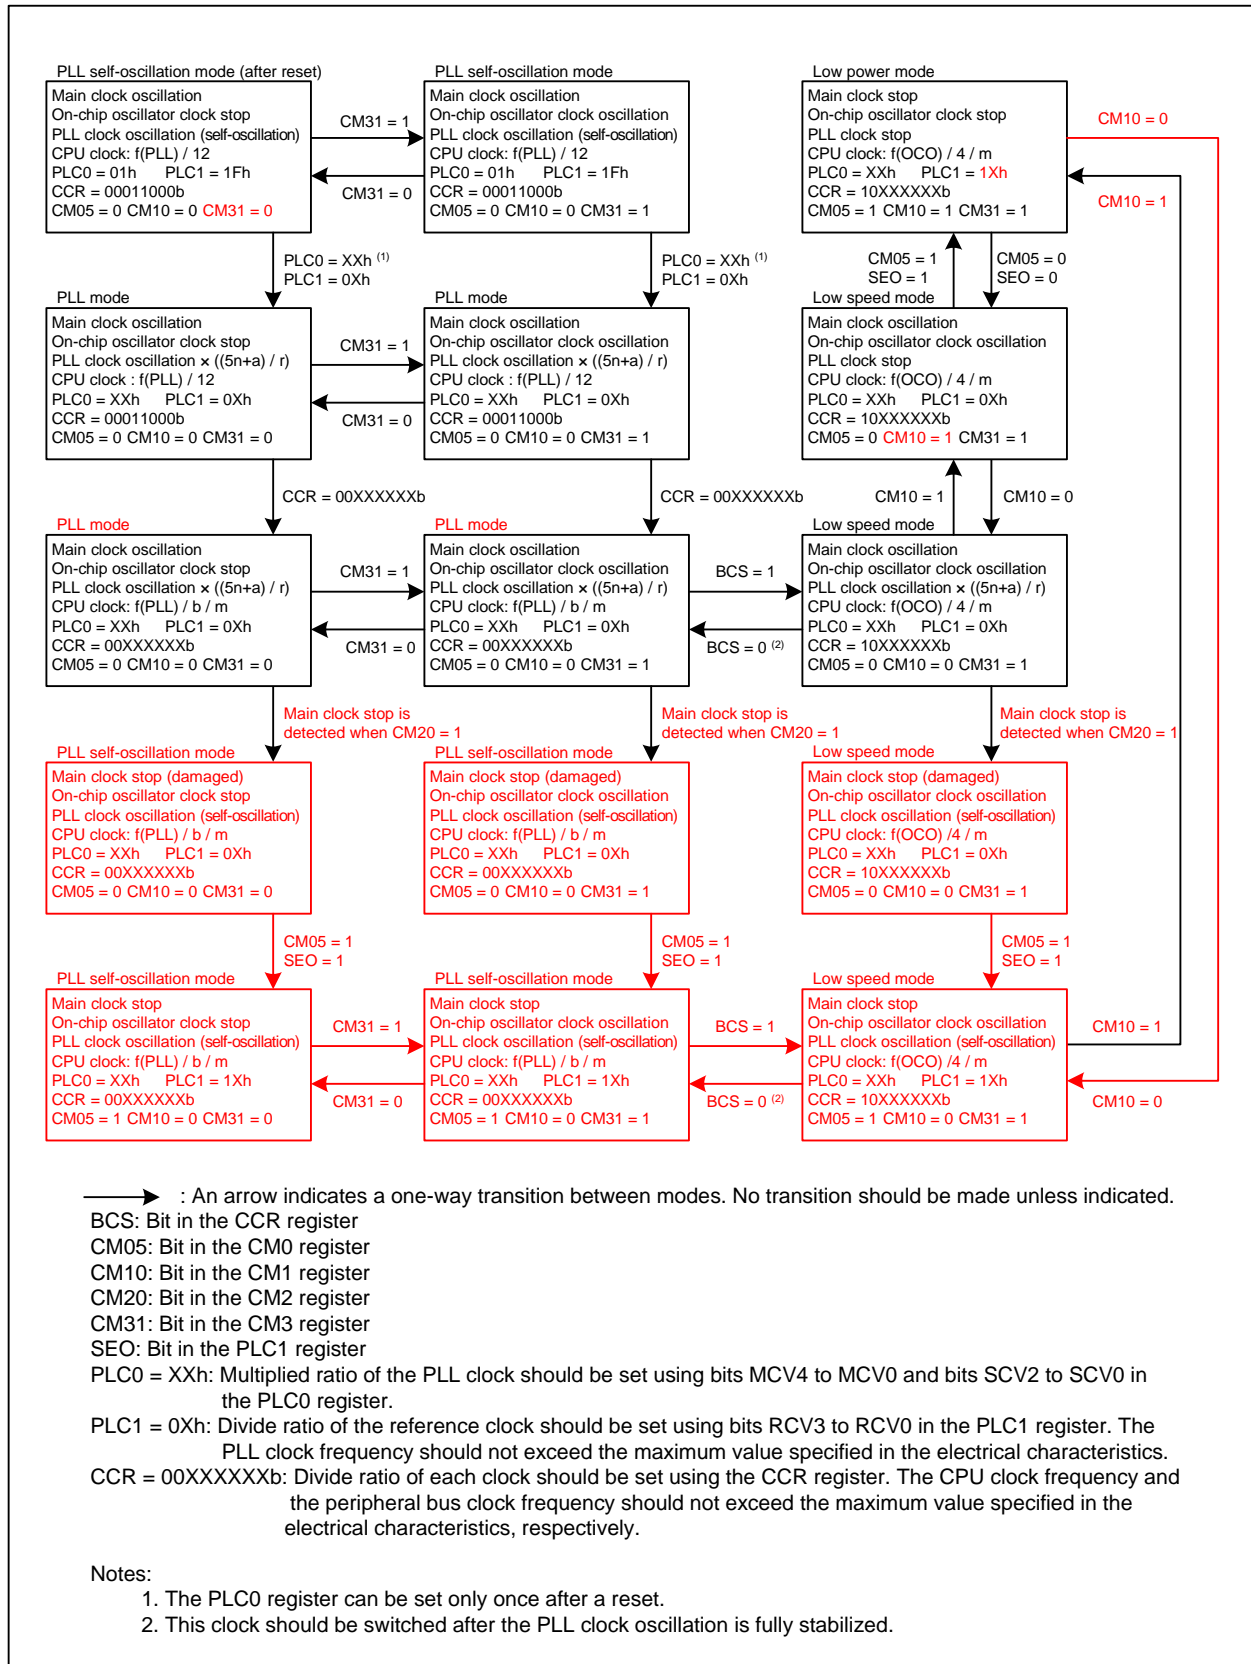
Figure 8.19 State Transition (when the on-chip oscillator clock is used)

•Page 89 of 516, descriptions of “CM31 = 1” in the first row and “CM10 = 0” in the second row in Figure 8.19 are corrected, and the flowchart are clarified as follows:

(Note 3 “The CM05 bit is not set to 1 when an oscillator stop is detected through the oscillation stop detector.” is deleted from Figure 8.19)

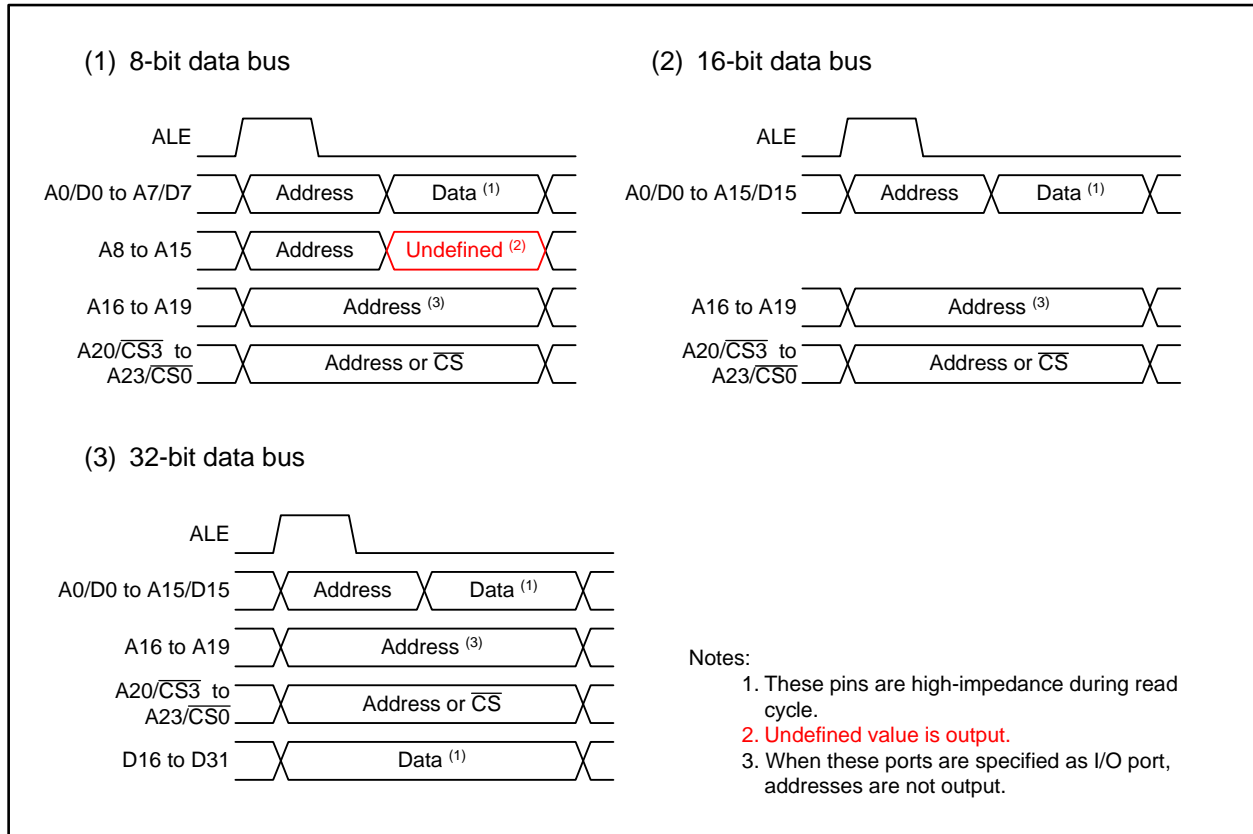
Figure 9.15 ALE Signal and Address Bus/Data Bus

•Page 117 of 516, Figure 9.15 is corrected as follows:

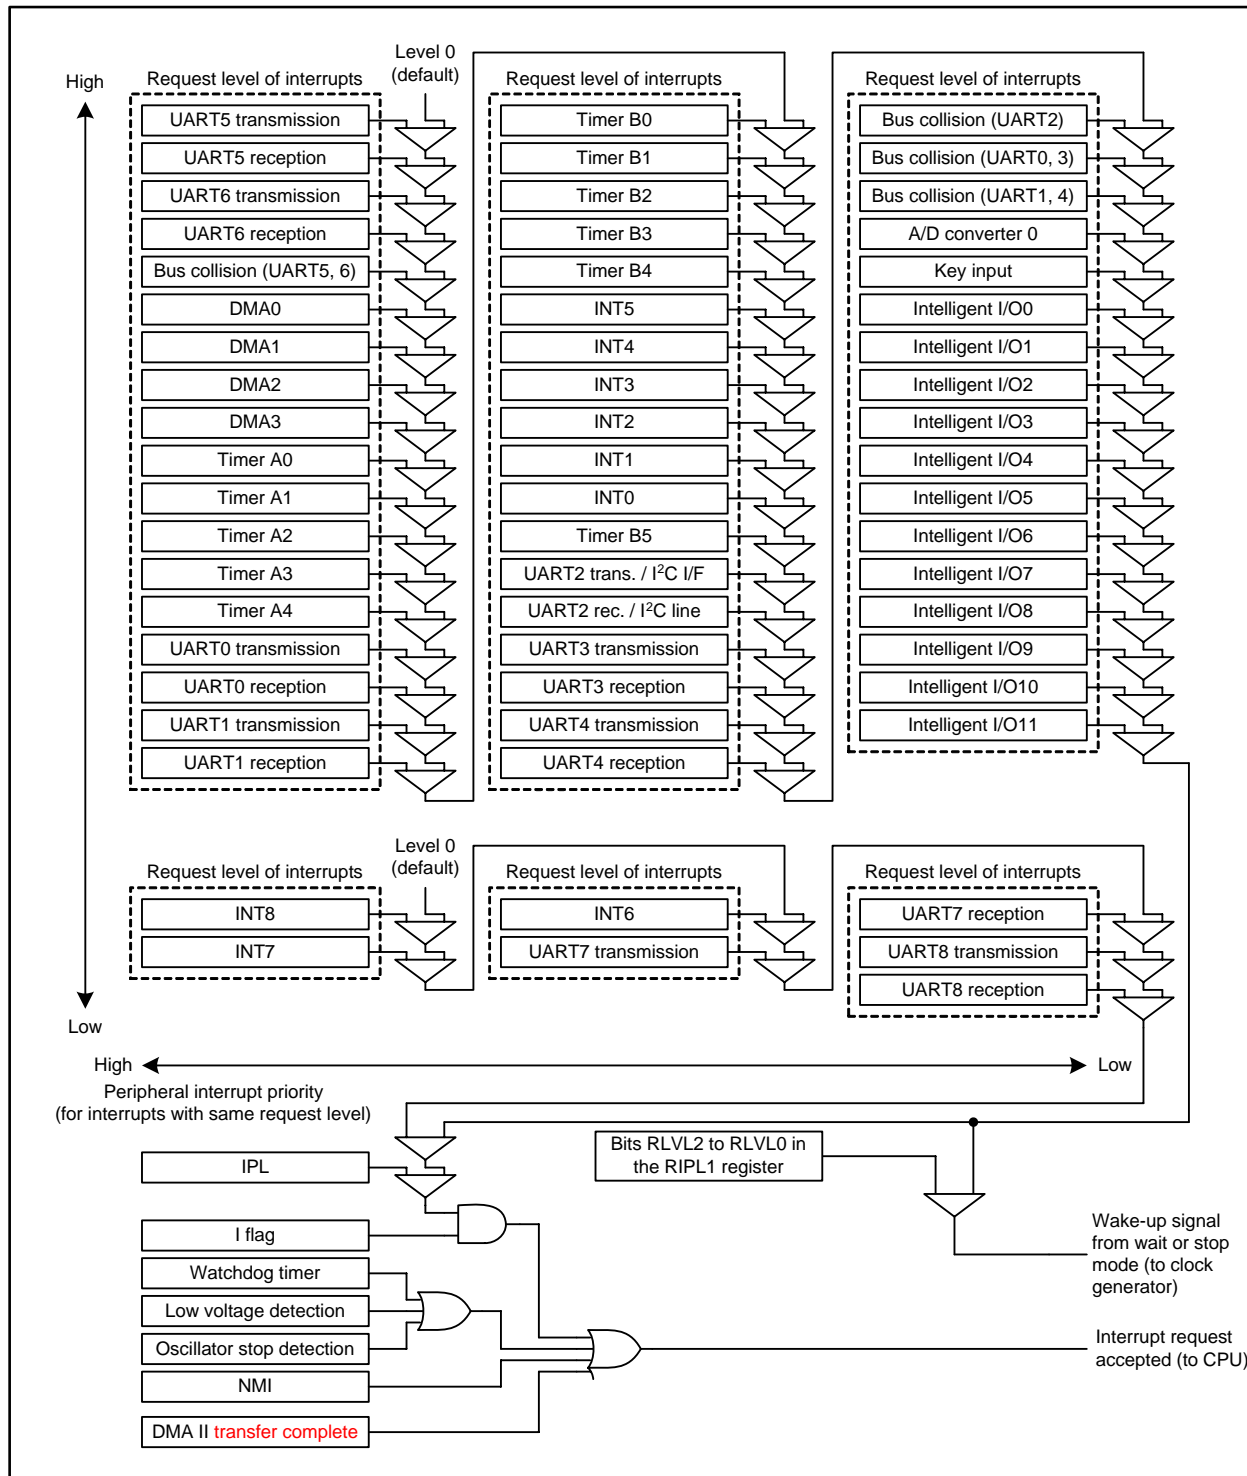
Figure 11.8 Priority Resolver

•Page 144 of 516, Figure 11.8 is corrected as follows:

(Description “Bits RLVL2 to RLVL0 in the RIPL2 register” and associated signal lines are deleted from Figure 11.8)

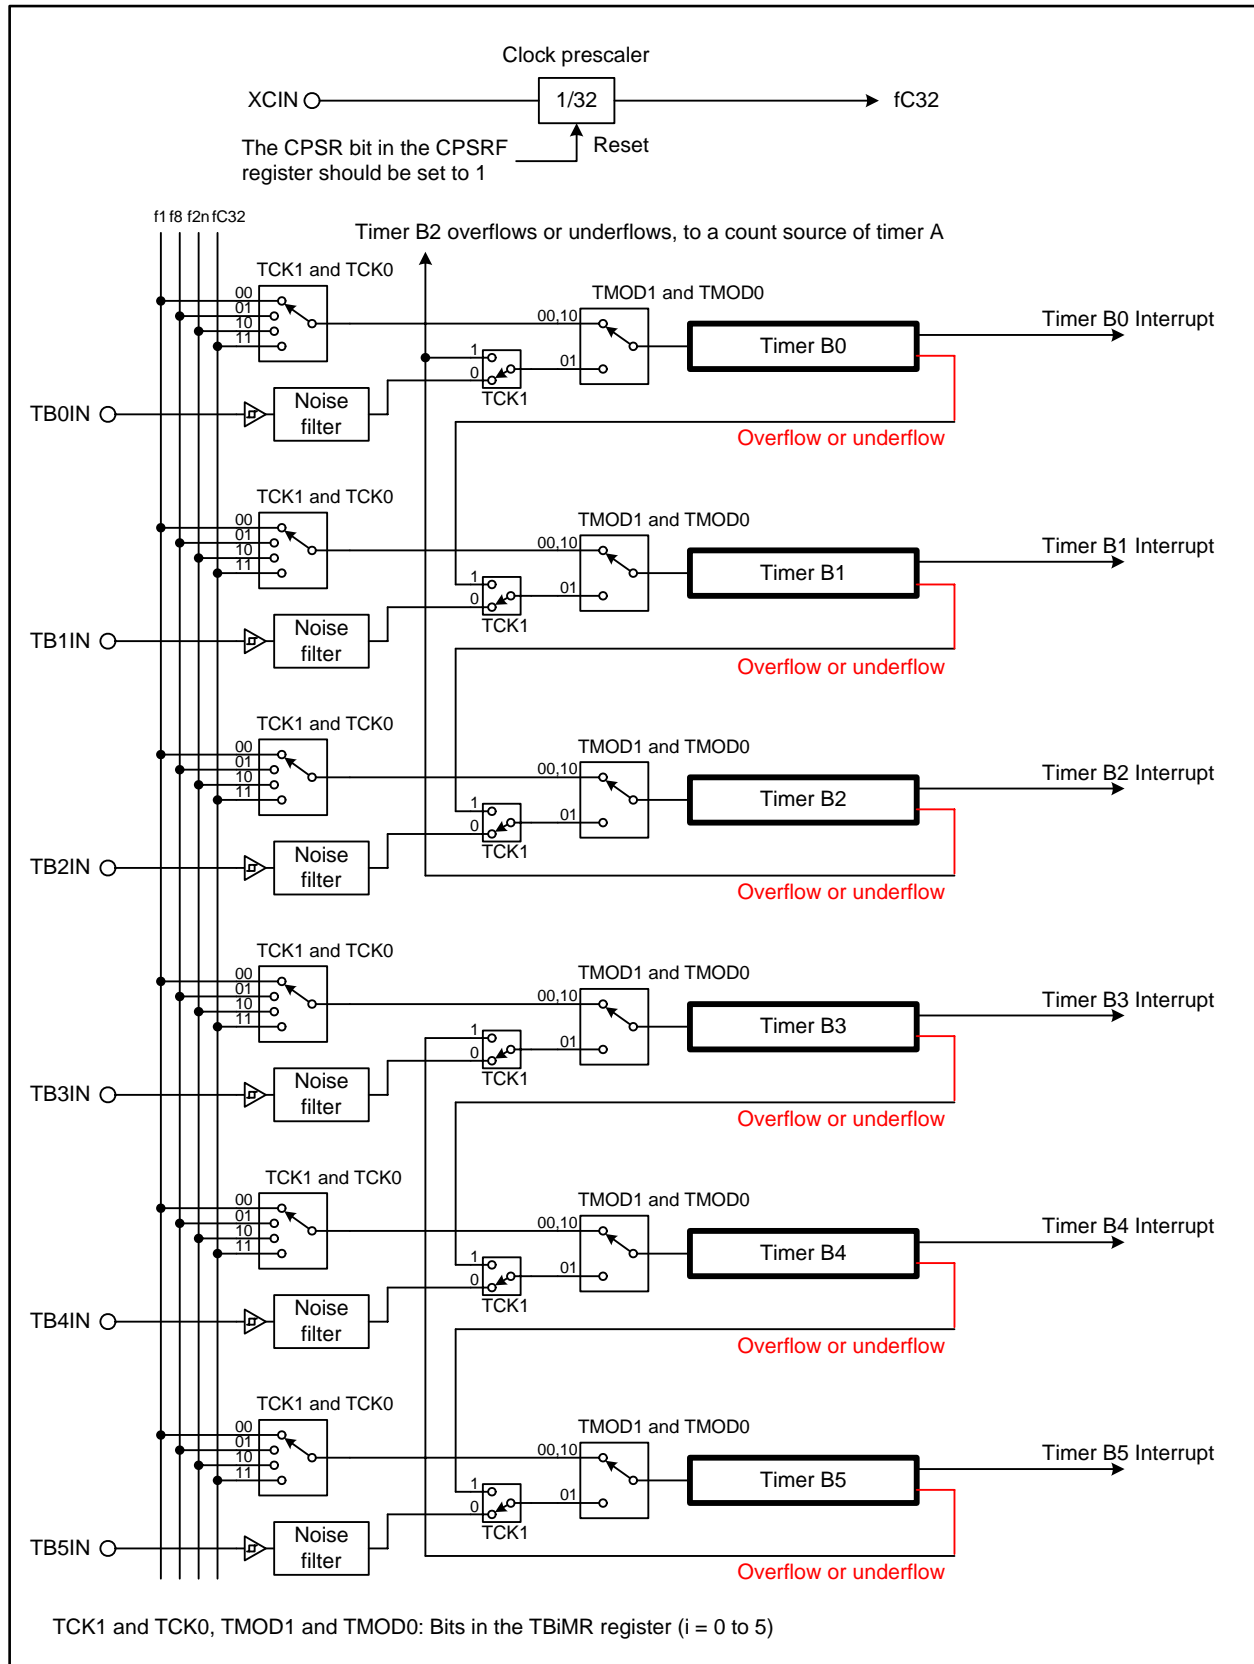
Figure 16.2 Timer B Configuration

•Page 182 of 516, Figure 16.2 is corrected as follows:

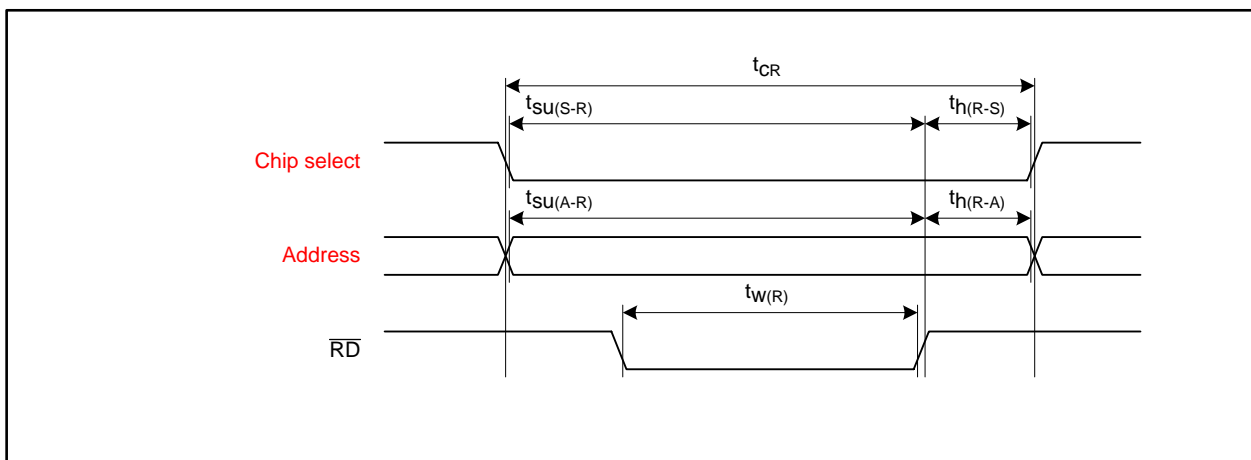
Figure 26.13 Read Timing

•Page 436 and 438 of 516, descriptions in Figures 26.13, 26.14, and 27.5 are corrected as follows:
