[Notes]

R20TS0895EC0100
Rev.1.00
Dec. 01, 2022

e² studio Smart Configurator for RL78 Plug-in,
Smart Configurator for RL78

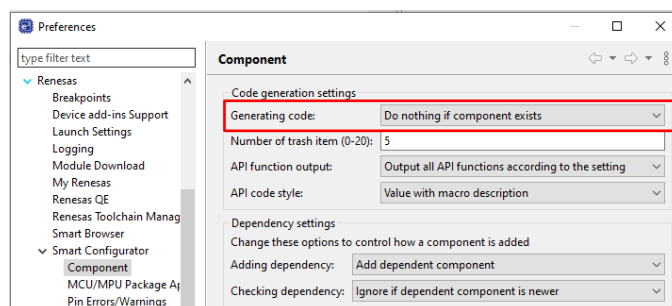
Figure 1-3 “Do nothing if component exists” setting

2. When using Smart Configurator (V1.0.1 or later) and preferences setting [Smart Configurator] > [Component] > [Generating code] selects “Do nothing if component exists”
