Application Note

Shared IRQ Line Considerations

AN-PM-059

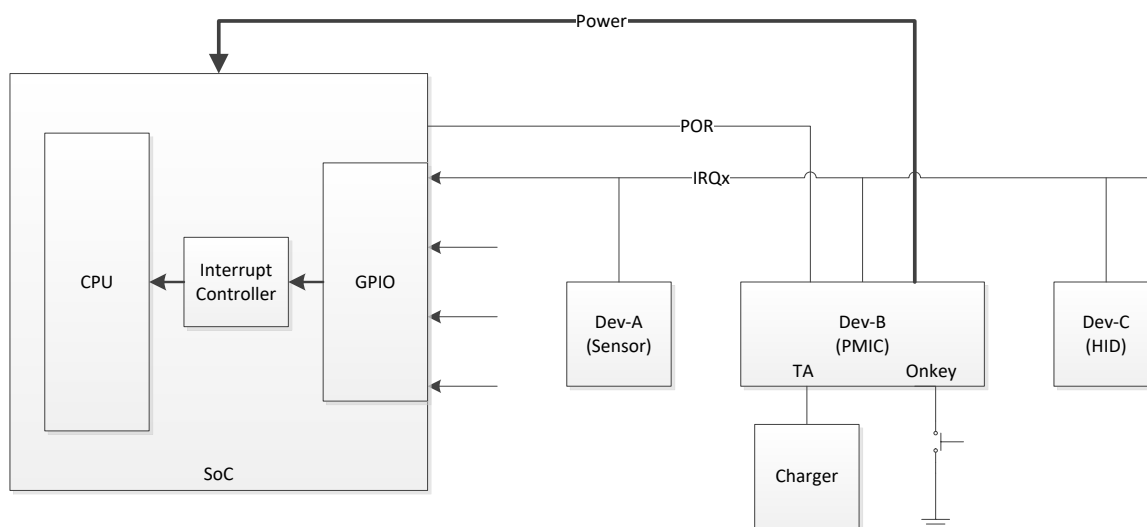
Figure 1: Shared Interrupt Line Block Diagram Example

Figure 1 diagram shows a typical system where a Dialog PMIC delivers power to the SoC and shares the IRQx input with two other devices.

Each device has its own software interrupt service routine (ISR). These ISRs are called in turn by the operating system once the IRQx is received.

7. If an ISR for either Dev-A or Dev-C is called before the PMIC device driver has been installed, the CPU may repeatedly call the Dev-A and/or Dev-C ISR as the interrupt line will still be held by Dev-B (PMIC).
