Customer Notification

EWRL78 V2.xx/V3.xx/V4.xx

Embedded Workbench® for RL78 V2.xx/V3.xx/
V4.xx

Operating Precautions

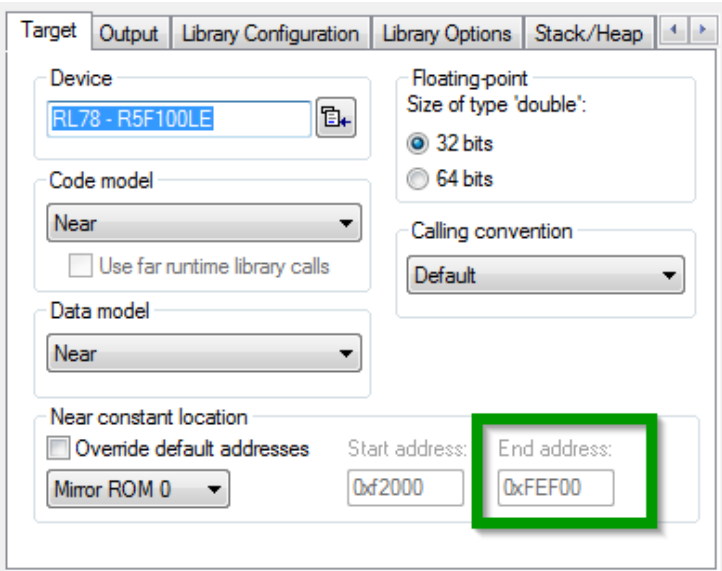
No. A3	<p>Wrong mirror end address</p>
<p><u>IAE Reference</u> EWRL78-541</p> <p><u>Details</u> The mirror area end address displayed in the project settings dialog is set to the real end-address plus one instead of the just the end-address. This does not affect the linked code which uses correct values.</p>

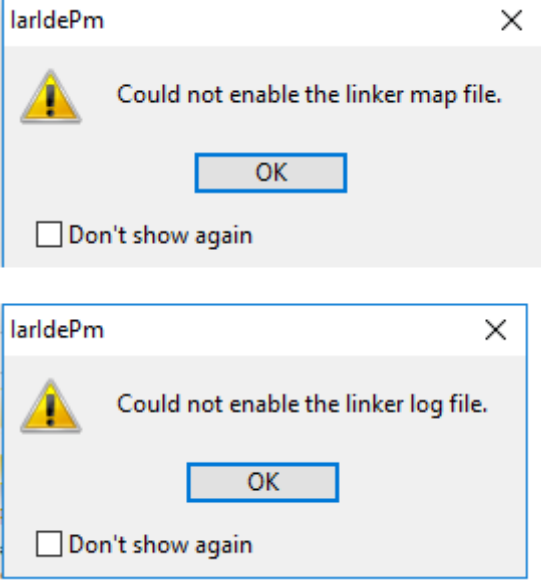
<p><u>Workaround</u> If enough Flash memory is available, don't use a mirror area of size zero.</p>
No. A5	Loading of .ipcf file generates warnings
	<p><u>IAR Reference</u> IDE-2878</p> <p><u>Details</u> During the load procedure "Add Project Connection..." of an *.ipcf file the following warnings might occur:</p>

<p><u>Workaround</u> Press the "OK" button and ignore the messages.</p>

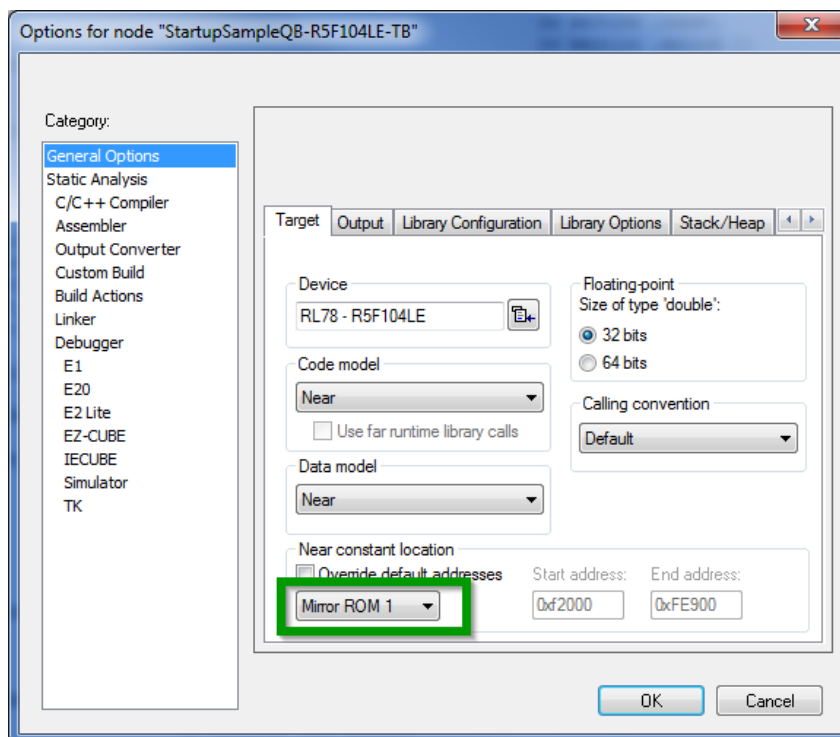
No. A6 **The symbol `_NEAR_CONST_LOCATION_SIZE` will be wrong calculated if Mirror ROM 1 is selected**

The symbol `_NEAR_CONST_LOCATION_SIZE` will be wrong calculated if Mirror ROM 1 is selected as shown below:

Replace `_NEAR_CONST_LOCATION_SIZE` in the linker file at the following two places with the correct size.

$$_NEAR_CONST_LOCATION_SIZE = 0xFE900 - 0xF2000 = 0xC900$$

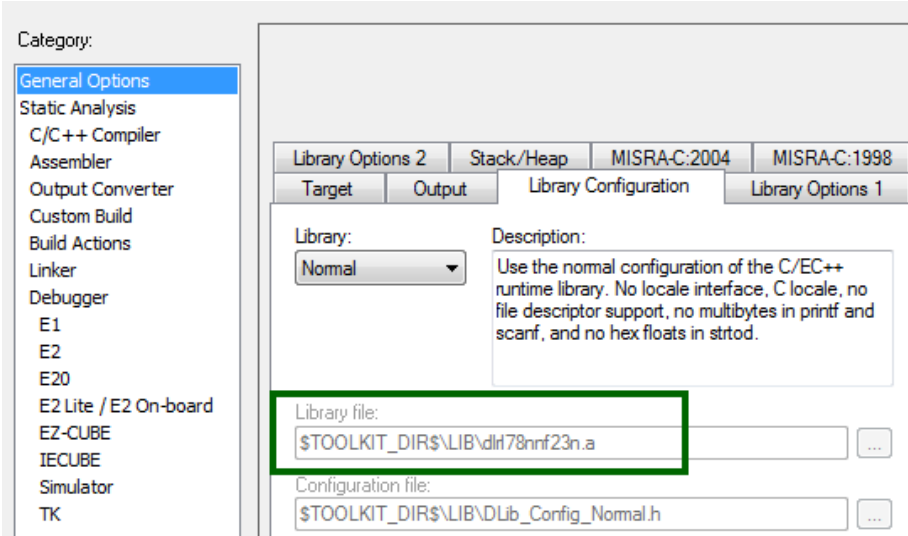
No. A9	<p>Library Configuration tab under General Options displays the old style of library names</p>
<p><u>IA Reference</u> EWRL78-763</p> <p><u>Details</u> The Library Configuration tab under General Options displays the old style of library names instead of the new one used by V4.10</p> <p>Example:</p> <p>The library file in the following example should be dlrlnnf23n.a instead of dlrl78nnf23n.a:</p>

<p><u>Workaround</u> Please ignore the displayed library file. Internally the correct file will be used.</p>

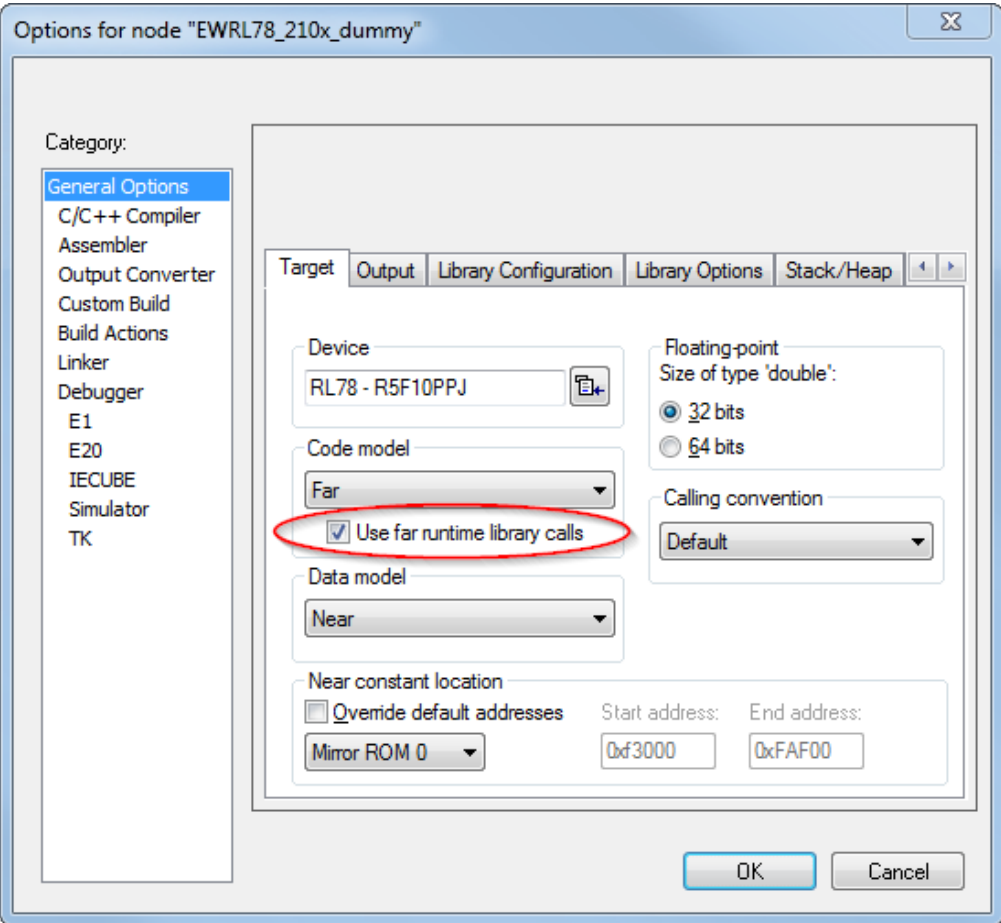
No. D1	<p>Runtime Model Conflict using far Runtime-Library-Calls</p>
	<p><u>IAR Reference</u> EW25570</p> <p><u>Details</u> In case of using far runtime-library-calls, the following linker error occurs as a matching runtime library variant is missing:</p> <pre>Error[Li009]: runtime model conflict: Module __dbg_xxexit.o(dbgrl78fnf23d.a) specifies that '__far_rt_calls' must be 'false', but module <xxxxx.o> has the value 'true'</pre> <p>Using far runtime library calls is only necessary, if the runtime library itself shall be executed in RAM. The feature can be enabled in the GUI or by compiler command line option "--generate_far_runtime_library_calls" :</p>

<p><u>Workaround</u> Use a customer specific runtime library build with option 'Using far runtime library calls' enabled.</p>

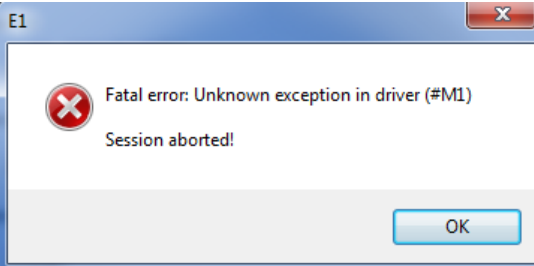
No. E4	E1 C-SPY Driver: Step-in Step over doesn't work for switch case construct with more than 99 cases
	<p><u>JAR Reference</u> EW25950</p> <p><u>Details</u> Temporary breakpoints are used for example in case of a single-step at C level. If you exceed the number of available temporary breakpoints that the OCD driver has allocated space for, an error is generated.</p>

<p><u>Workaround</u> Step at assembler level instead of at C level.</p>

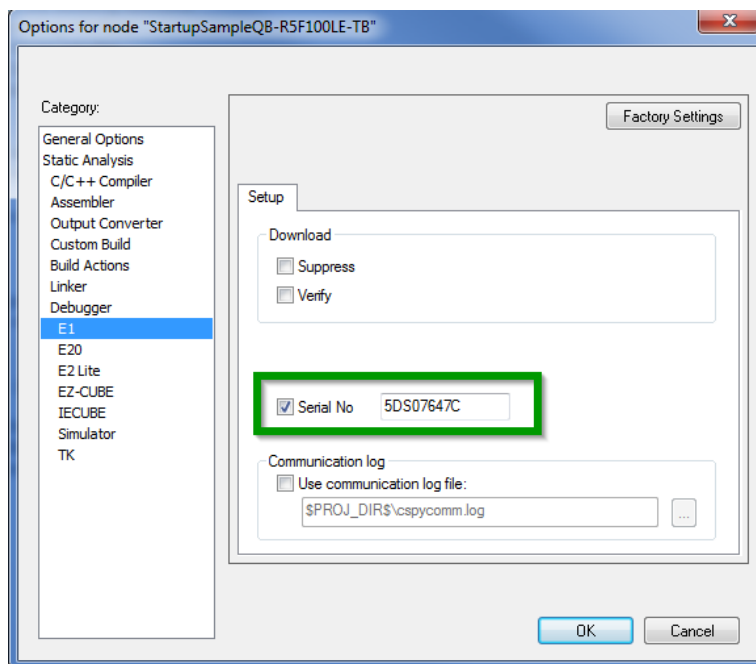
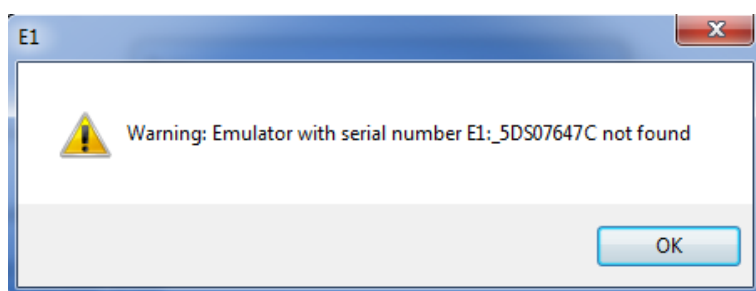
The E1 serial number defined by the user will sometimes not be found whereas it is the correct one.

The debugger will throw the following warning and the debug session will be terminated.

In case there is only one E1 required you can use the automated detection of the E1 instead of entering the serial number. Please uncheck the "Serial No" checkbox in that case.

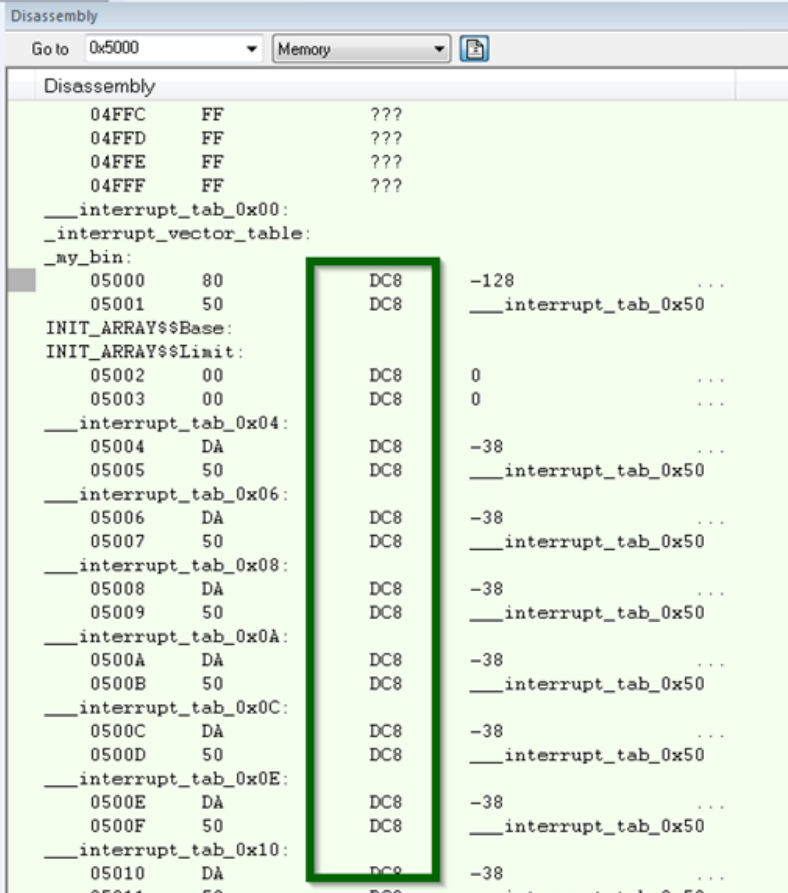
No. E10	<p>Binary image not showing symbol info in “Disassembly” window</p>
<p><u>JAR Reference</u> EWRL78-672</p> <p><u>Details</u> During the build process of an application it is possible to link a pure binary file via the linker option <code>-image_input</code>. The content of the binary file could be code or constant data. However, in the debug session the “Disassembly” window always represents that content as a constant even if an additional debug file with code is loaded to the same area.</p>

<p><u>Workaround</u> None</p>
