Customer Notification

EWRL78 V1.xx

Embedded Workbench® for RL78 V1.xx

Operating Precautions

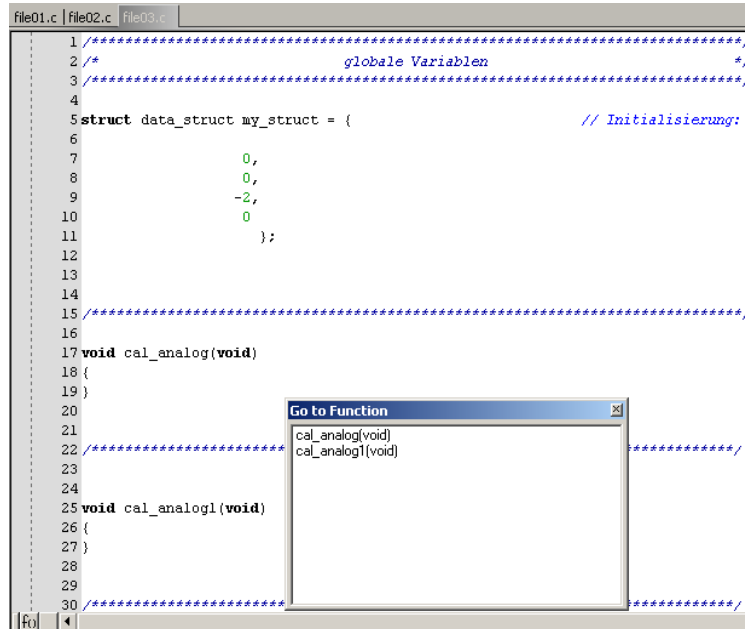
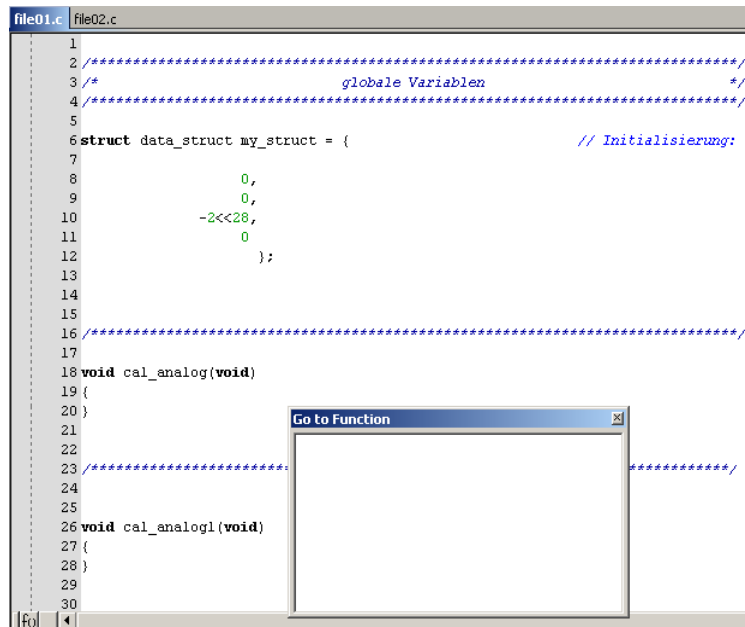
Depending on some source code constructions (e.g. using shift operator to initialize a structure element) the Go to Function Window may be empty.
 Correct Go to Function Window:

Empty Go to Function Window although there are several functions defined in the active source file:

None. The problem will be fixed in the next EWRL78 platform update.

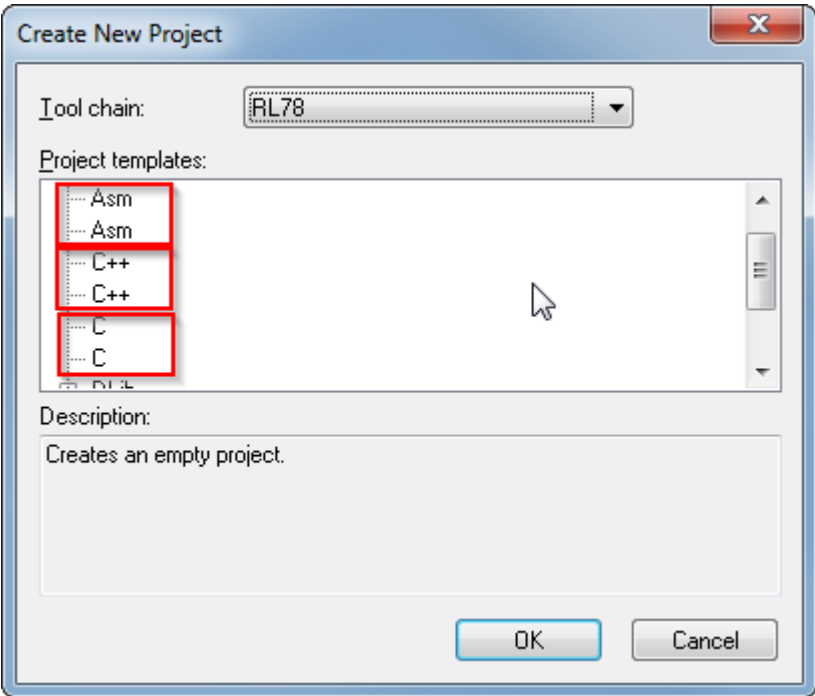
No. A11	<p>Double Entries in Create New Project Dialogue</p>
	<p><u>IAR Reference:</u> EWxxxxx</p> <p><u>Details</u></p> <p>Due to a problem in localization of EWRL78 there are double entries for each project template in the 'Create New Project Dialogue':</p>

<p>The created project templates are correct, it is only a display issue.</p> <p><u>Workarounds</u></p> <p>Please replace some files by the files included in patch 'EWRL78_V1.40.6_UpdateProjectTemplate.zip'.</p>

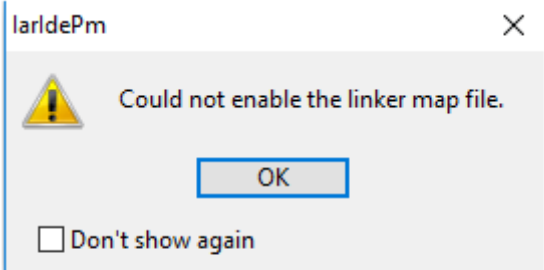
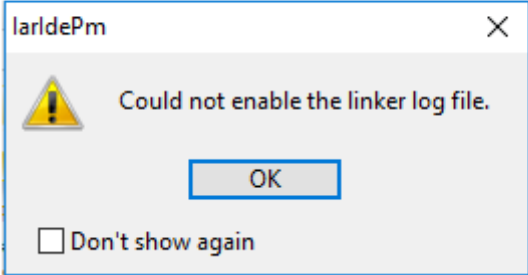
No. A14	Loading of .ipcf file generates warnings
<p><u>IAR Reference:</u> IDE-2878</p> <p><u>Details</u></p> <p>During the load procedure “Add ProjectConnection...” of an *.ipcf file the following warnings might occur:</p> <div data-bbox="612 524 1158 792">

A screenshot of a Windows-style warning dialog box titled 'IarIdePm'. It features a yellow warning triangle icon on the left. The text reads 'Could not enable the linker log file.' Below the text is an 'OK' button and a checkbox labeled 'Don't show again' which is currently unchecked.</div> <p><u>Workarounds</u> Press the “OK” button and ignore the messages.</p>

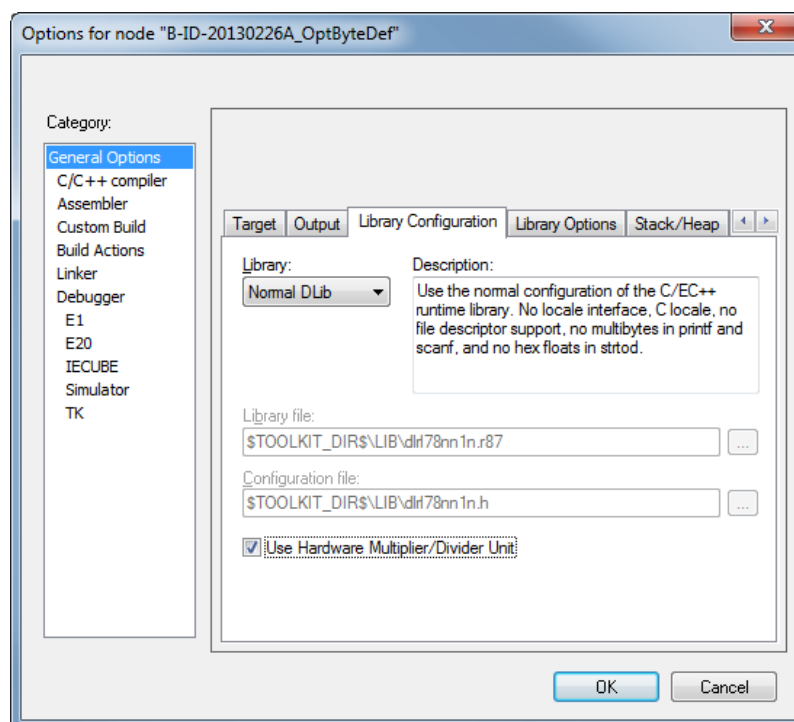
The signed division functions using the hardware multiplier/divider used as replacement for the IAR runtime library functions for signed divisions are not interrupt-safe. Affected are all RL78 Core2 devices, e.g. series RL78/G14, RL78/F13, RL78/F14

If a signed division is interrupted and a second division shall be executed in the ISR, the first division result may be wrong.

- 1) [Download the update V1.05 of the HW-MDU functions](#) and replace the existing module 'hwmdu_LibReplacement.s87' in your application.

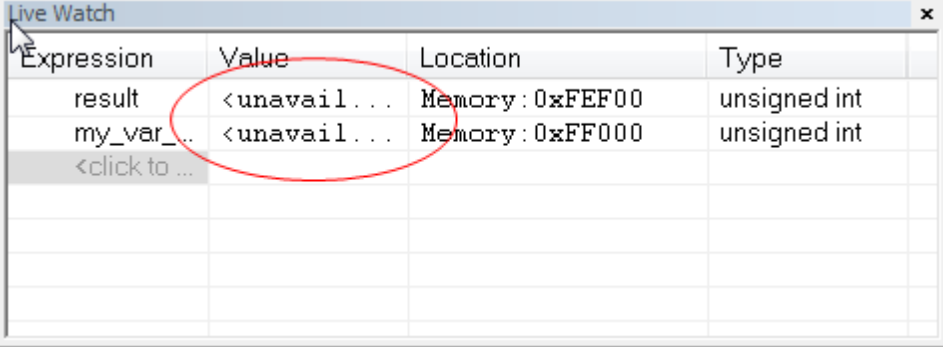
No. E9	E1 C-SPY Driver: No automatic Mapping for Variables added to Live Watch Window
<p><u>Details</u></p> <p>Variables added to Live Watch Window are not updated automatically, because the automatic mapping doesn't work. Instead of the value <unavailable> is displayed.</p>

<p><u>Workaround</u></p> <p>As a temporary workaround until the next update patch is available please open the Live Memory Window and select the corresponding memory area for the variables listed in Live Watch Window.</p>

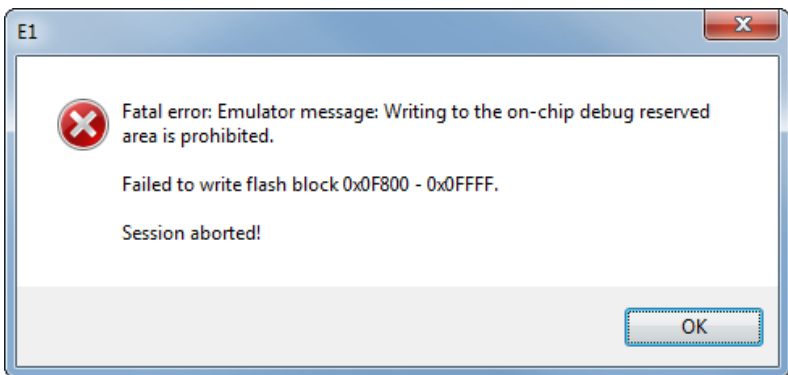
No. E28	E1 C-SPY Driver: Wrong Address area displayed in Error Message
	<p><u>IAR Reference</u> ---</p> <p><u>Details</u></p> <p>In case of using the E1 OCD emulator, the highest 256bytes of the Flash memory must be reserved as described in the RL78 E1 Manual Addendum. In case of a violation of this requirement, a debug session cannot be started and an error message occurs instead. In this error message instead of the highest 256 bytes the address range of the corresponding Flash memory block is displayed.</p> <div data-bbox="325 1137 1117 1509" style="border: 1px solid gray; padding: 10px; margin: 10px 0;">

</div> <p><u>Workaround</u></p> <p>Not necessary as the error message is correct.</p>
