Customer Notification

EWRL78 V2.xx/V3.xx/V4.xx

Embedded Workbench® for RL78 V2.xx/V3.xx/
V4.xx

Operating Precautions

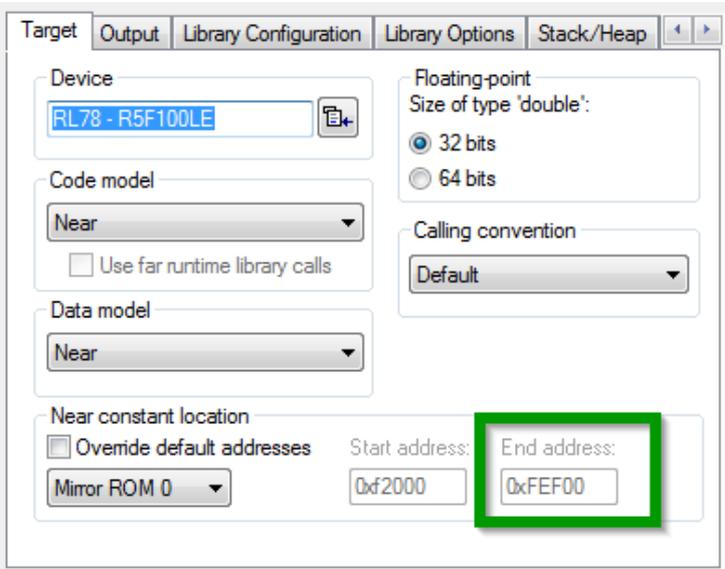
No. A3	<p>Wrong mirror end address</p>
<p><u>IAE Reference</u> EWRL78-541</p> <p><u>Details</u> The mirror area end address displayed in the project settings dialog is set to the real end-address plus one instead of the just the end-address. This does not affect the linked code which uses correct values.</p>

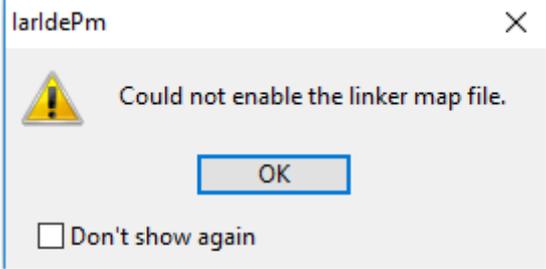
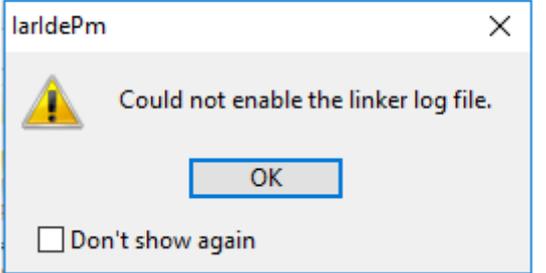
No. A5	<p>Loading of .ipcf file generates warnings</p>
<p><u>IAR Reference</u> IDE-2878</p> <p><u>Details</u> During the load procedure "Add Project Connection..." of an *.ipcf file the following warnings might occur:</p> <div data-bbox="612 1061 1158 1639" style="margin: 10px 0;">

</div> <p><u>Workaround</u> Press the "OK" button and ignore the messages.</p>

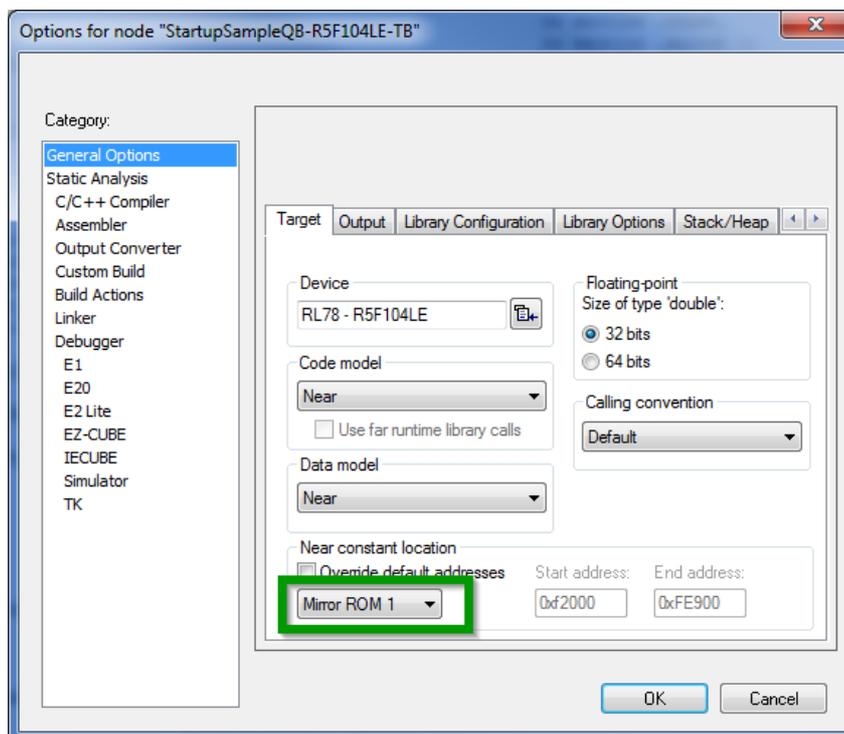
No. A6 **The symbol `_NEAR_CONST_LOCATION_SIZE` will be wrong calculated if Mirror ROM 1 is selected**

The symbol `_NEAR_CONST_LOCATION_SIZE` will be wrong calculated if Mirror ROM 1 is selected as shown below:

Replace `_NEAR_CONST_LOCATION_SIZE` in the linker file at the following two places with the correct size.

$$_NEAR_CONST_LOCATION_SIZE = 0xFE900 - 0xF2000 = 0xC900$$

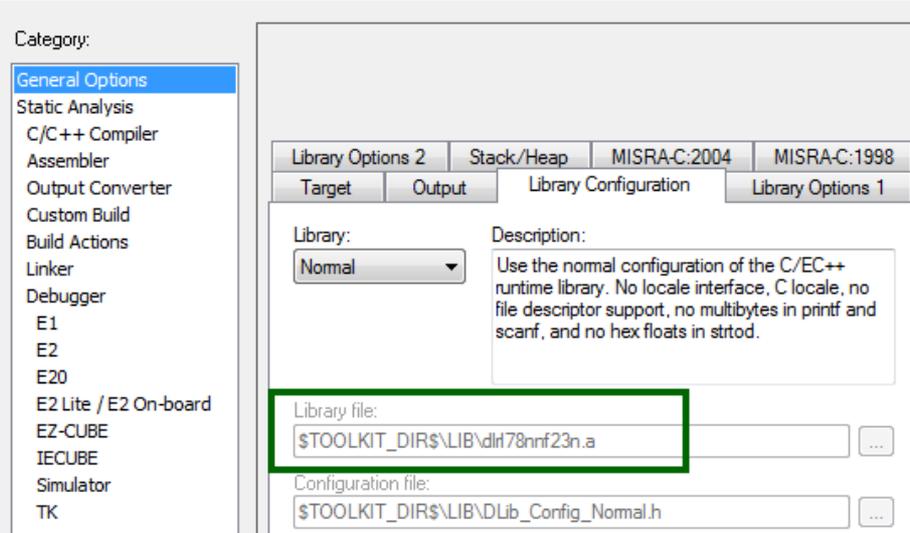
No. A9	<p>Library Configuration tab under General Options displays the old style of library names</p>
<p><u>IA Reference</u> EWRL78-763</p> <p><u>Details</u> The Library Configuration tab under General Options displays the old style of library names instead of the new one used by V4.10</p> <p>Example: The library file in the following example should be dlrlnnf23n.a instead of dlrl78nnf23n.a:</p>

<p><u>Workaround</u> Please ignore the displayed library file. Internally the correct file will be used.</p>

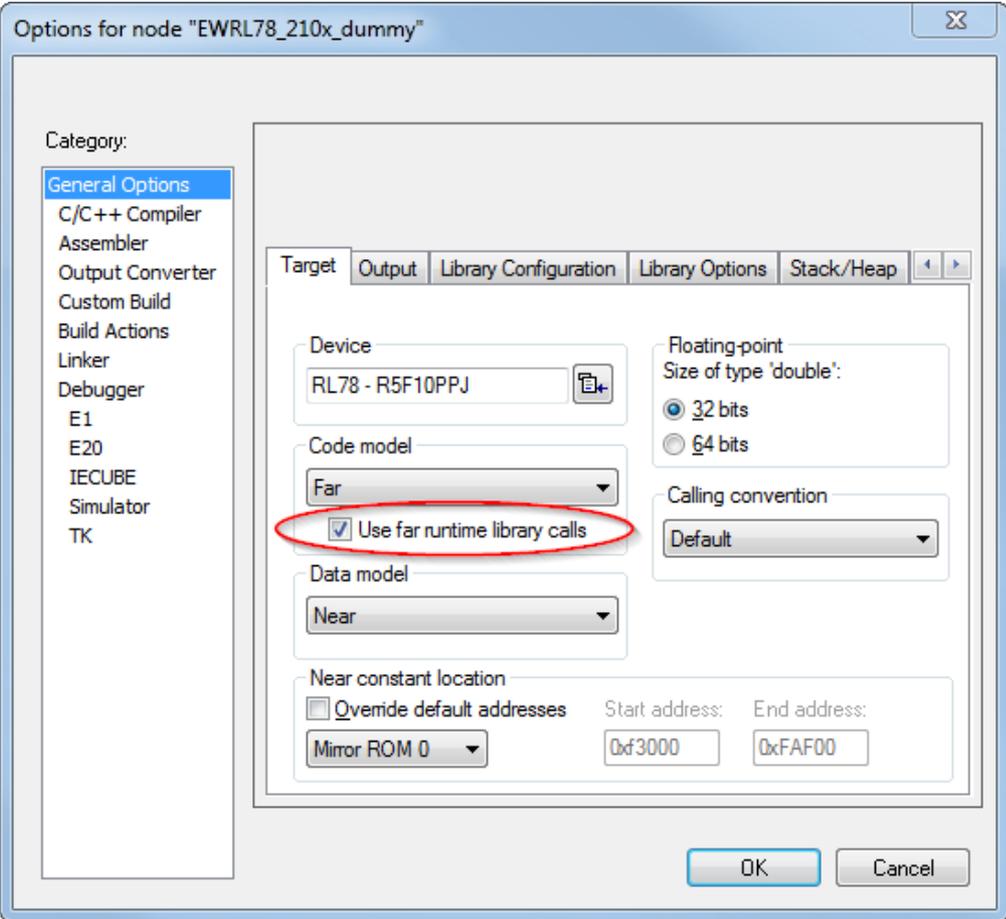
No. D1	<p>Runtime Model Conflict using far Runtime-Library-Calls</p>
	<p><u>IAR Reference</u> EW25570</p> <p><u>Details</u> In case of using far runtime-library-calls, the following linker error occurs as a matching runtime library variant is missing:</p> <pre>Error[Li009]: runtime model conflict: Module __dbg_xxexit.o(dbgrl78fnf23d.a) specifies that '__far_rt_calls' must be 'false', but module <xxxxx.o> has the value 'true'</pre> <p>Using far runtime library calls is only necessary, if the runtime library itself shall be executed in RAM. The feature can be enabled in the GUI or by compiler command line option "--generate_far_runtime_library_calls" :</p>

<p><u>Workaround</u> Use a customer specific runtime library build with option 'Using far runtime library calls' enabled.</p>

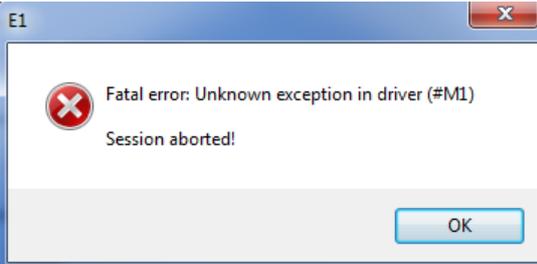
No. E4	E1 C-SPY Driver: Step-in Step over doesn't work for switch case construct with more than 99 cases
	<p><u>JAR Reference</u> EW25950</p> <p><u>Details</u> Temporary breakpoints are used for example in case of a single-step at C level. If you exceed the number of available temporary breakpoints that the OCD driver has allocated space for, an error is generated.</p>

<p><u>Workaround</u> Step at assembler level instead of at C level.</p>

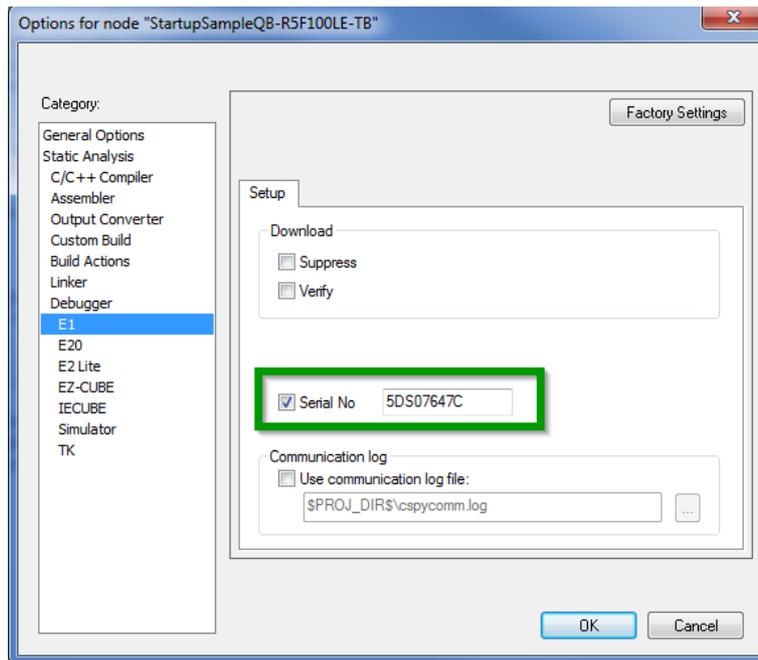
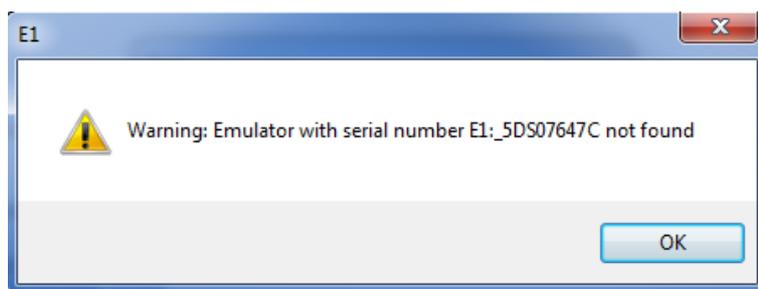
The E1 serial number defined by the user will sometimes not be found whereas it is the correct one.

The debugger will throw the following warning and the debug session will be terminated.

In case there is only one E1 required you can use the automated detection of the E1 instead of entering the serial number. Please uncheck the "Serial No" checkbox in that case.

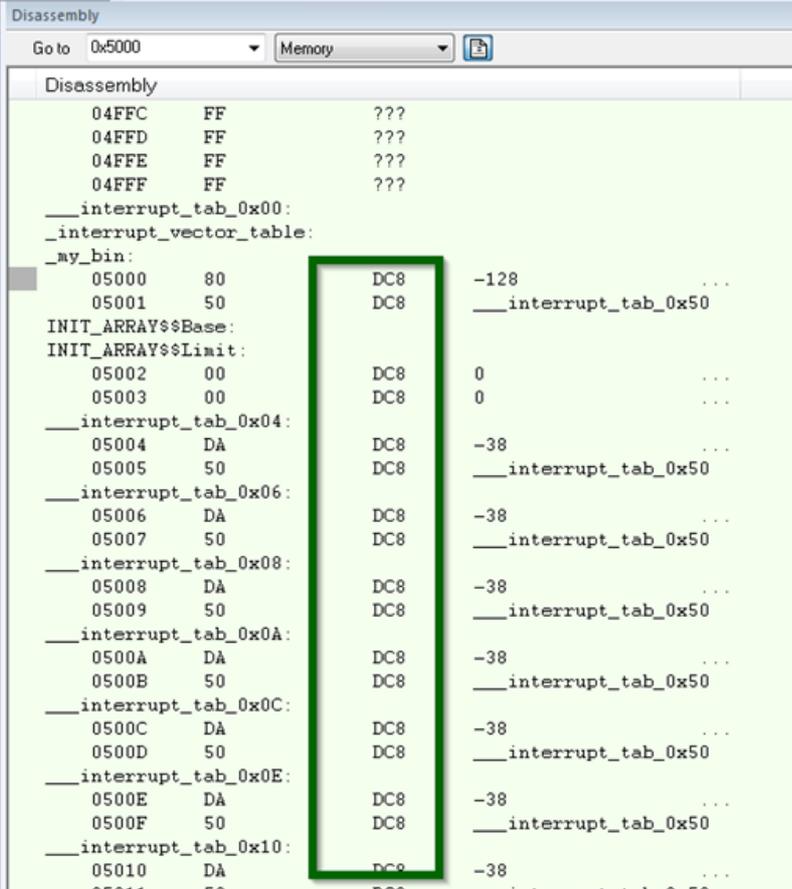
No. E10	<p>Binary image not showing symbol info in “Disassembly” window</p>
<p><u>IA Reference</u> EWRL78-672</p> <p><u>Details</u> During the build process of an application it is possible to link a pure binary file via the linker option <code>-image_input</code>. The content of the binary file could be code or constant data. However, in the debug session the “Disassembly” window always represents that content as a constant even if an additional debug file with code is loaded to the same area.</p>

<p><u>Workaround</u> None</p>
