Customer Notification

EWRL78 V2.xx/V3.xx/V4.xx

Embedded Workbench® for RL78 V2.xx/V3.xx/
V4.xx

Operating Precautions

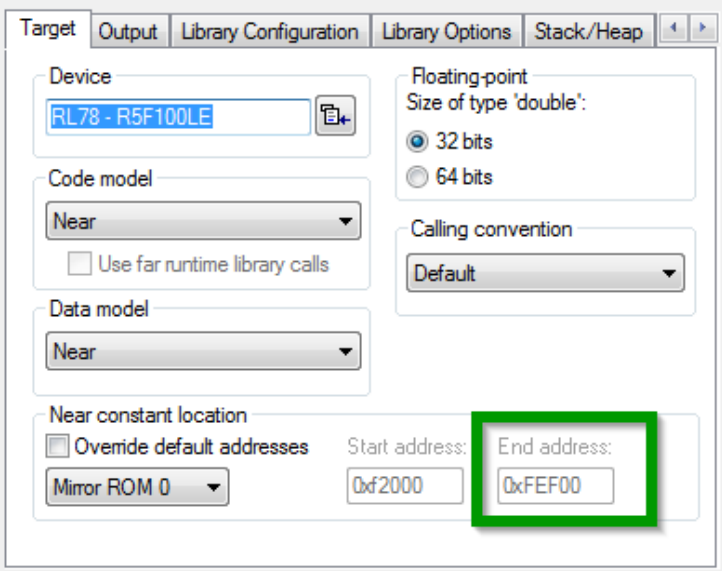
No. A3	<p>Wrong mirror end address</p>
<p><u>IAR Reference</u> EWRL78-541</p> <p><u>Details</u> The mirror area end address displayed in the project settings dialog is set to the real end-address plus one instead of the just the end-address. This does not affect the linked code which uses correct values.</p>

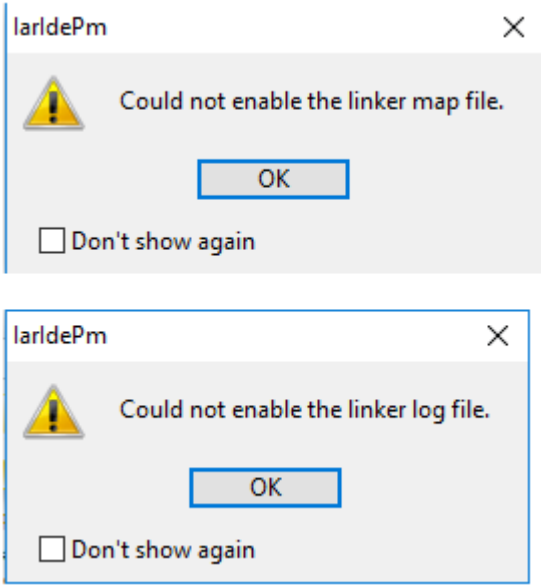
No. A5	<p>Loading of .ipcf file generates warnings</p>
	<p><u>IAR Reference</u> IDE-2878</p> <p><u>Details</u> During the load procedure “Add Project Connection...” of an *.ipcf file the following warnings might occur:</p>

<p><u>Workaround</u> Press the “OK” button and ignore the messages.</p>

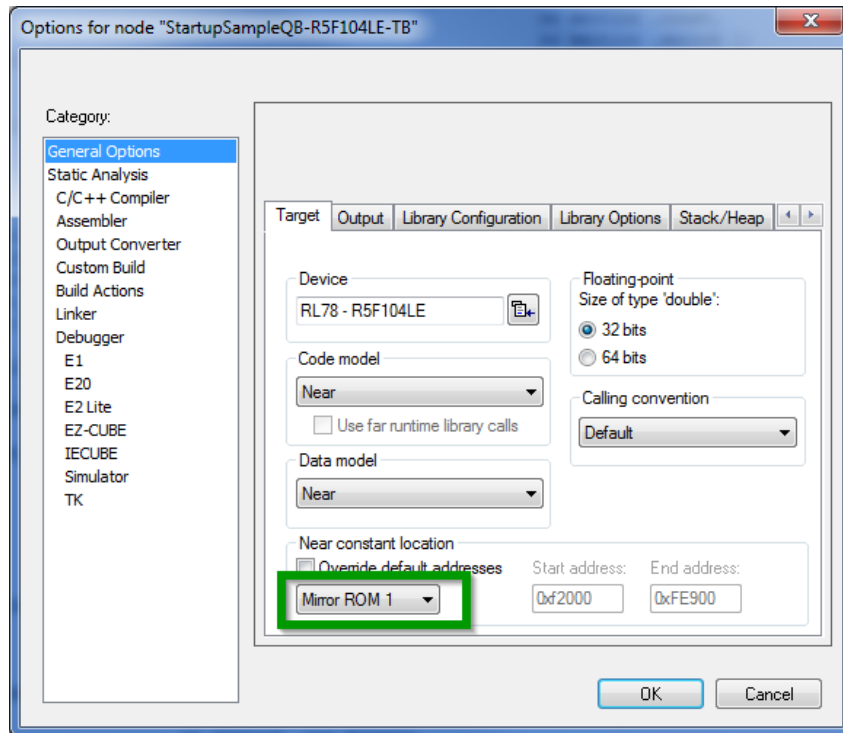
No. A6

The symbol `_NEAR_CONST_LOCATION_SIZE` will be wrong calculated if Mirror ROM 1 is selected

The symbol `_NEAR_CONST_LOCATION_SIZE` will be wrong calculated if Mirror ROM 1 is selected as shown below:

Replace `_NEAR_CONST_LOCATION_SIZE` in the linker file at the following two places with the correct size.

The size for the above screenshot values shall be calculated as follows
`_NEAR_CONST_LOCATION_SIZE = 0xFE900 - 0xF2000 = 0xC900`

The `define _NEAR_CONST_LOCATION_SIZE` shall be replaced within the linker file as follows:

```
define block MIRROR_ROM with maximum size = 0xC900 { ro R_CONST_init,
ro section .const_init, ro section .switch_init };
```

```
define block MIRROR_RAM with maximum size = 0xC900 { rw R_CONST, rw
section .const, rw section .switch };
```

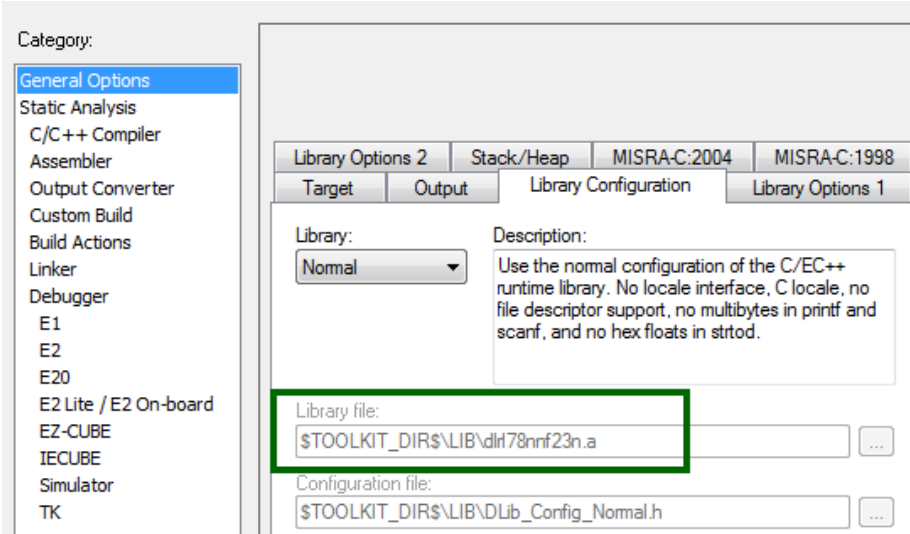
No. A9	<p>Library Configuration tab under General Options displays the old style of library names</p>
	<p><u>IAR Reference</u> EWRL78-763</p> <p><u>Details</u> The Library Configuration tab under General Options displays the old style of library names instead of the new one used by V4.10</p> <p>Example:</p> <p>The library file in the following example should be dlrl78nnf23n.a instead of dlrl78nnf23n.a:</p>

<p><u>Workaround</u> Please ignore the displayed library file. Internally the correct file will be used.</p>

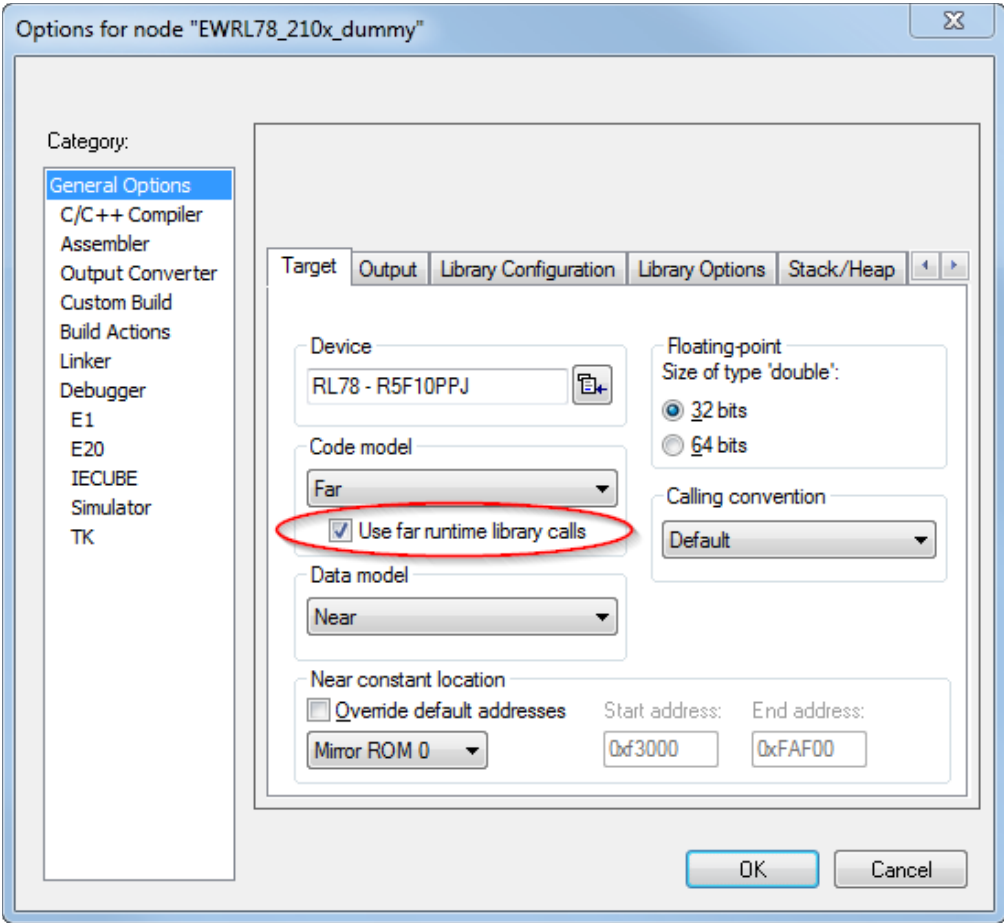
No. D1	<p>Runtime Model Conflict using far Runtime-Library-Calls</p>
	<p><u>IAR Reference</u> EW25570</p> <p><u>Details</u> In case of using far runtime-library-calls, the following linker error occurs as a matching runtime library variant is missing:</p> <pre>Error[Li009]: runtime model conflict: Module __dbg_xxexit.o(dbgrl78fnf23d.a) specifies that '__far_rt_calls' must be 'false', but module <xxxxx.o> has the value 'true'</pre> <p>Using far runtime library calls is only necessary, if the runtime library itself shall be executed in RAM. The feature can be enabled in the GUI or by compiler command line option "--generate_far_runtime_library_calls" :</p>

<p><u>Workaround</u> Use a customer specific runtime library build with option 'Using far runtime library calls' enabled.</p>

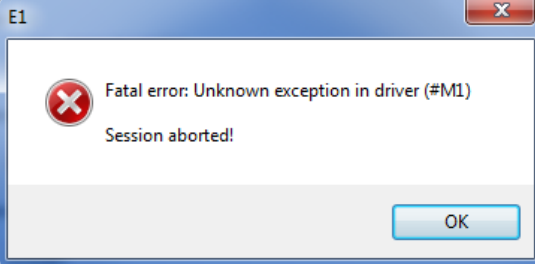
No. E4	E1 C-SPY Driver: Step-in Step over doesn't work for switch case construct with more than 99 cases
	<p><u>JAR Reference</u> EW25950</p> <p><u>Details</u> Temporary breakpoints are used for example in case of a single-step at C level. If you exceed the number of available temporary breakpoints that the OCD driver has allocated space for, an error is generated.</p>

<p><u>Workaround</u> Step at assembler level instead of at C level.</p>

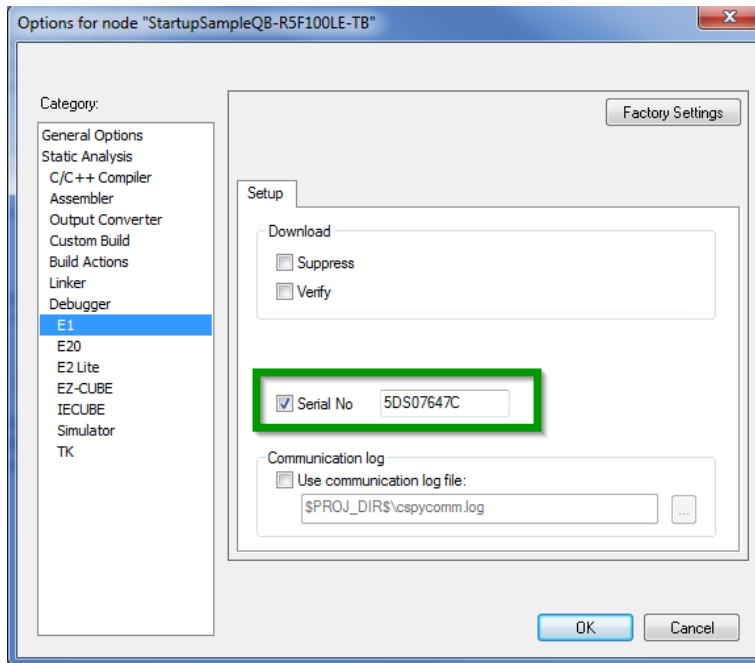
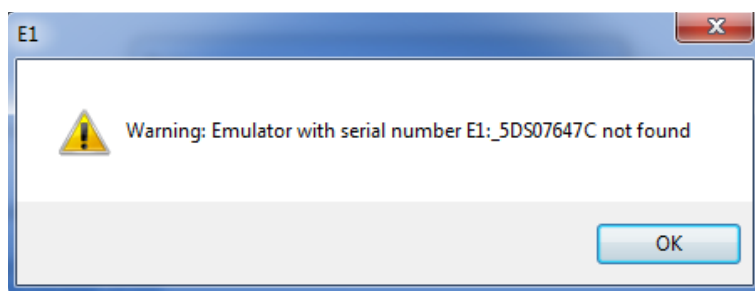
The E1 serial number defined by the user will sometimes not be found whereas it is the correct one.

The debugger will throw the following warning and the debug session will be terminated.

In case there is only one E1 required you can use the automated detection of the E1 instead of entering the serial number. Please uncheck the “Serial No” checkbox in that case.

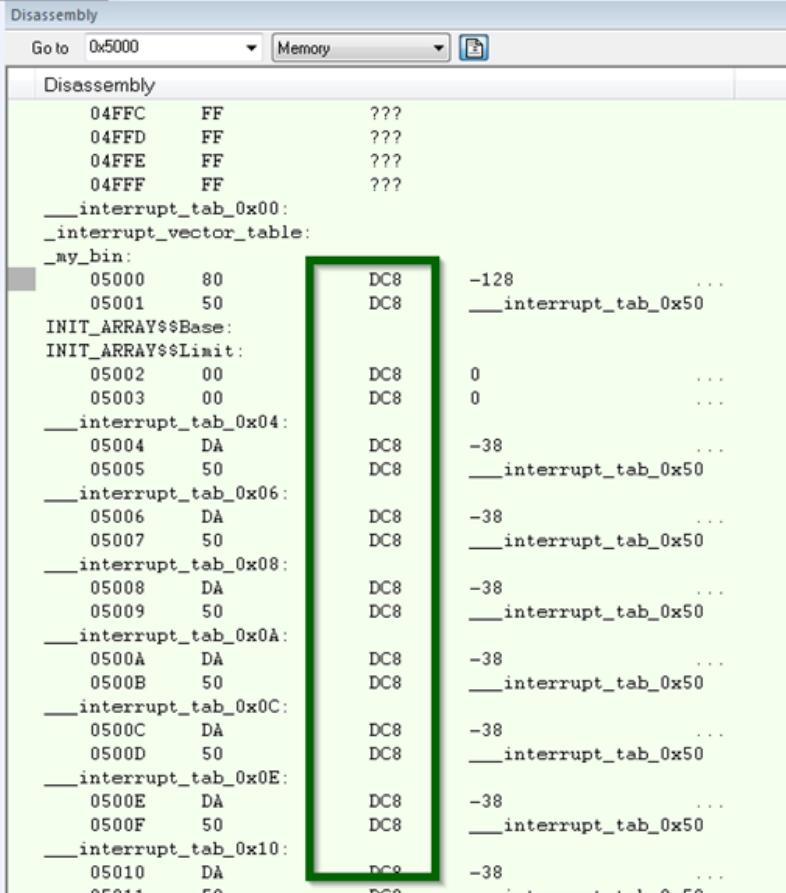
No. E10	<p>Binary image not showing symbol info in “Disassembly” window</p>
<p><u>IA Reference</u> EWRL78-672</p> <p><u>Details</u> During the build process of an application it is possible to link a pure binary file via the linker option <code>-image_input</code>. The content of the binary file could be code or constant data. However, in the debug session the “Disassembly” window always represents that content as a constant even if an additional debug file with code is loaded to the same area.</p>

<p><u>Workaround</u> None</p>
