# RENESAS TECHNICAL UPDATE

| Product Category | MPU & MCU | | Document No. | TN-16C-A237A/E | Rev. | 1.00 |
| Title | Deletion of Specifications and Errata for R32C/111 Group User's Manual: Hardware | | Information Category | Technical Notification | | |
| Applicable Product | R32C/111 Group | Lot No. | Reference Document | R32C/111 Group User's Manual: Hardware Rev. 1.20 (R01UH0209EJ0120) | | |

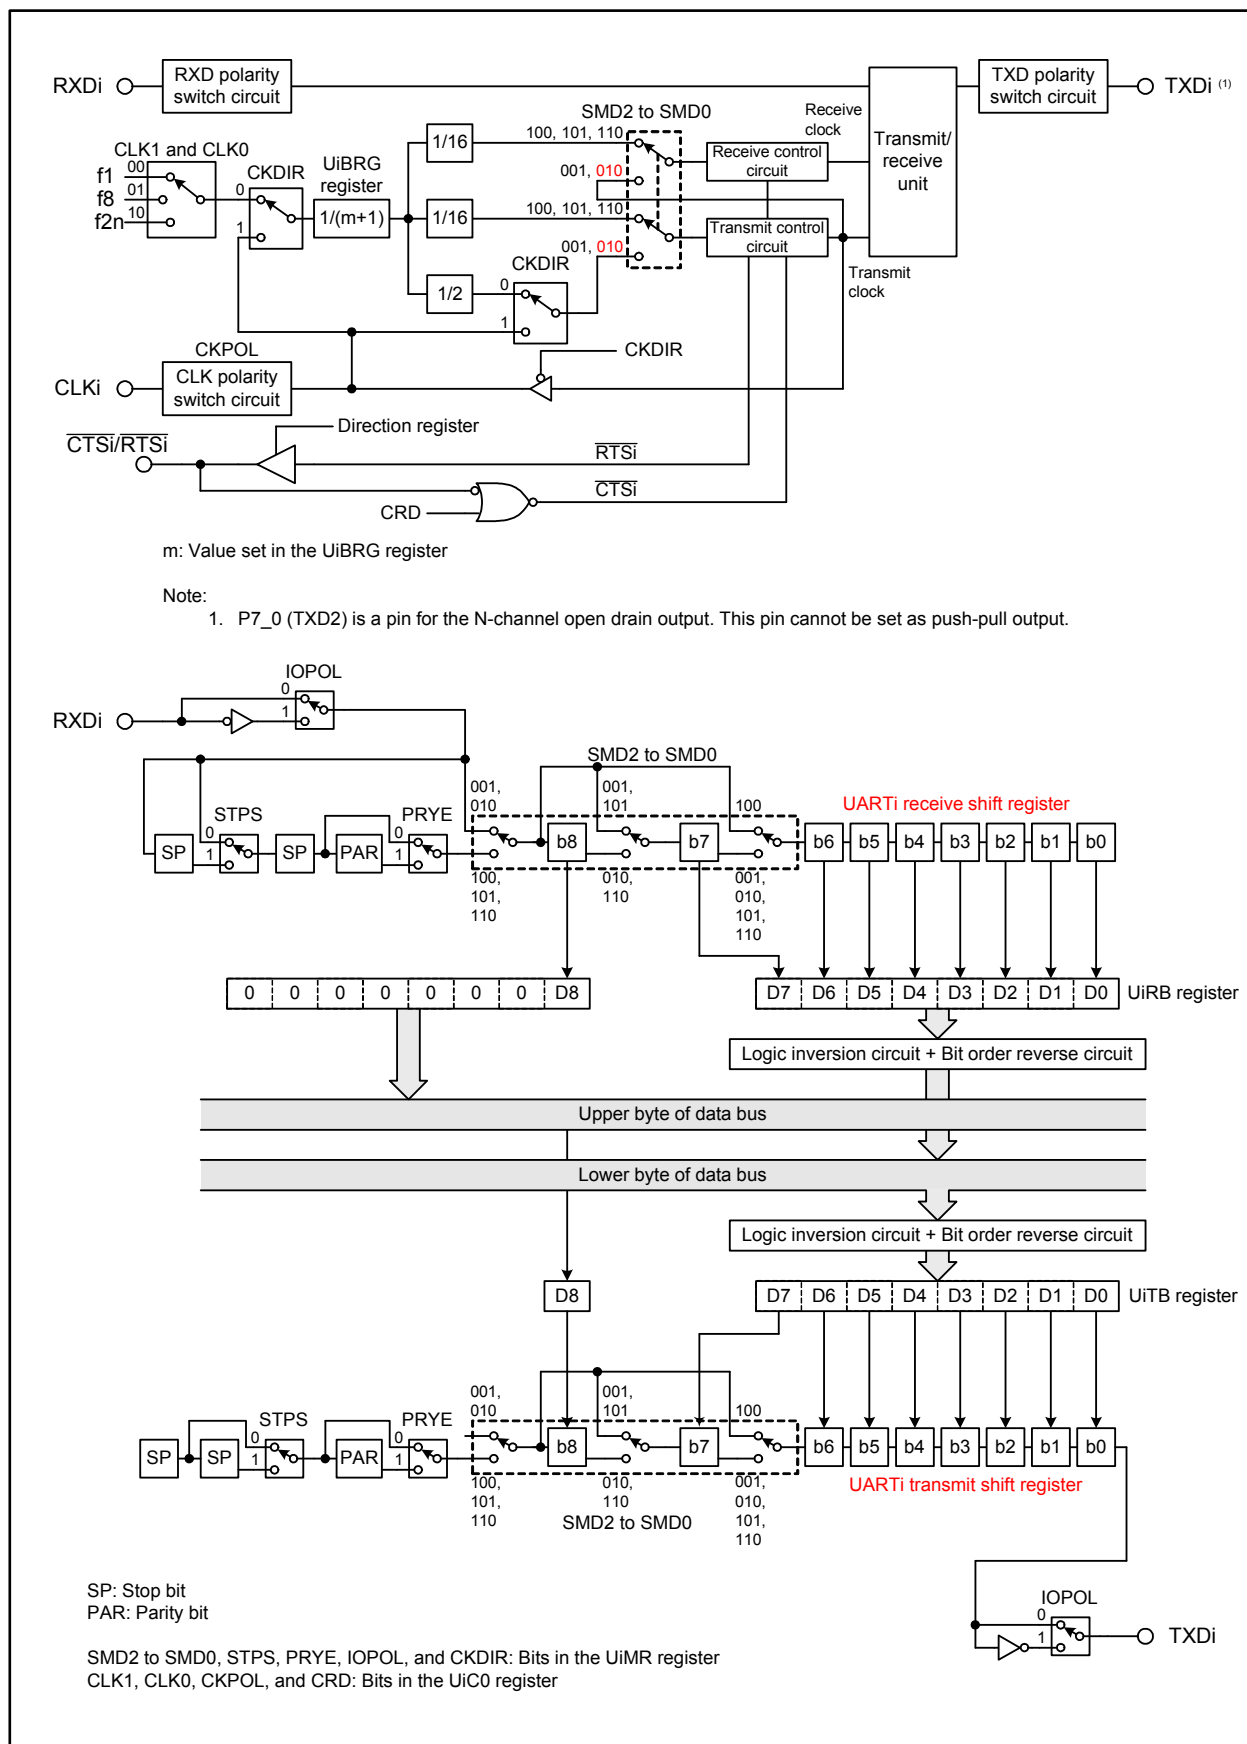
•Page 240 of 493, positions of “010” for bits SMD2 to SMD0 in Figure 18.1 are corrected as follows:

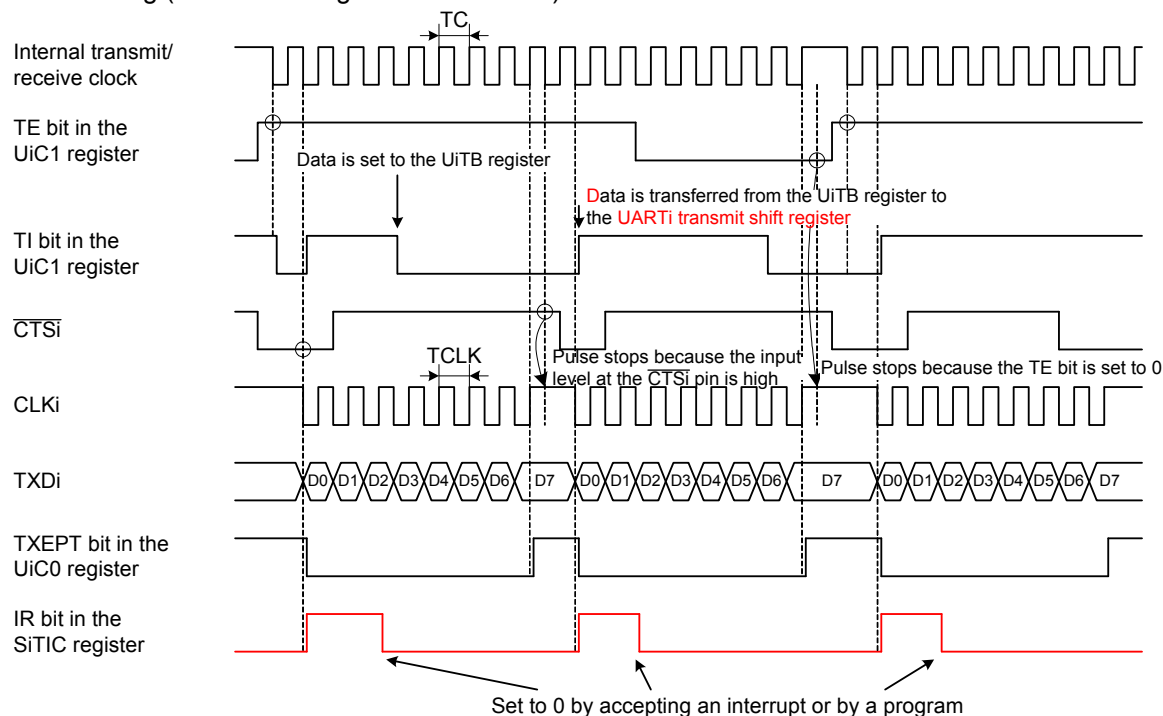
#### Transmit timing (when selecting an internal clock)

- Page 246 of 493, description in Function of the UIIRS bit in Figure 18.7 is modified as follows:  
“0: **Transmit buffer** is empty (TI = 1)”
- Page 250 of 493, expression “baud rate generator count source” in the function of bits DL0 to DL2 in Figure 18.12 is corrected as follows:  
“**count source for the UiBRG register**”
- Pages 257, 258, 265, 266, 275, 285 of 493, descriptions in Function of the UiBRG register in Tables 18.3, 18.4, 18.6, 18.7, 18.10, and 18.15 are modified as follows:  
“**Set the divide ratio according to the bit rate**”
- Pages 258, 266 of 493, description for (b7 to b4) to registers UiC1 and U78CON in Tables 18.4 and 18.7 is added as follows:  
“(b7 to b4) **Set the bits to 0000b**”
- Page 259 of 493, waveform of the IR bit in Figure 18.20 is corrected as follows:

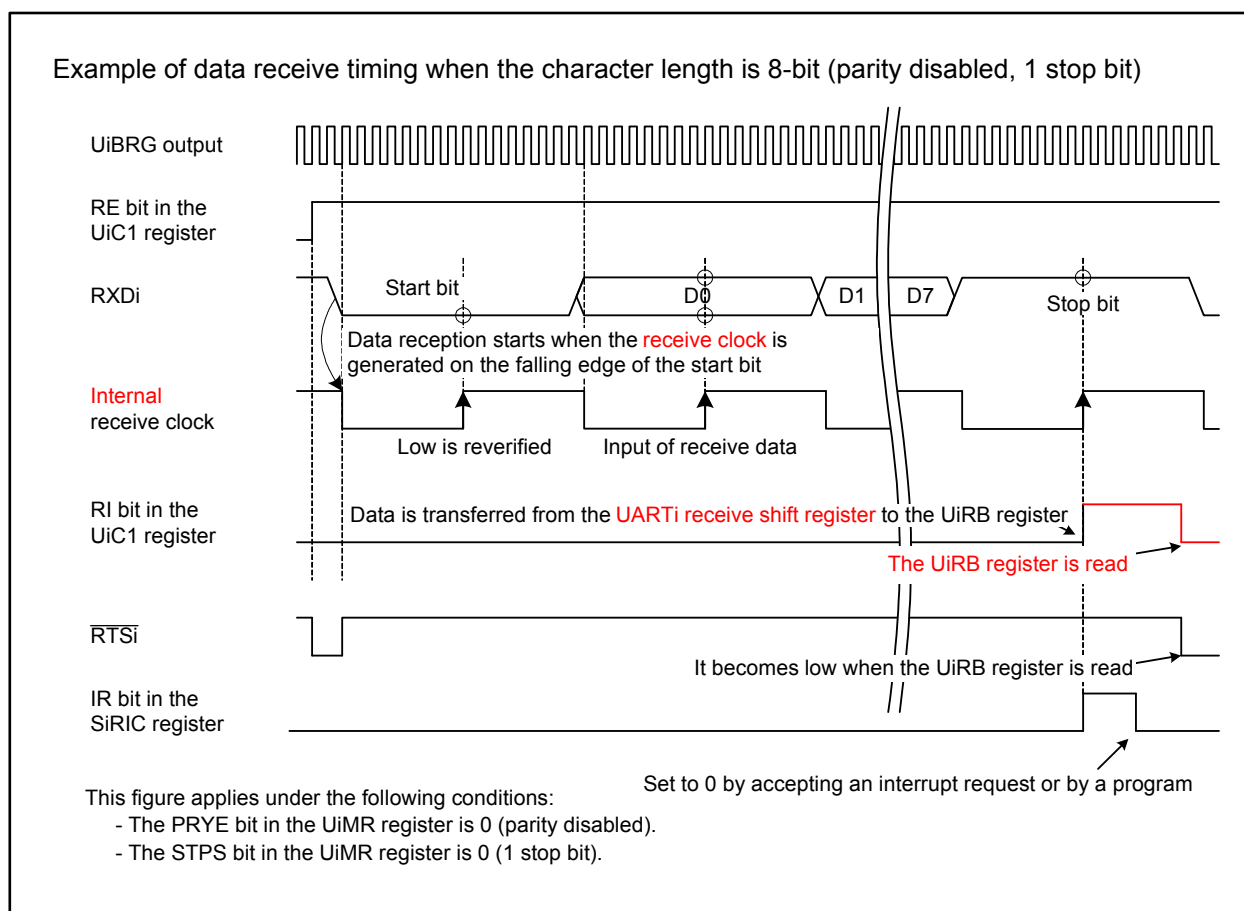
- Page 269 of 493, Figure 18.27 is corrected as follows:
