RENESAS TECHNICAL UPDATE

Product Category	MPU & MCU		Document No.	TN-16C-A208A/E	Rev.	1.00
Title	Errata to R32C/111 Group Hardware Manual No. 3		Information Category	Technical Notification		
Applicable Product	R32C/111 Group	Lot No.	Reference Document	R32C/111 Group Hardware Manual Rev. 1.10 (REJ09B0424-0110)

This document describes corrections to the R32C/111 Group Hardware Manual, Rev. 1.10.
The corrections are indicated in red in the list below.

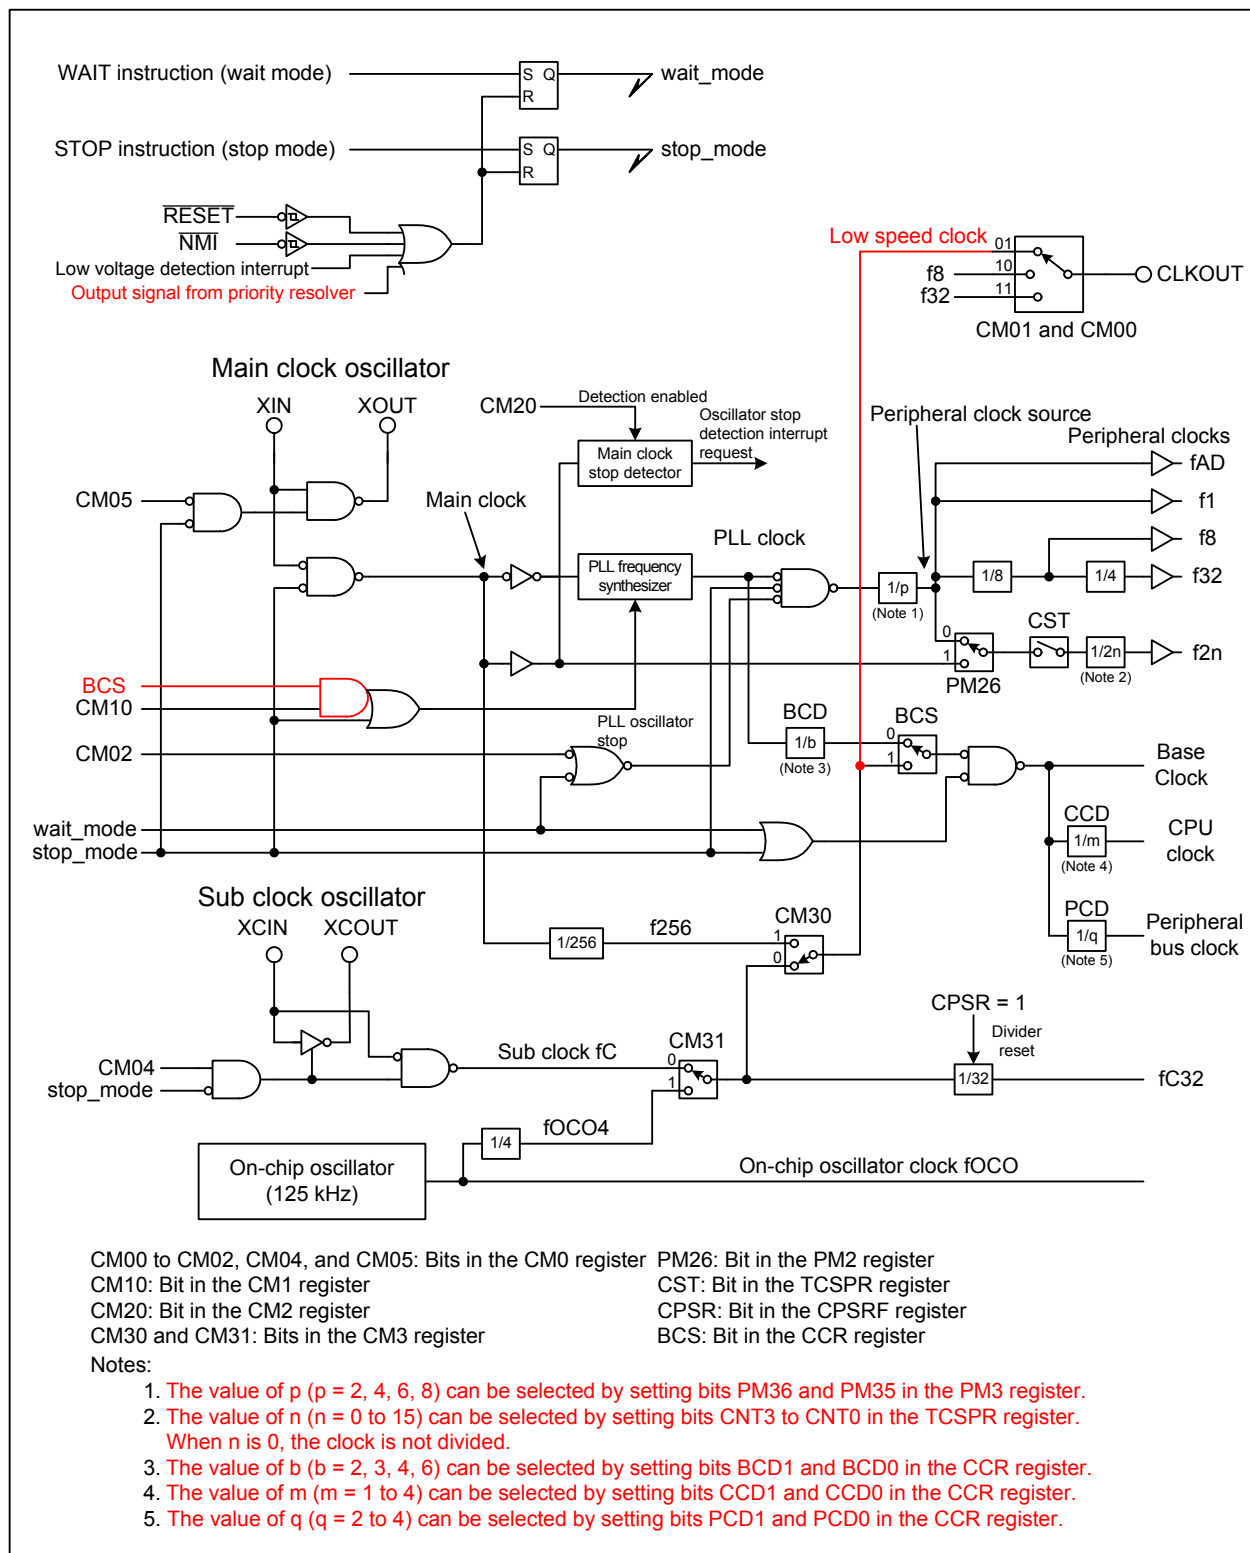
Figure 8.1 Clock Generation Circuitry

•Page 76 of 493, Figure 8.1 is corrected as follows:

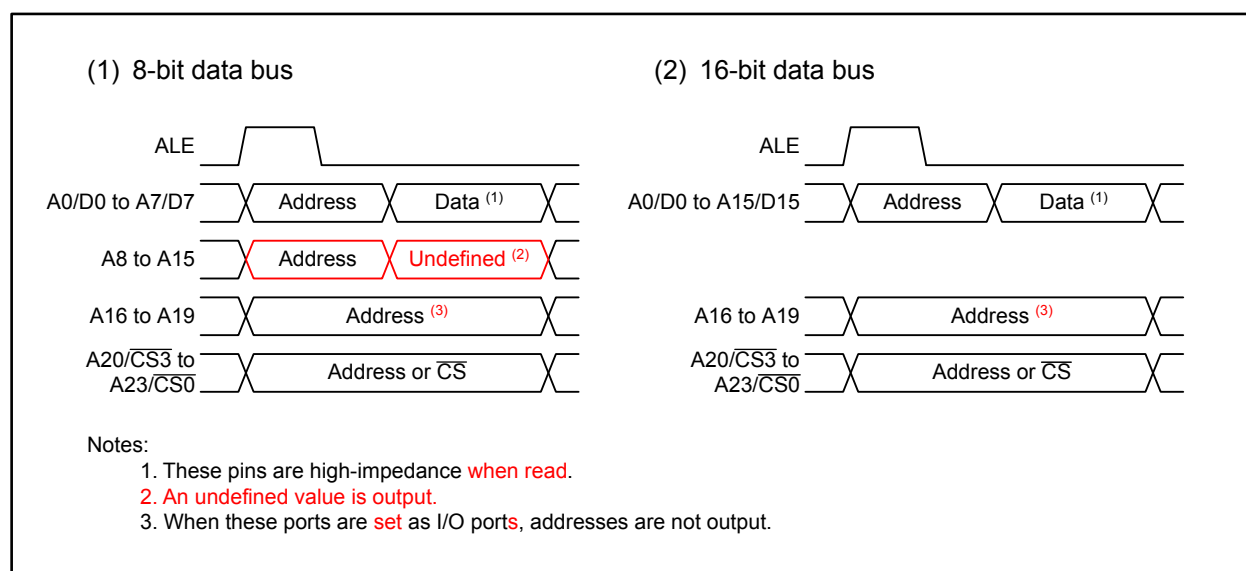
Figure 9.14 ALE Signal and Address Bus/Data Bus

- Page 123 of 493, Figure 9.14 is corrected as follows:

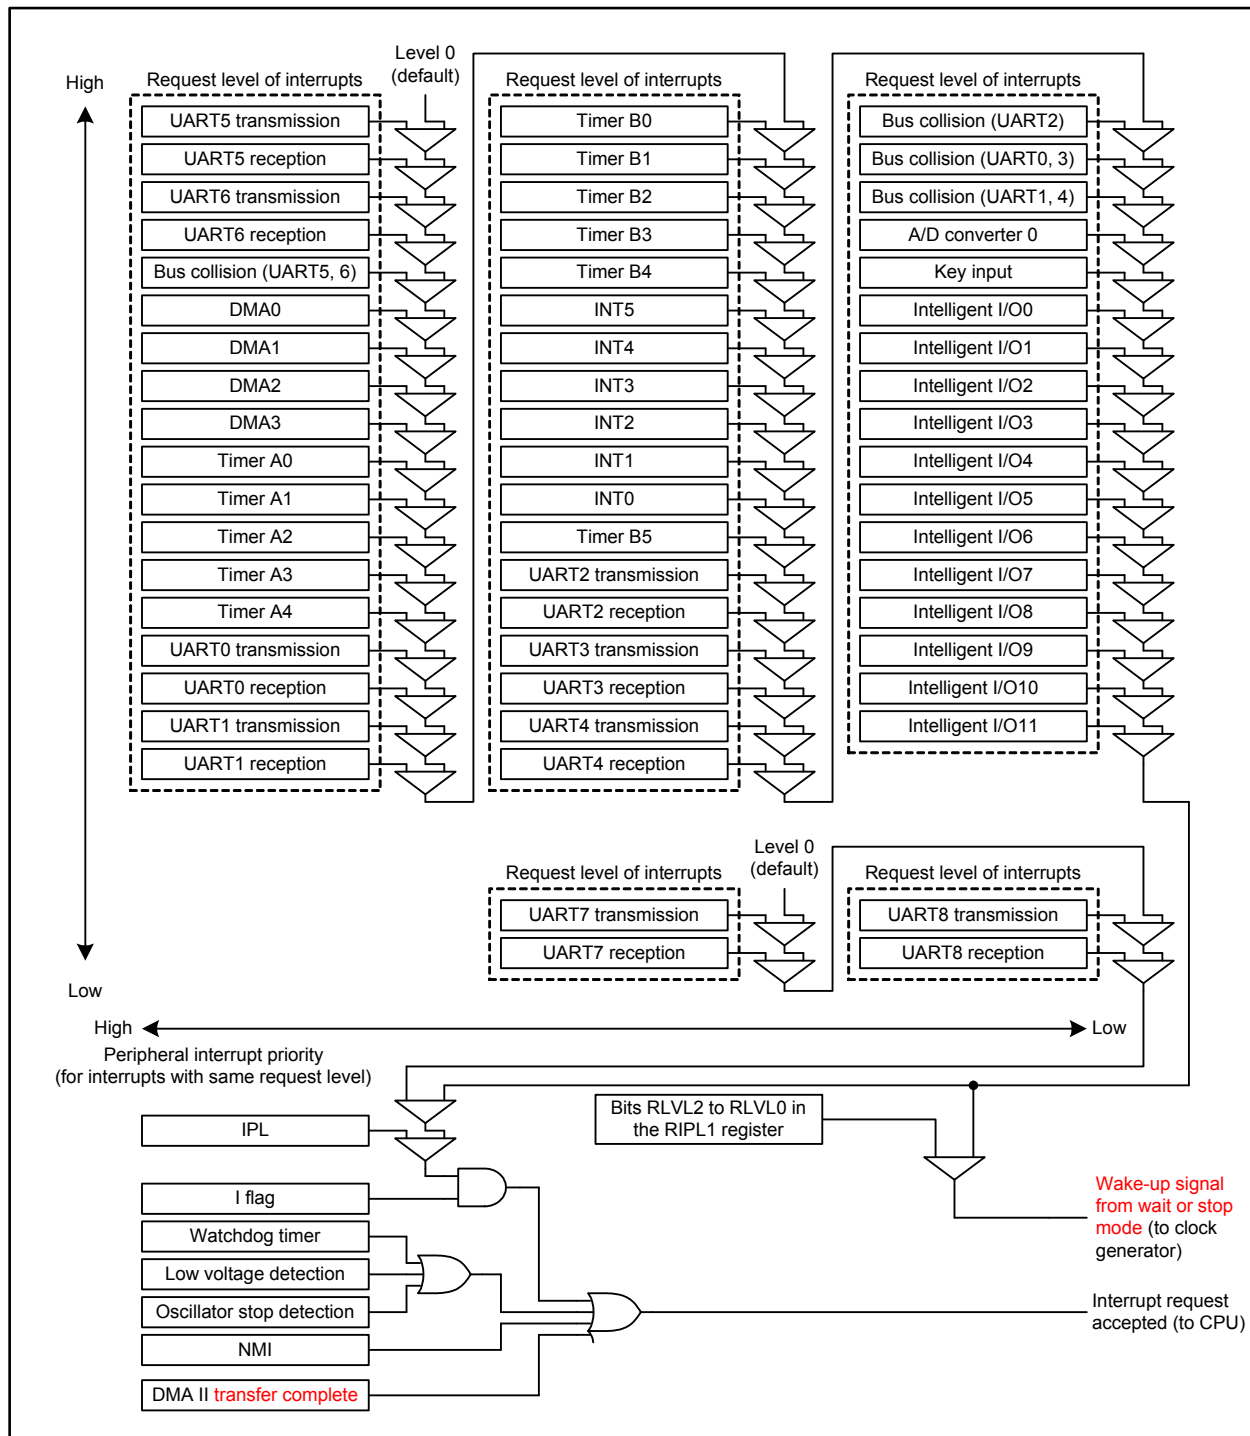
Figure 11.8 Priority Resolver

•Page 150 of 493, Figure 11.8 is corrected as follows:

(Description "Bits RLVL2 to RLVL0 in the RIPL2 register" and associated signal lines are deleted from Figure 11.8)

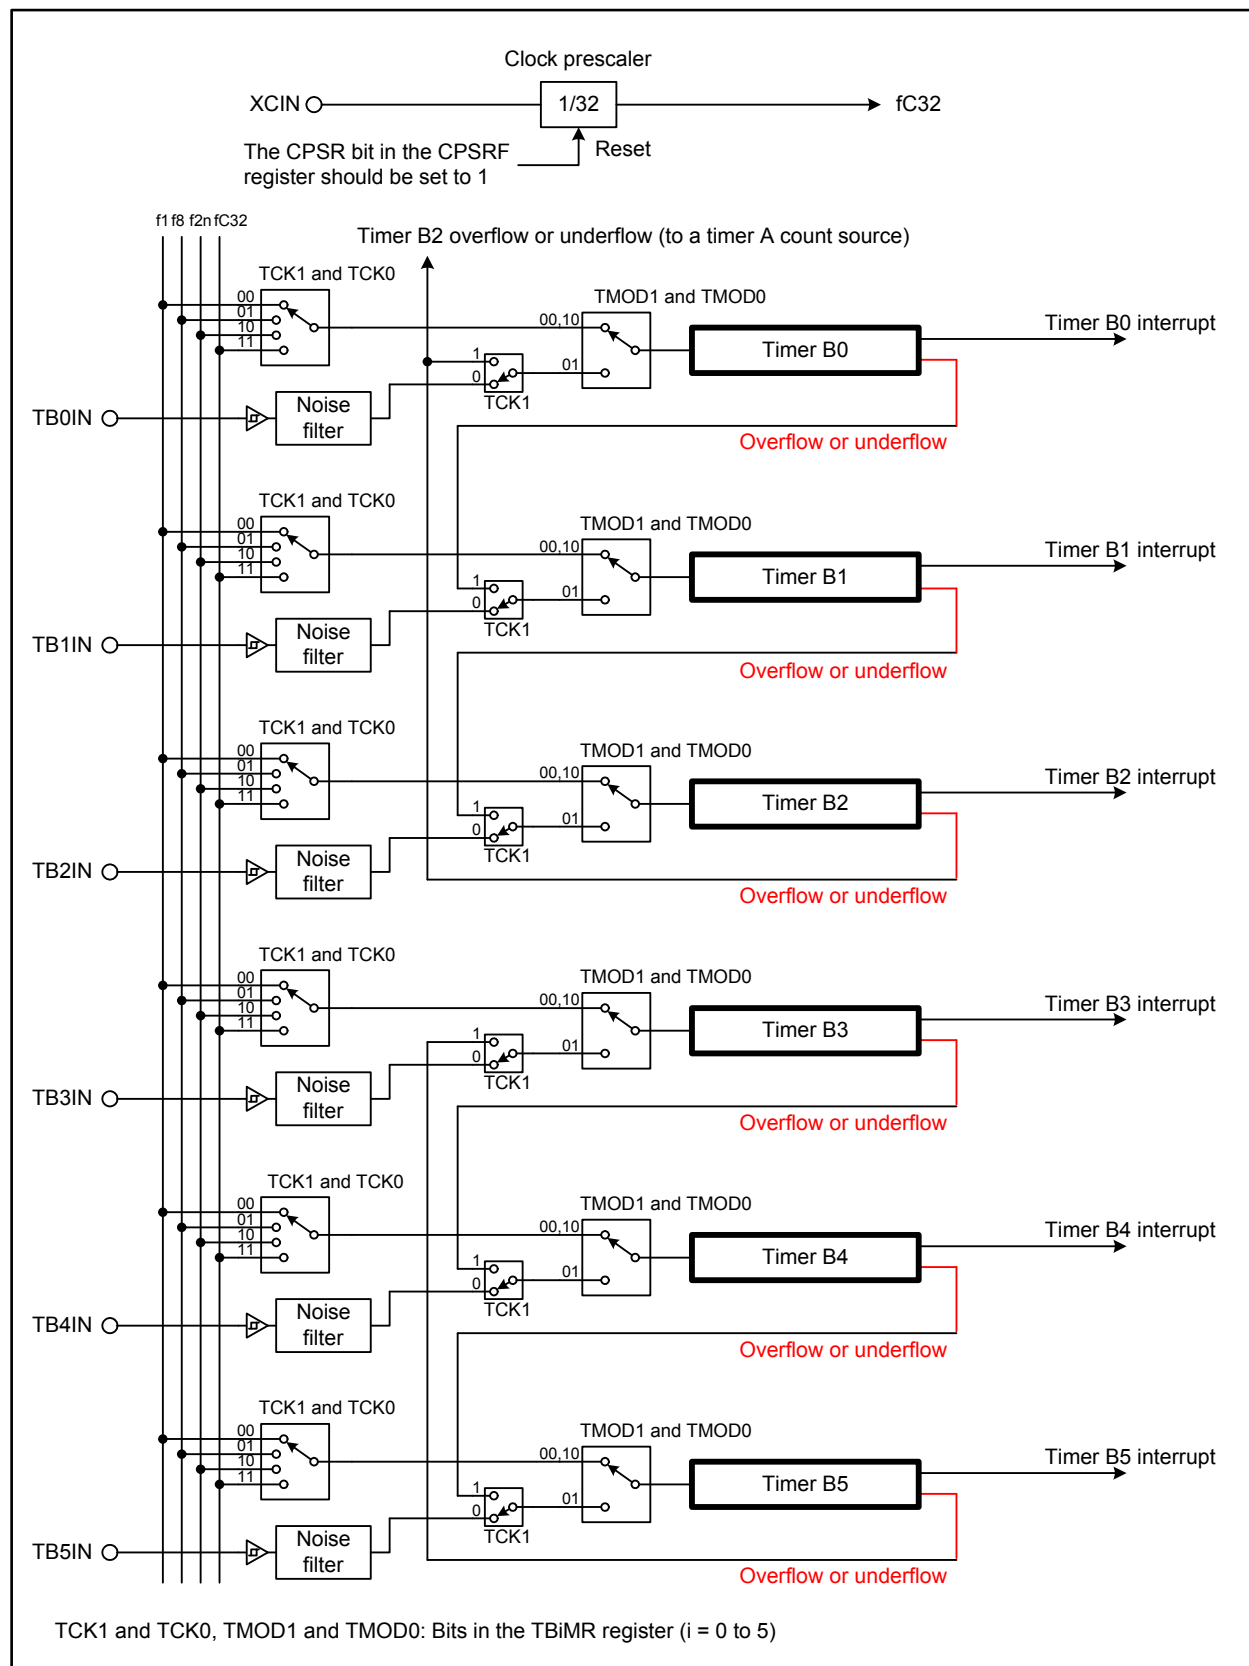
Figure 16.2 Timer B Configuration

•Page 189 of 493, Figure 16.2 is corrected as follows:

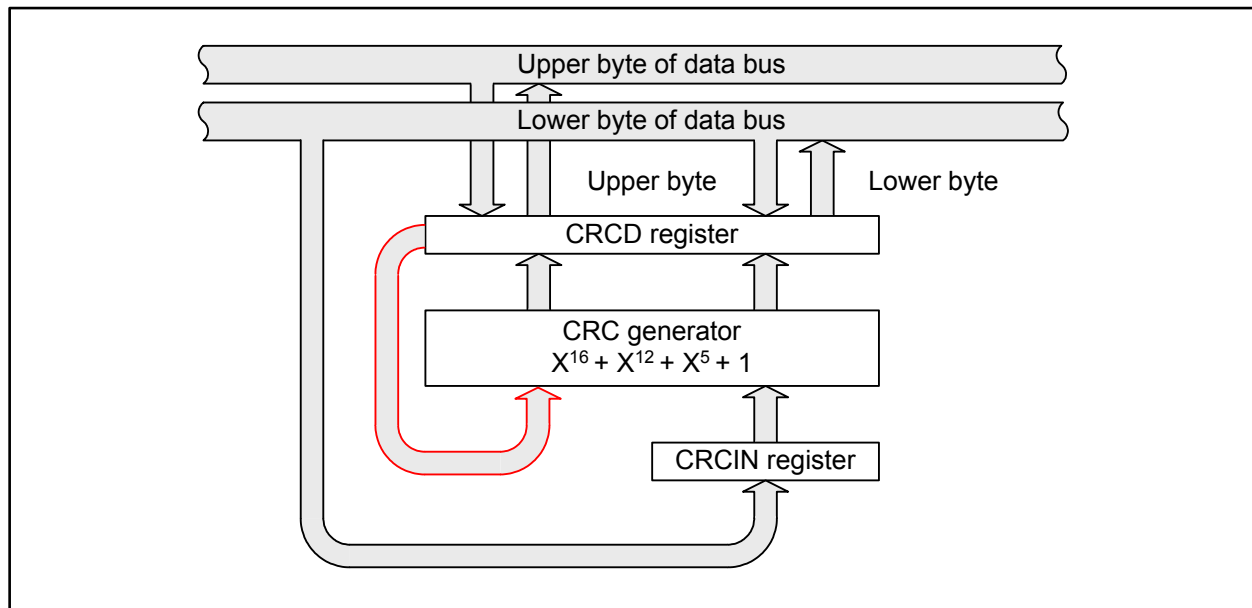
Figure 21.1 CRC Calculator Block Diagram

- Page 315 of 493, Figure 21.1 is corrected as follows:

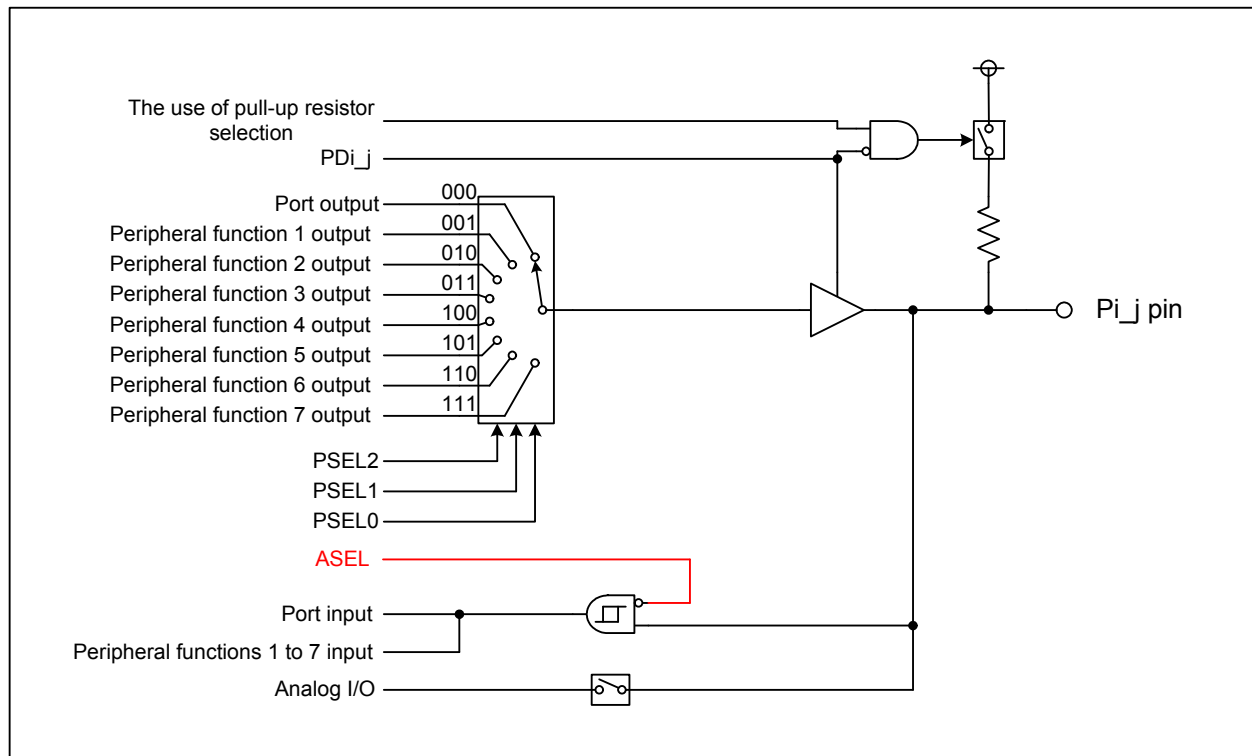
Figure 24.1 Typical I/O Pin Block Diagram (i = 0 to 10; J = 0 to 7)

- Page 369 of 493, Figure 24.1 is corrected as follows (refer to TN_16C_A198A/E):

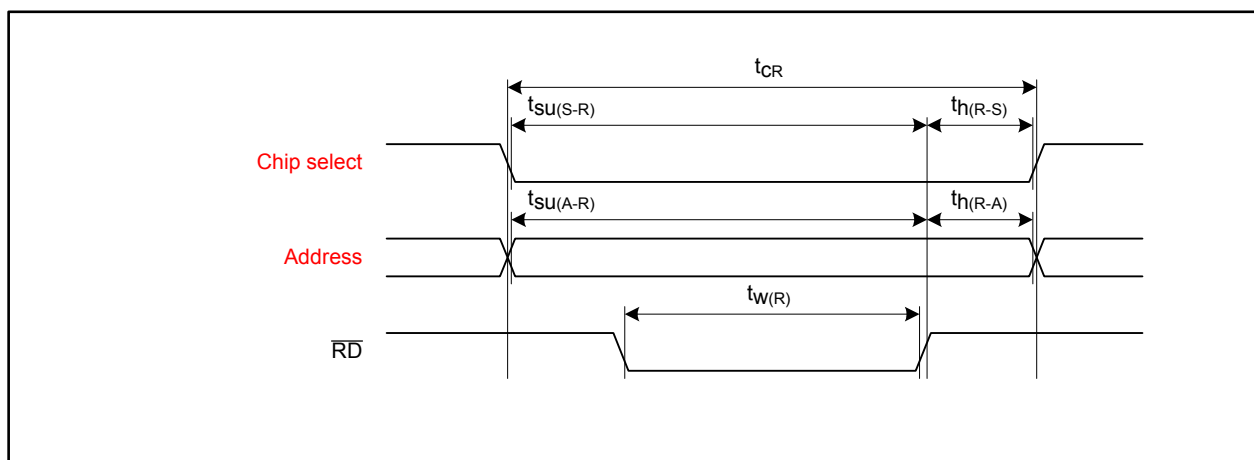
Figure 25.12 Read Timing

- Pages 410 and 412 of 493, descriptions in Figures 25.12 and 25.13 are corrected as follows:

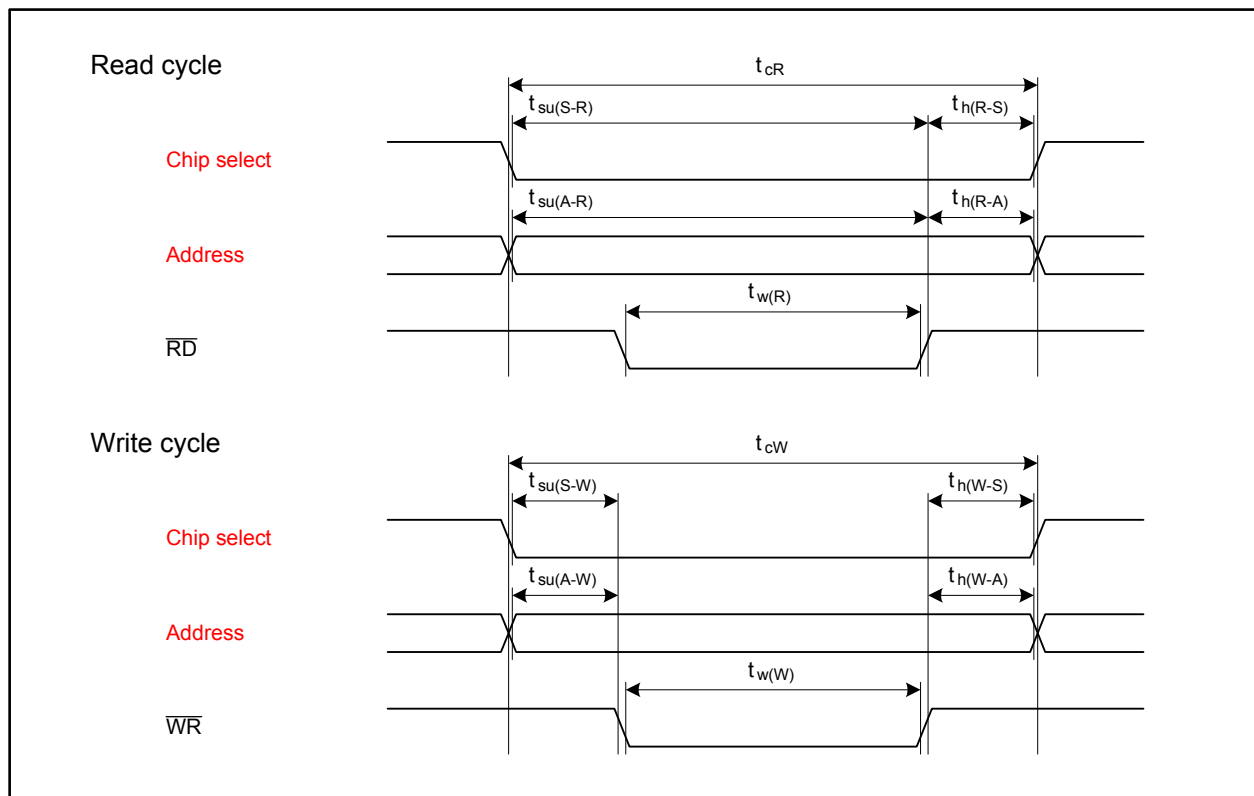
Figure 26.5 Flash Memory CPU Rewrite Mode Timing

- Page 441 of 493, descriptions in Figure 26.5 are corrected as follows:
