RENESAS TECHNICAL UPDATE

Product Category	MPU/MCU		Document No.	TN-16C-A200A/E	Rev.	1.00
Title	Errata to R32C/116 Group, R32C/117 Group, R32C/118 Group, R32C/116A Group, R32C/117A Group, R32C/118A Group User's Manuals		Information Category	Technical Notification		
Applicable Product	R32C/116 Group R32C/117 Group R32C/118 Group R32C/116A Group R32C/117A Group R32C/118A Group	Lot No.	Reference Document	R32C/116 Group User's Manual: Hardware Rev. 1.10 (REJ09B0532-0110) R32C/117 Group User's Manual: Hardware Rev. 1.10 (REJ09B0533-0110) R32C/118 Group User's Manual: Hardware Rev. 1.10 (REJ09B0534-0110) R32C/116A Group User's Manual: Hardware Rev. 1.00 (REJ09B0575-0100) R32C/117A Group User's Manual: Hardware Rev. 1.00 (REJ09B0576-0100) R32C/118A Group User's Manual: Hardware Rev. 1.00 (REJ09B0577-0100)

This document describes corrections to the I/O Pins chapter of the user's manuals listed above.

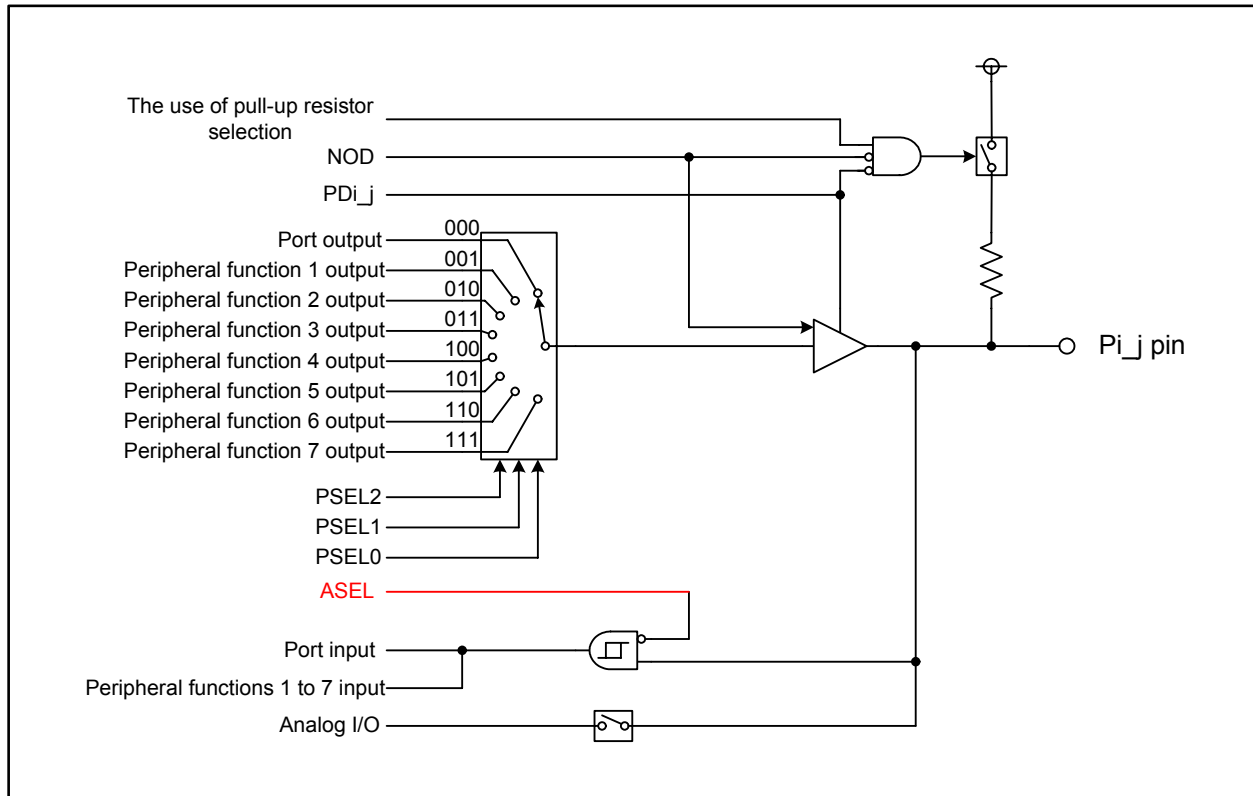
•The typical I/O pin block diagram in the first page of the I/O Pins chapter was corrected as follows:

(The ASEL bit was deleted from conditions for separating a pull-up resistor.)
