# RENESAS TECHNICAL UPDATE

Product Category	MPU & MCU	Document No.	TN-16C-A234A/E	Rev.	1.00
Title	Errata to R32C/152 Group User's Manual: Hardware		Information Category	Technical Notification	
Applicable Product	R32C/152 Group	Lot No.	Reference Document	R32C/152 Group User's Manual: Hardware Rev. 1.10 (REJ09B0504-0110)

This document describes corrections to the R32C/152 Group User's Manual: Hardware, Rev. 1.10. The corrections are indicated in red in the list below.

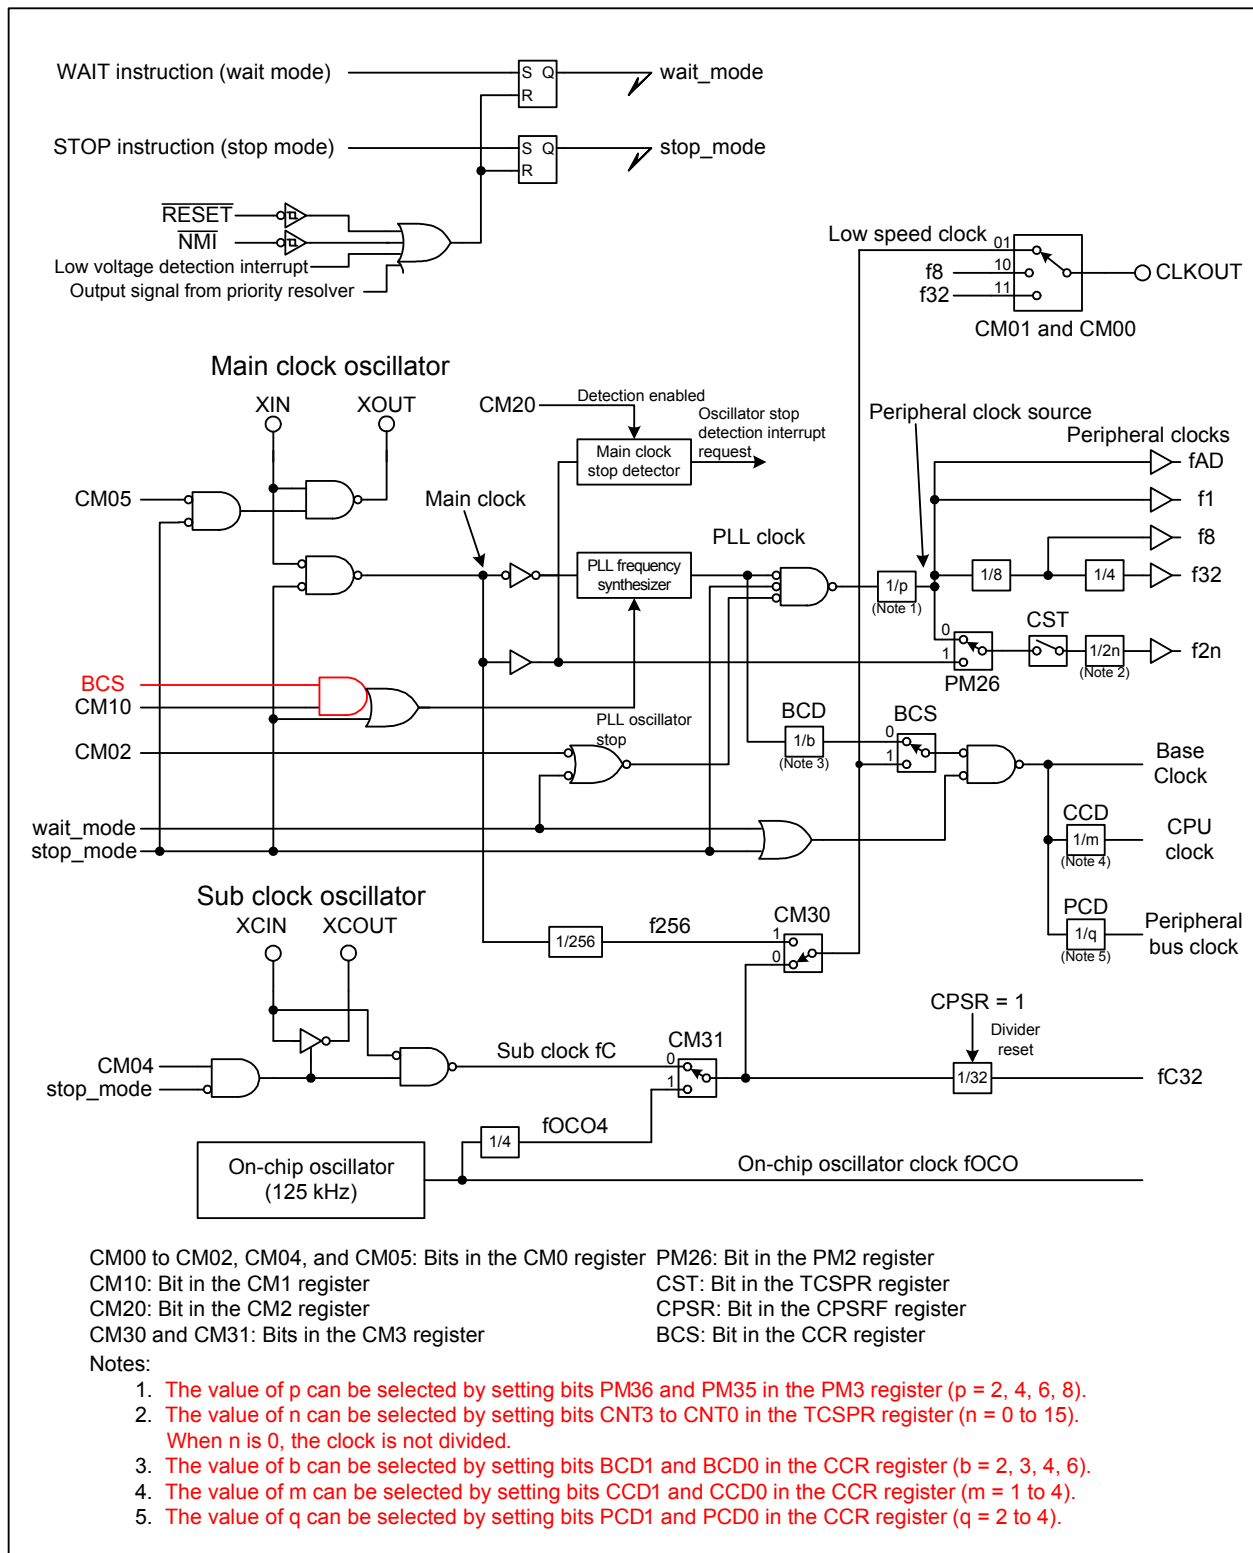
Figure 7.1 Clock Generation Circuitry

•Page 105 of 642, Figure 7.1 is corrected as follows:

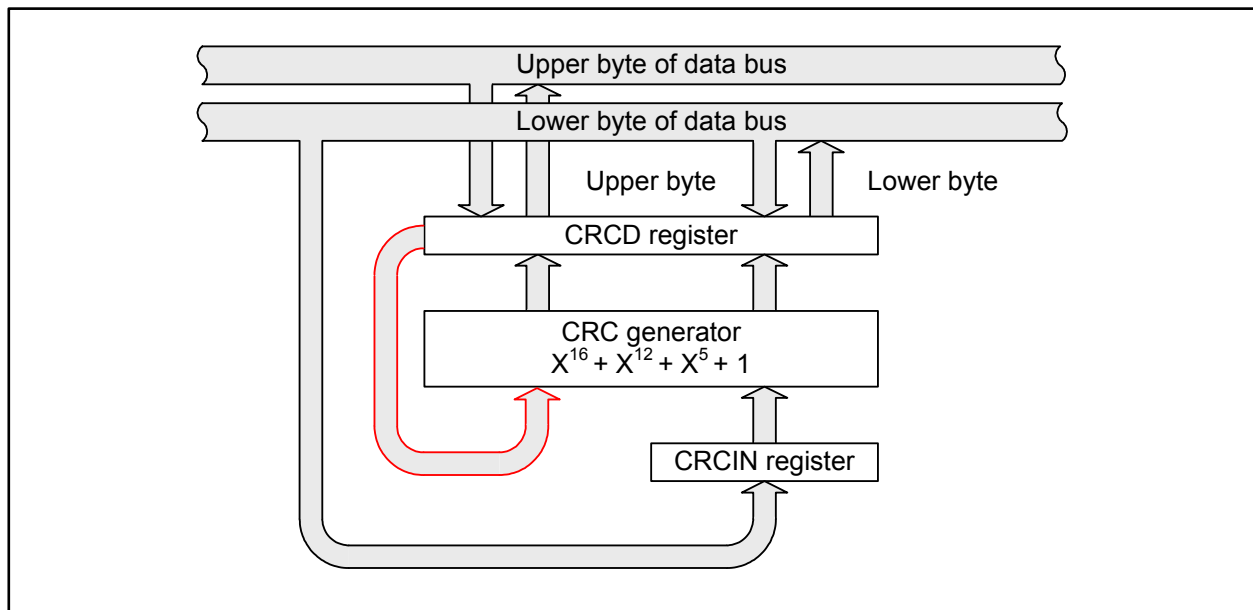
Figure 20.1 CRC Calculator Block Diagram

•Page 327 of 642, Figure 20.1 is corrected as follows:

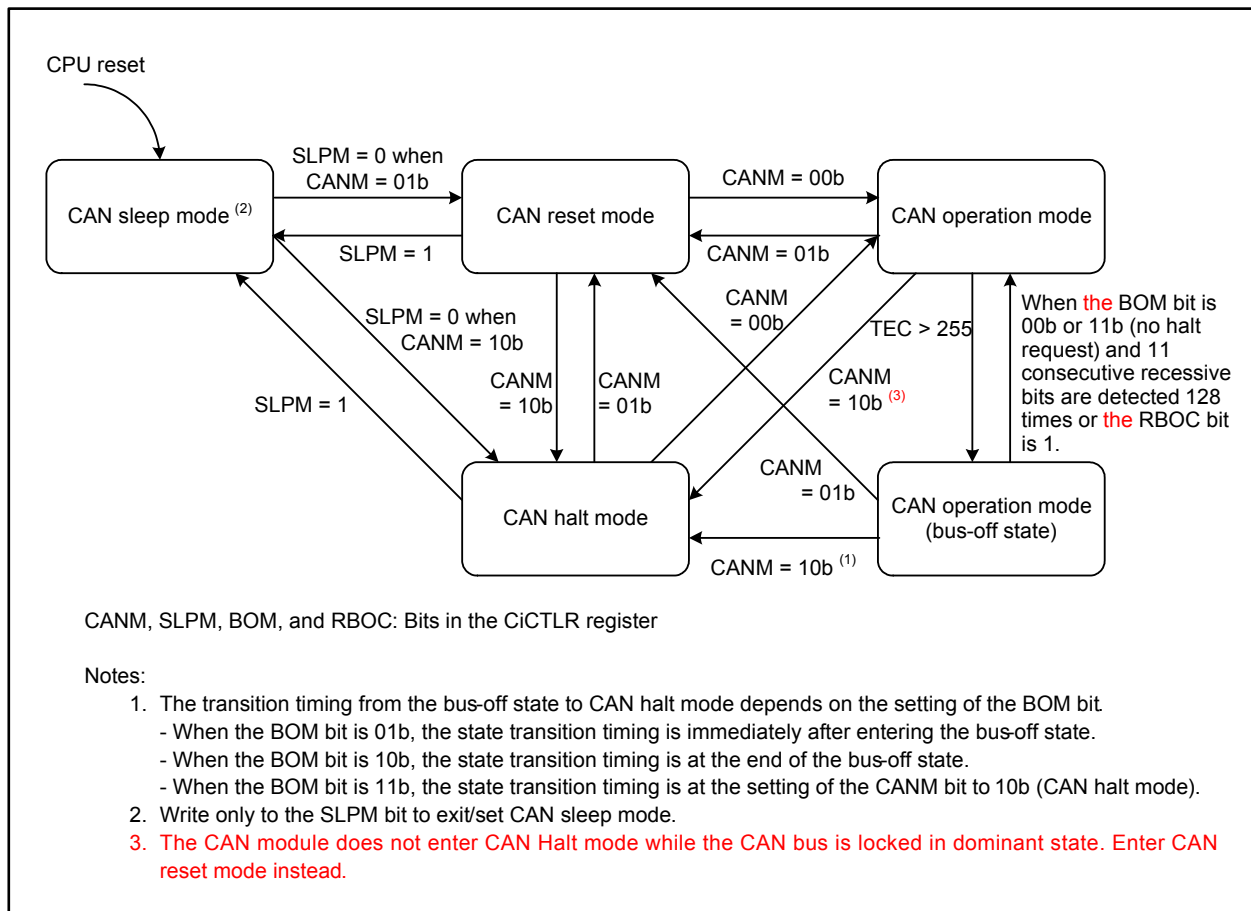
•Page 493 of 642, Note 3 is added to Figure 25.34 as follows (refer to TN-16C-A229A/E):

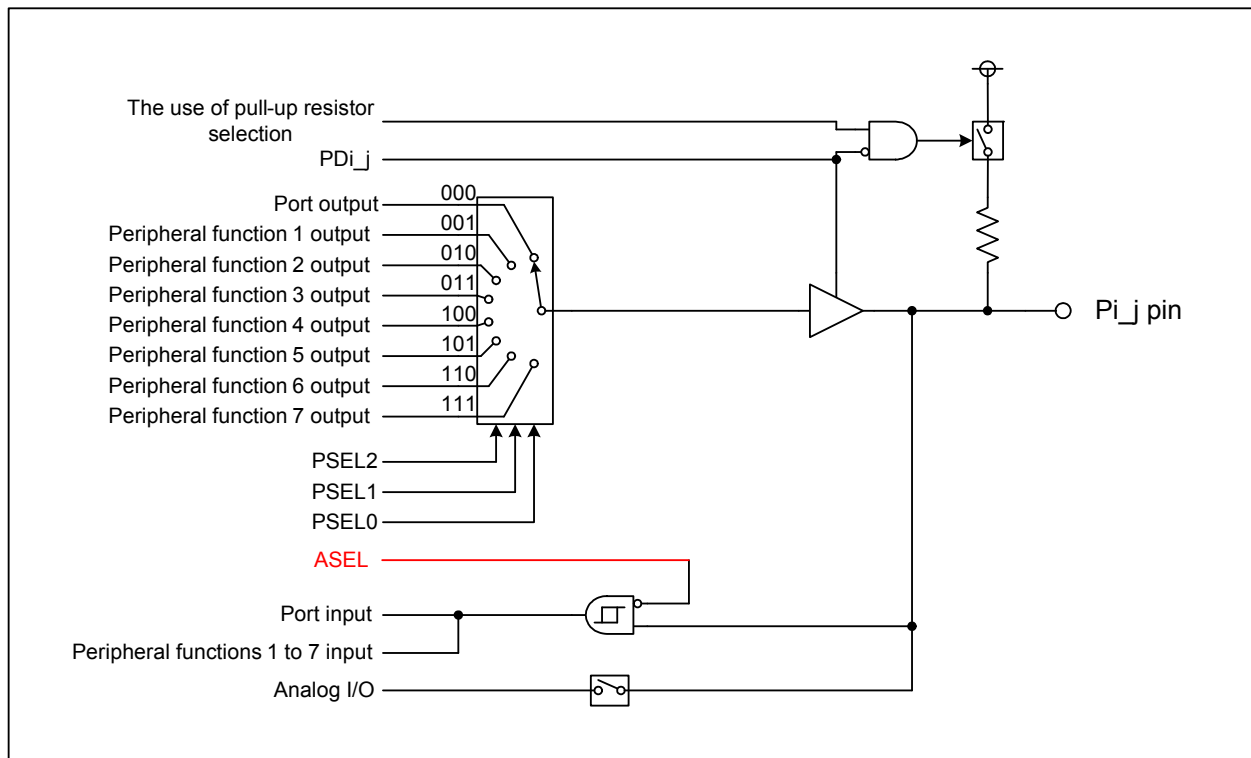
**Figure 26.1 Typical I/O Pin Block Diagram (i = 0 to 15; j = 0 to 7)**

•Page 511 of 642, Figure 256.1 is corrected as follows (refer to TN-16C-A200A/E):
