RENESAS TECHNICAL UPDATE

Product Category	MPU & MCU	Document No.	TN-16C-A233A/E	Rev.	1.00
Title	Errata to R32C/153 Group User's Manual: Hardware		Information Category	Technical Notification	
Applicable Product	R32C/153 Group	Lot No.	Reference Document	R32C/153 Group User's Manual: Hardware Rev. 1.10 (REJ09B0505-0110)

This document describes corrections to the R32C/153 Group User's Manual: Hardware, Rev. 1.10. The corrections are indicated in red in the list below.

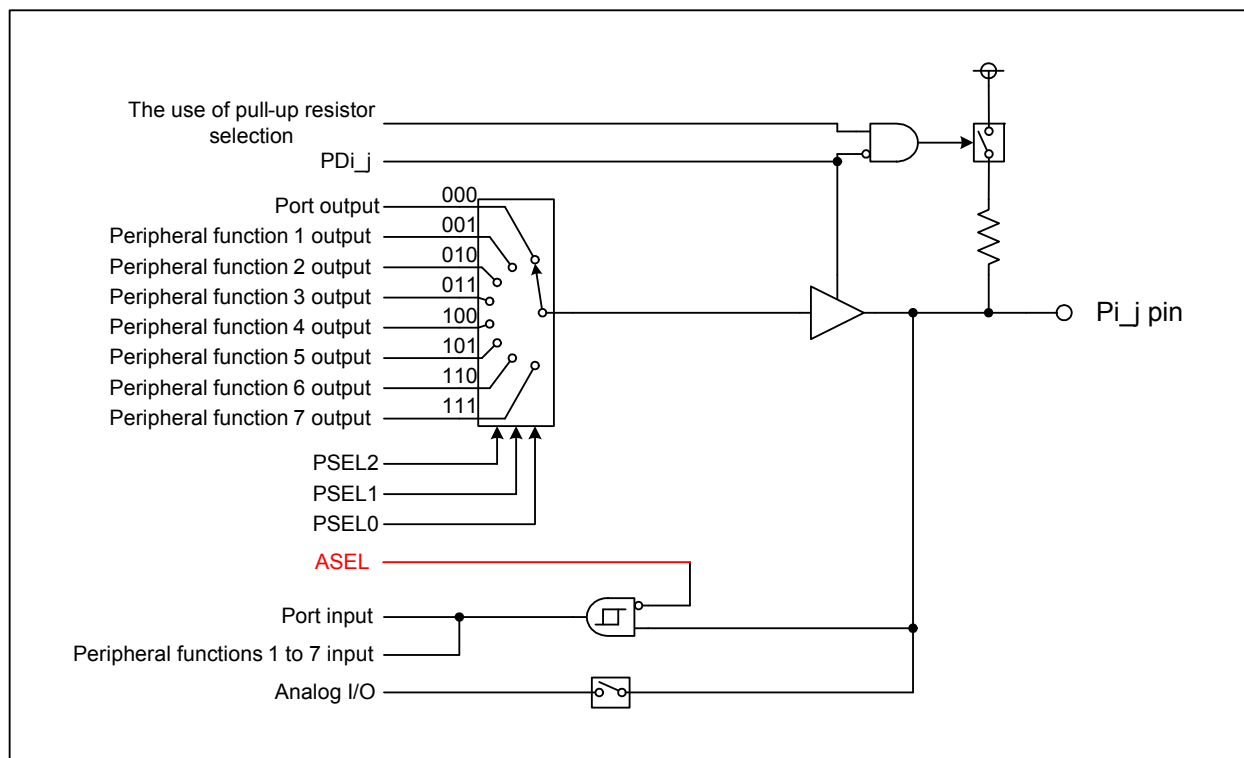
Figure 26.1 Typical I/O Pin Block Diagram (i = 0 to 15; j = 0 to 7)

- Page 525 of 656, Figure 256.1 is corrected as follows (refer to TN-16C-A200A/E):
