RENESAS TECHNICAL UPDATE

Product Category	MPU & MCU	Document No.	TN-16C-A196A/E	Rev.	1.00
Title	Errata to R32C/156 Group Hardware Manual		Information Category	Technical Notification	
Applicable Product	R32C/156 Group	Lot No.	Reference Document	R32C/156 Group Hardware Manual Rev. 1.03 (REJ09B0506-0103)

This document describes corrections to the R32C/156 Group Hardware Manual, Rev. 1.03.
The corrections are indicated in red in the list below.

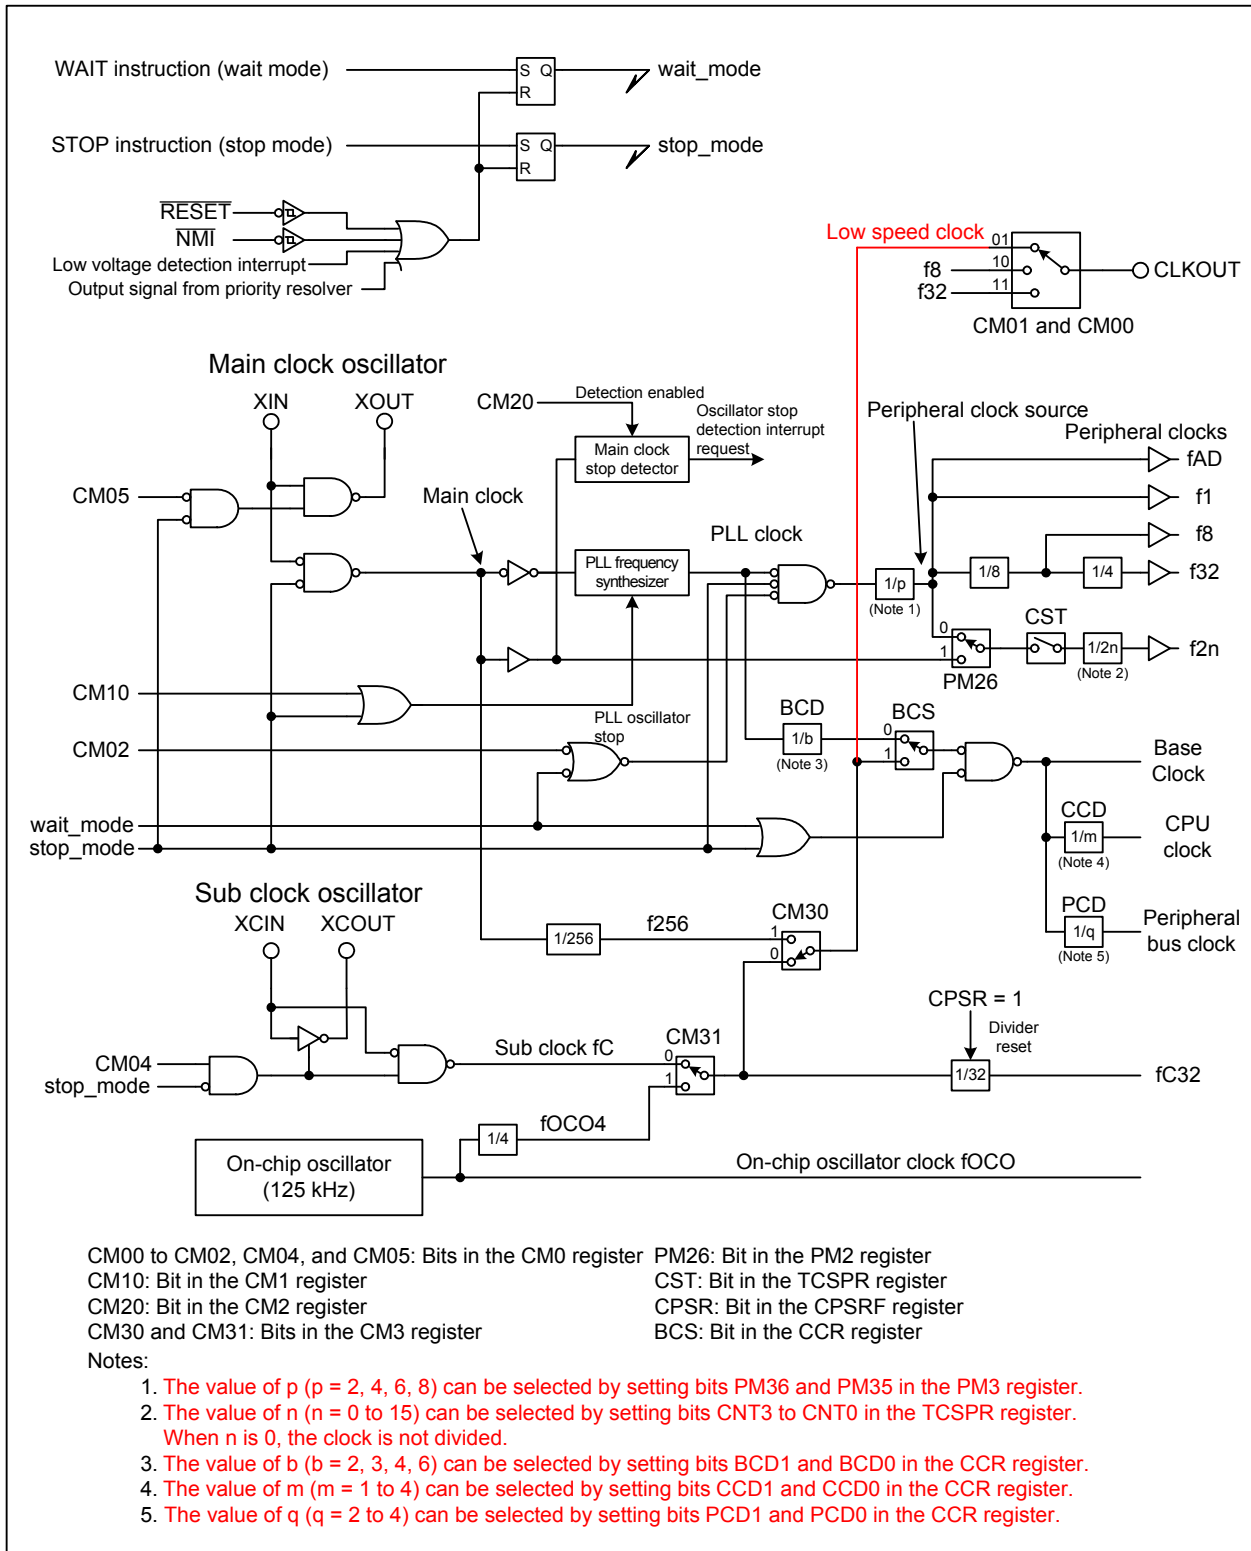
Figure 7.1 Clock Generation Circuitry

•Page 90 of 621, Figure 7.1 is corrected as follows:

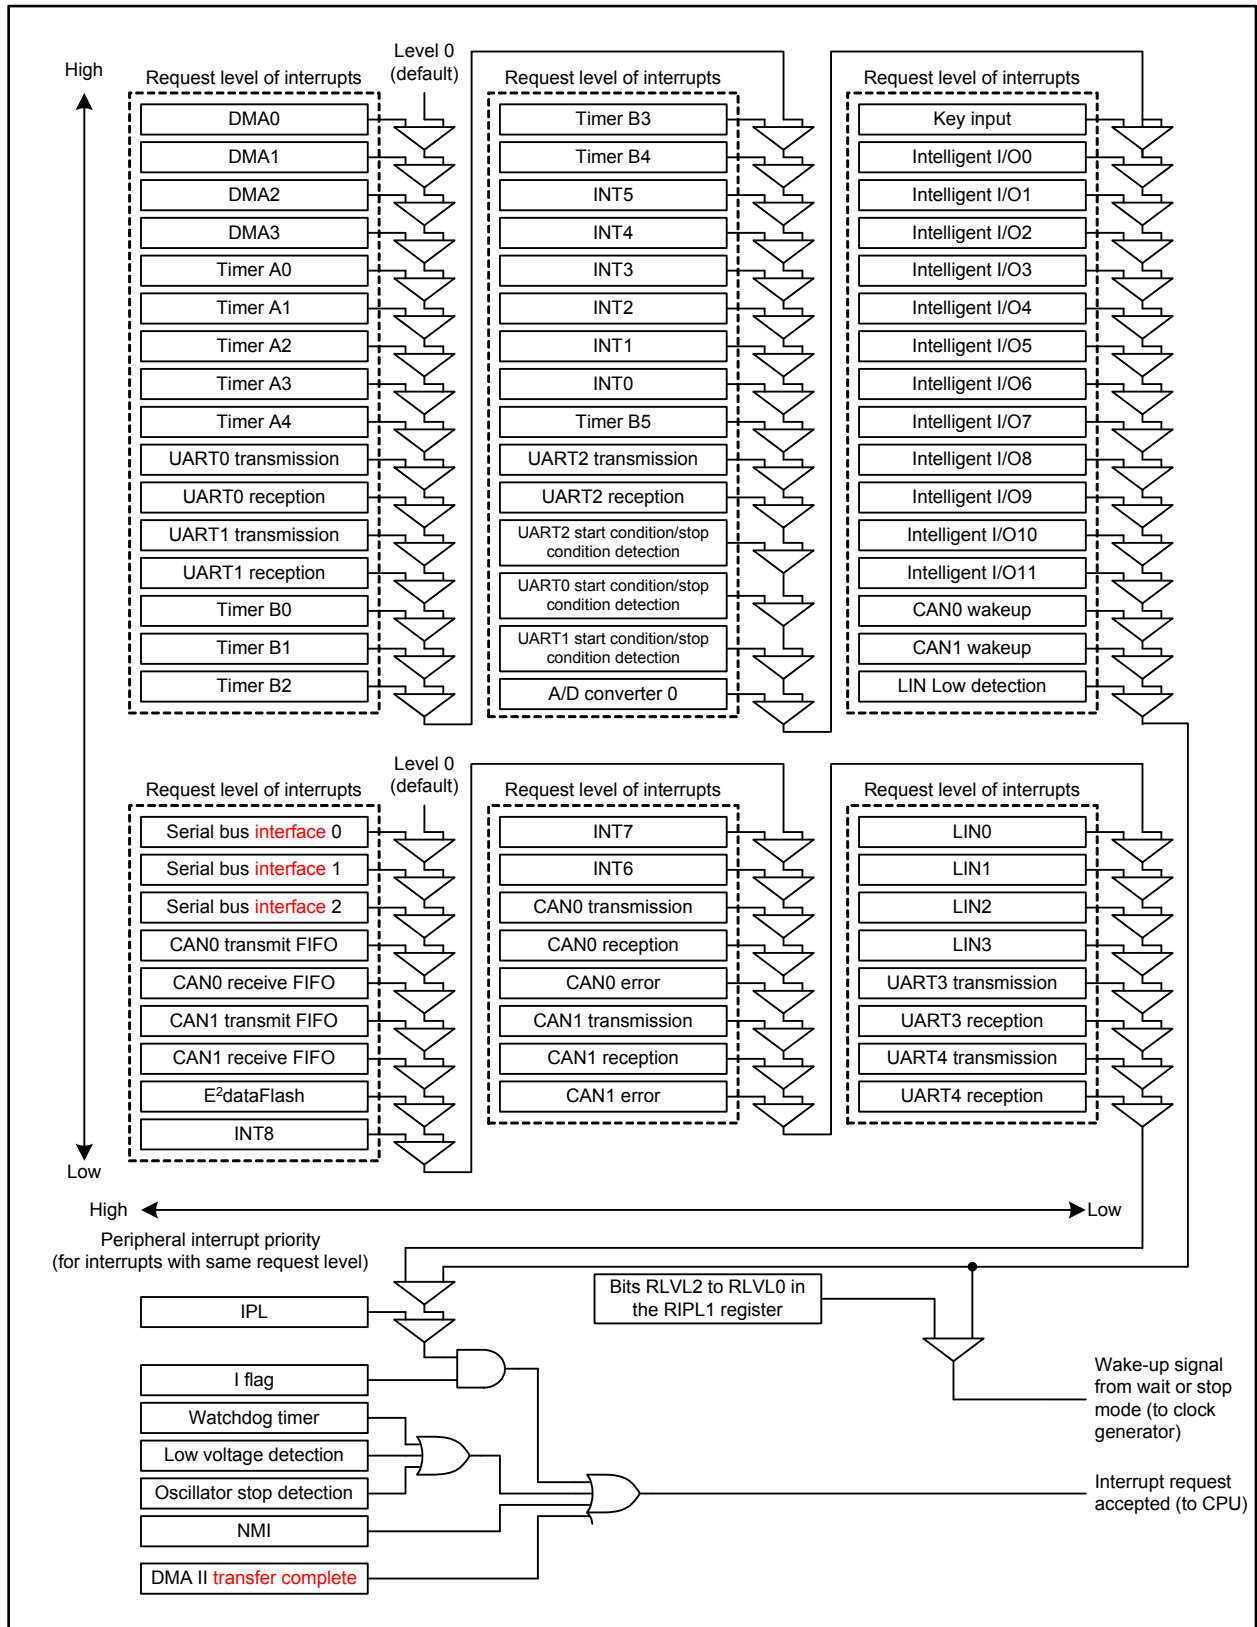
Figure 10.8 Priority Resolver

•Page 142 of 621, Figure 10.8 is corrected as follows:

(Description "Bits RLVL2 to RLVL0 in the RIPL2 register" and associated signal lines are deleted from Figure 10.8)

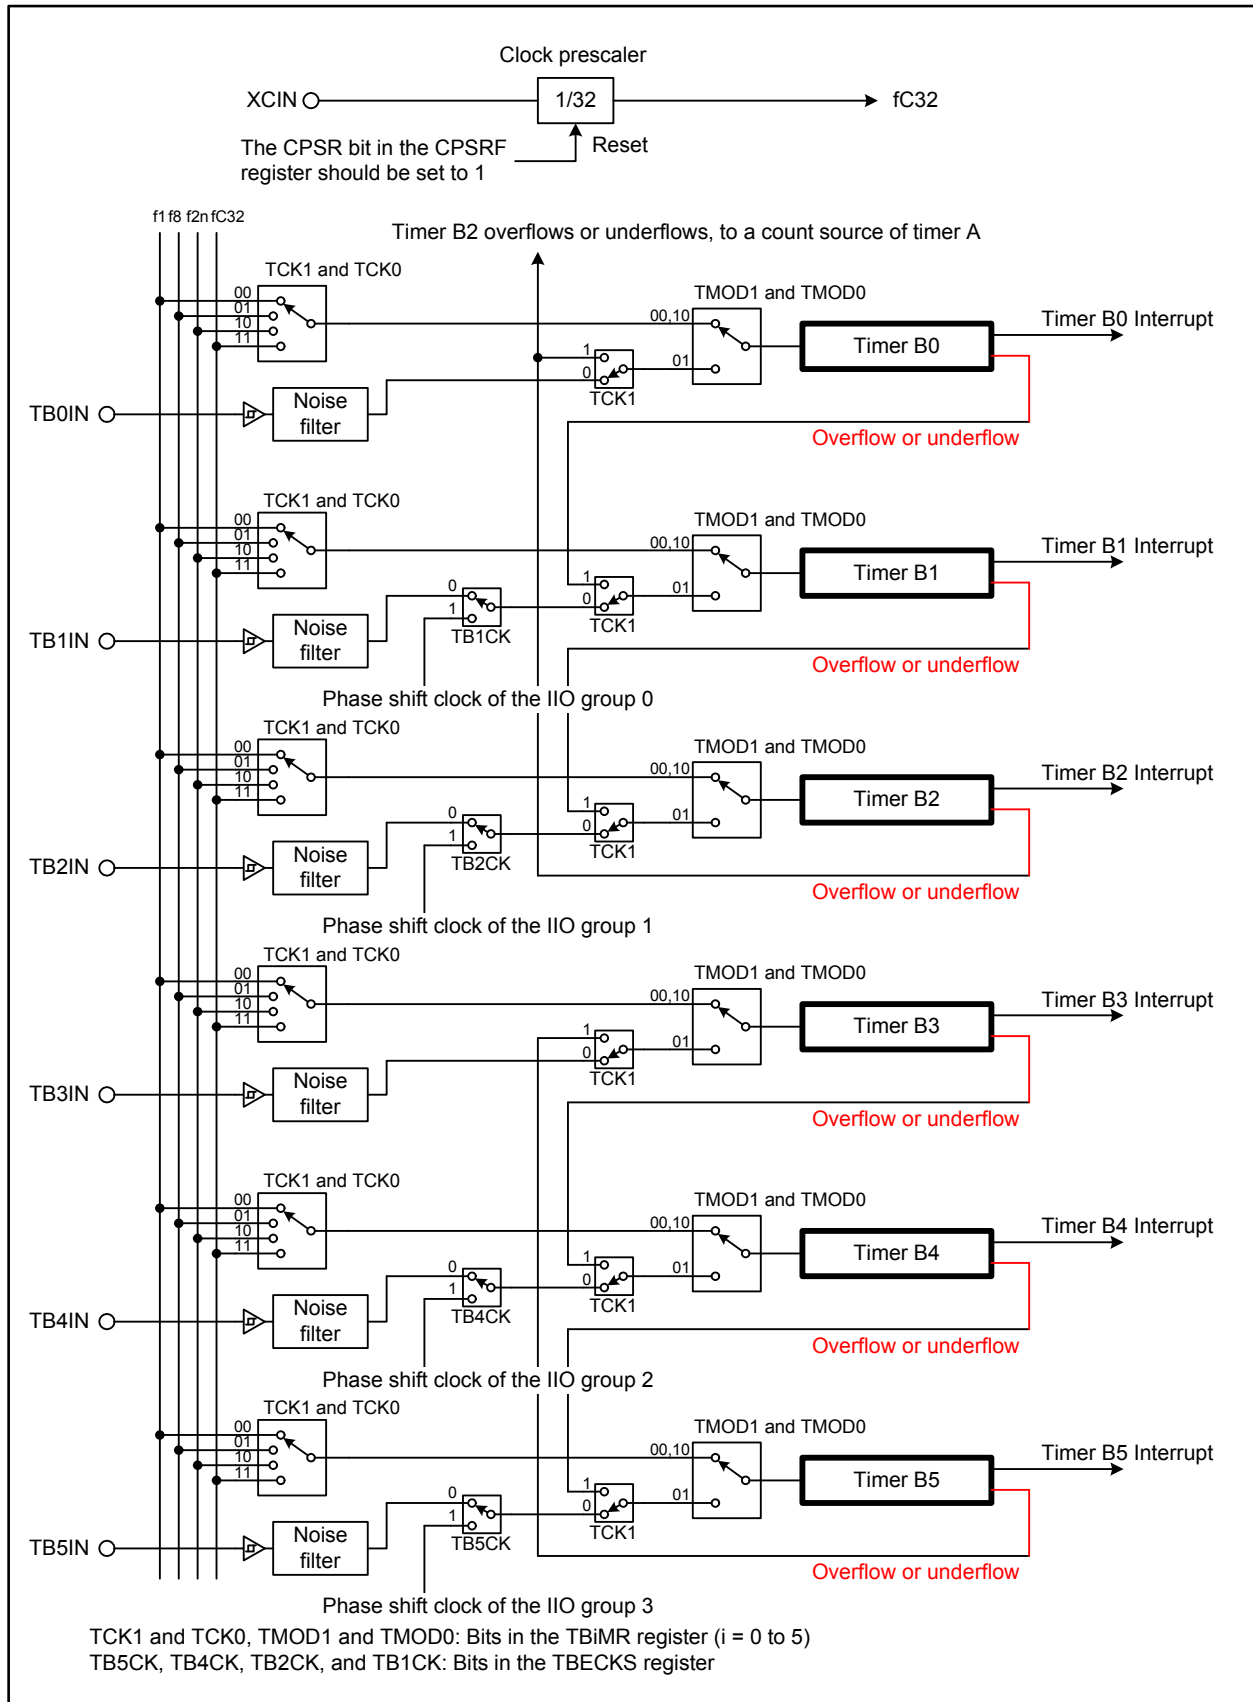
Figure 15.2 Timer B Configuration

•Page 184 of 621, Figure 15.2 is corrected as follows:

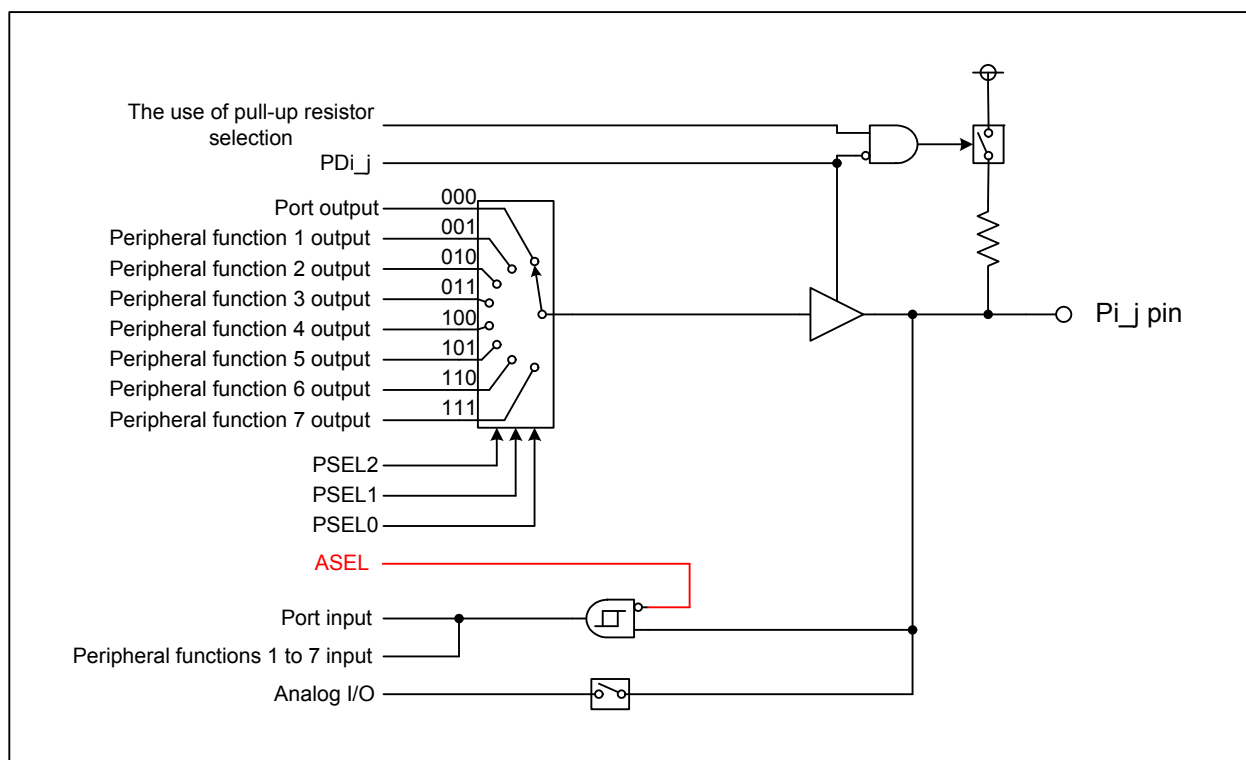
Figure 26.1 Typical I/O Pin Block Diagram (i = 0 to 15; j = 0 to 7)

- Page 493 of 621, Figure 26.1 is corrected as follows:

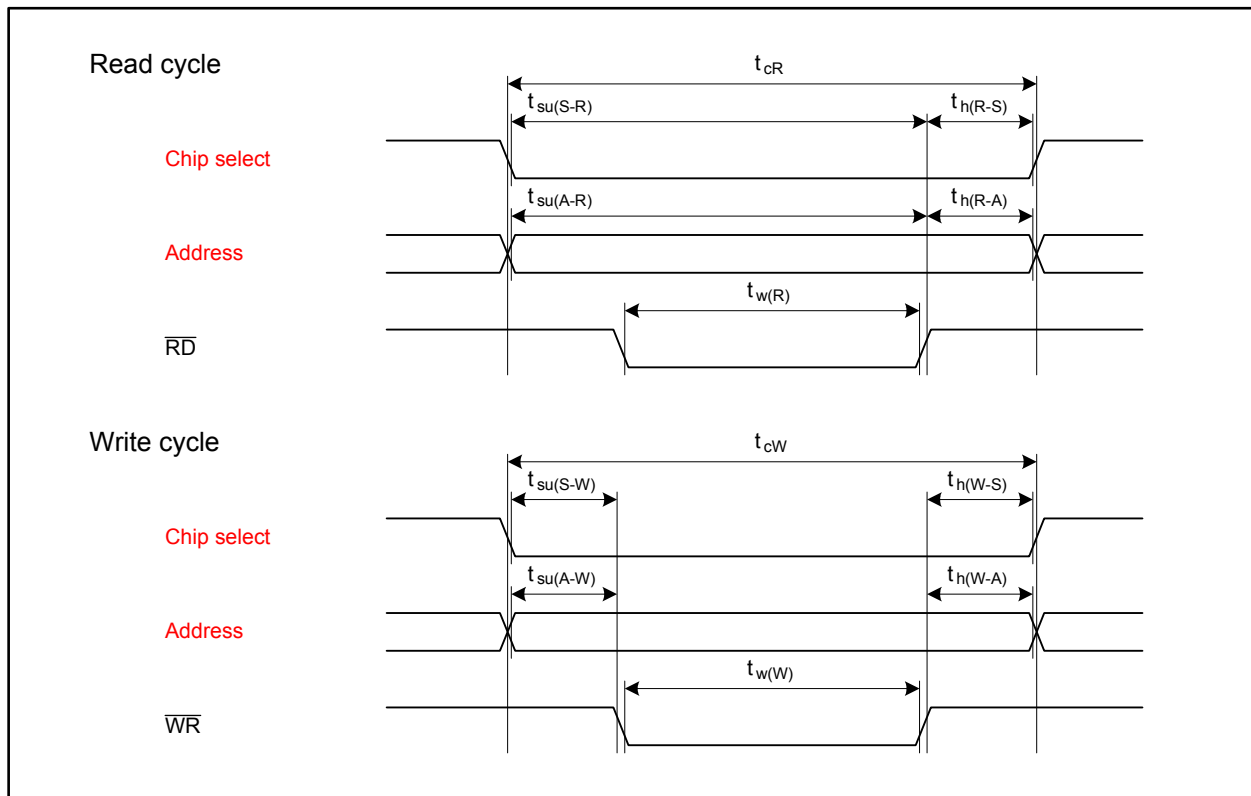
Figure 29.5 Flash Memory CPU Rewrite Mode Timing

- Page 555 of 621, description of Note 3 in Figure 28.2 is corrected as follows:
 “When this bit is set to 1, the module stops ongoing operations to enter its initial state. However, the registers are not initialized.”
- Page 555 of 621, description “This mode setting prevents data from being overwritten if a program goes out of control.” is deleted from Note 5 of Figure 28.2.
- Page 557 of 621, figure title “F2FI Register” for Figure 28.7 is corrected as follows:
 “E2FI Register”
- Page 561 of 621, description for EERR bit setting in Figure 28.12 is corrected as follows:
 “EERR bit in the E2FS0 register is 0?”
- Page 574 of 621, descriptions in Figure 29.5 are corrected as follows:
