RENESAS TECHNICAL UPDATE

Product Category	MPU & MCU	Document No.	TN-16C-A232A/E	Rev.	1.00
Title	Errata to R32C/156 Group User's Manual: Hardware		Information Category	Technical Notification	
Applicable Product	R32C/156 Group	Lot No.	Reference Document	R32C/156 Group User's Manual: Hardware Rev. 1.10 (REJ09B0506-0110)

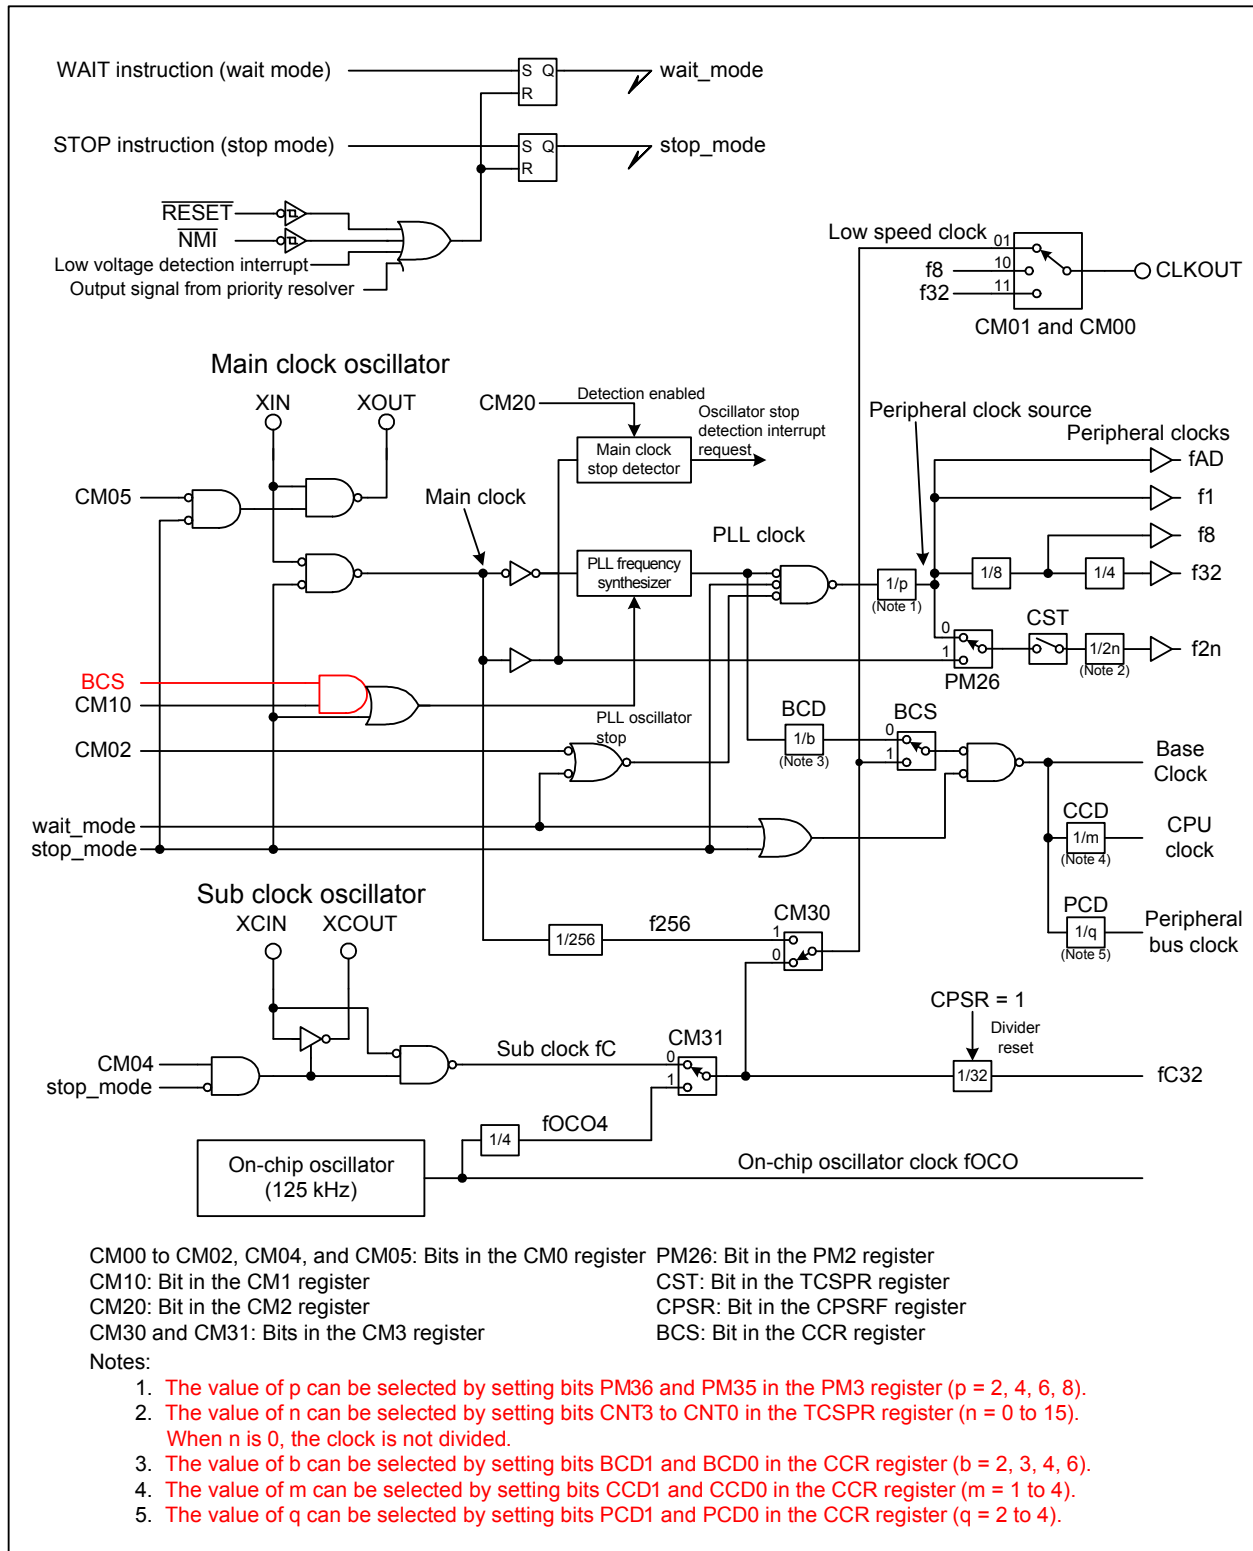
Figure 7.1 Clock Generation Circuitry

•Page 90 of 625, Figure 7.1 is corrected as follows:

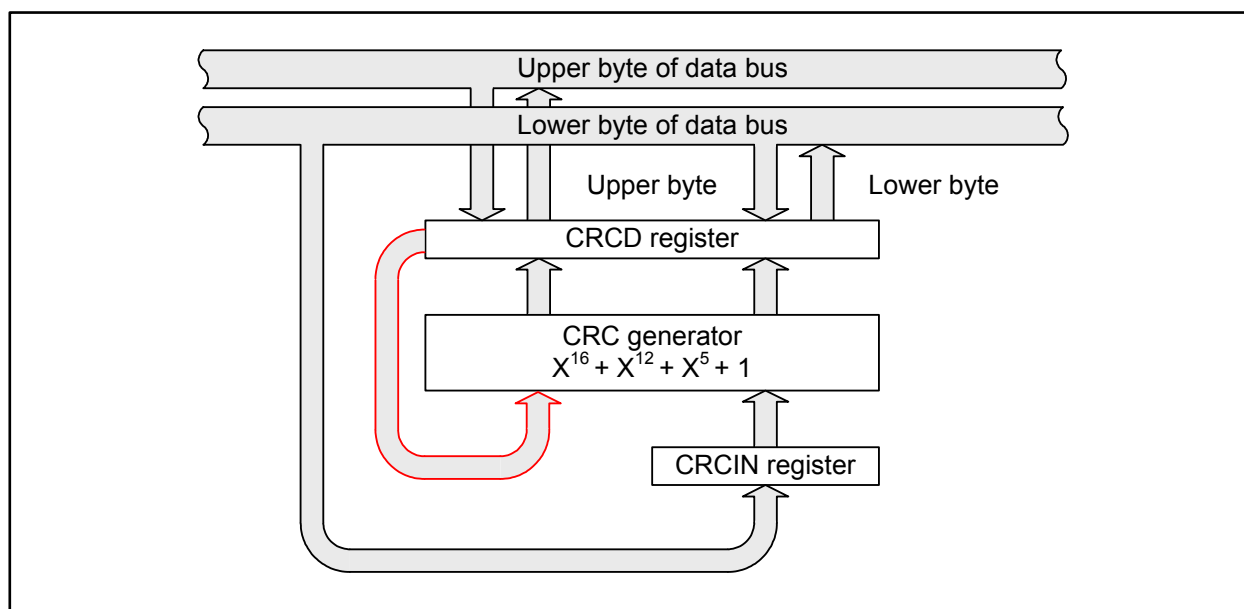
Figure 20.1 CRC Calculator Block Diagram

- Page 312 of 625, Figure 20.1 is corrected as follows:
